# Development of Best Practices for Inspection of PT Bridges in Minnesota

Minnesota  
Department of  
Transportation

**April 2012**

Research Project  
Final Report 2012-09

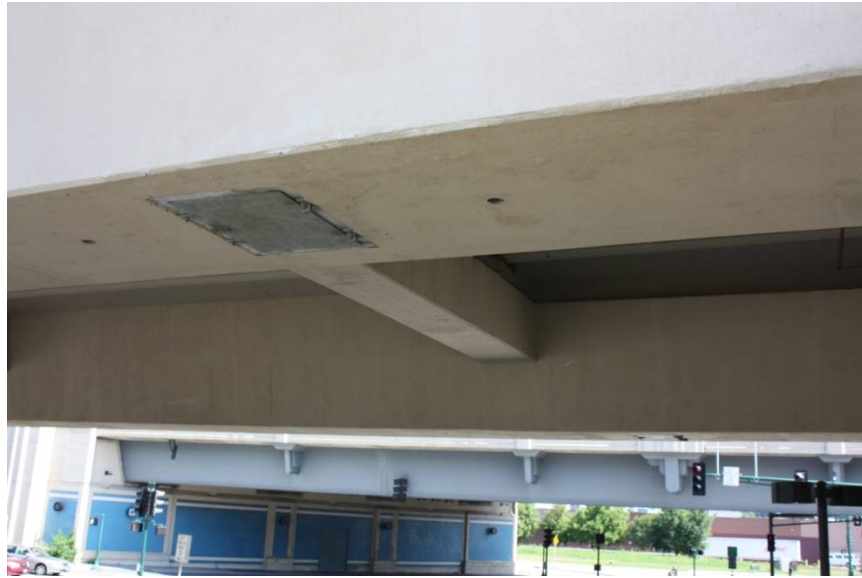
An inspection of the numerous access hatch doors showed no corrosion on the steel indicating there is no trapped water within the box girder. Figure 5.2 shows a typical access hatch along the bottom of the box girder.

**Figure 5.2. Access hatch of bridge 27262**

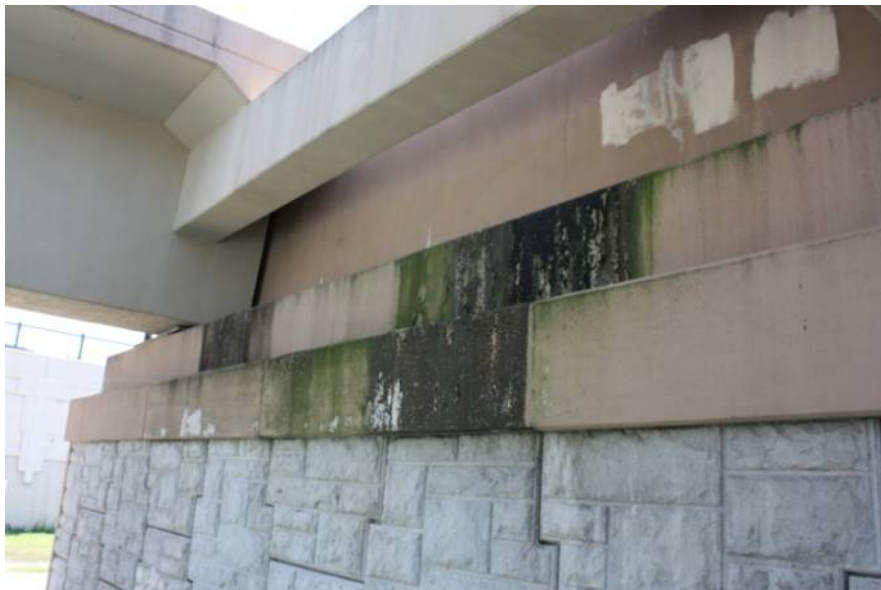
The abutment at one end of the structure had a substantial amount of discoloration. Figure 5.3 shows this discoloration, which is not staining any parts of the PT box girders.

**Figure 5.3. Discoloration of abutment**

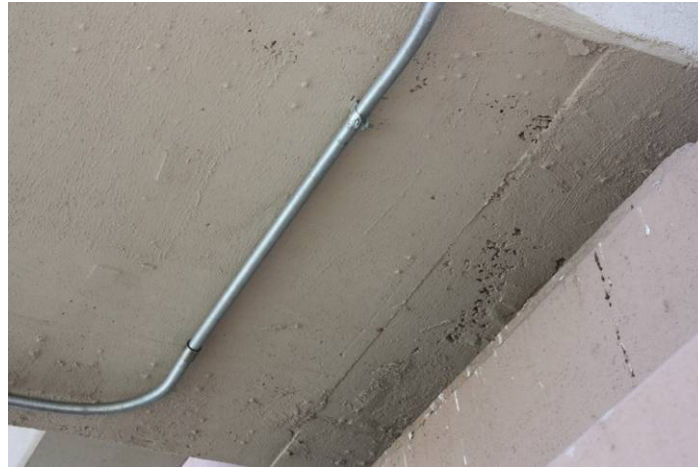
A closer look at one of the box girders showed signs of minor honeycombing. This is an indication of poor consolidation at the time of construction. Figure 5.4 shows a sample of the honeycombing that was observed along the bottom of the box girders.

**Figure 5.4. Honeycombing along bottom of box girder**

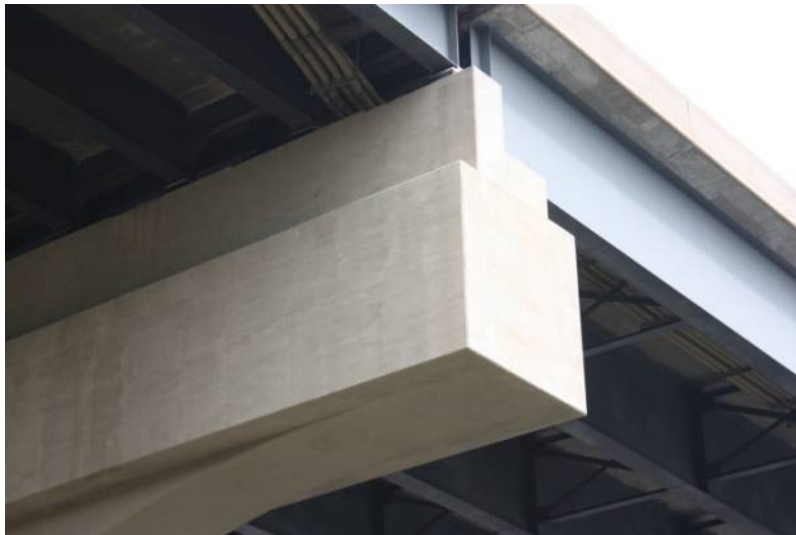
A closer look at the pour back area showed no signs of PT related cracking. Figure 5.6 shows a close-up of a typical pour back area on the post-tensioned pier.

**Figure 5.6. Post-tensioned pier cap**

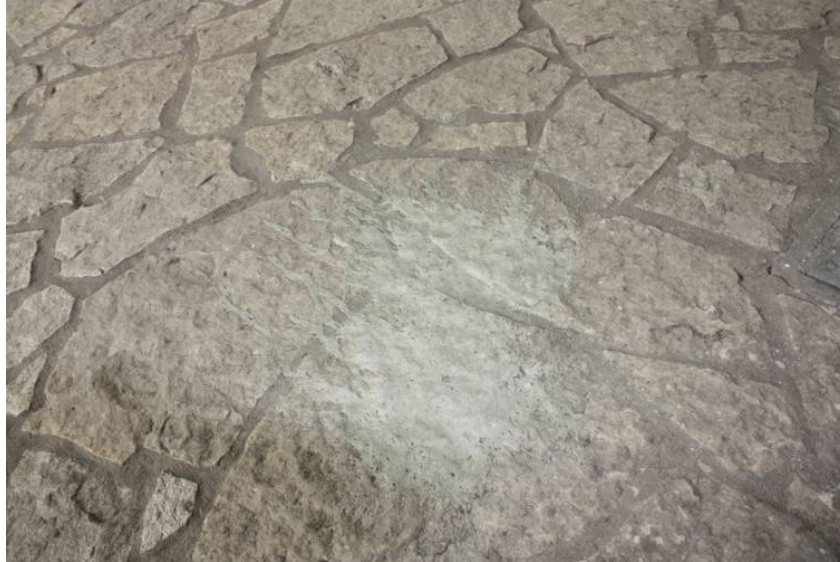
Below one of the access hatch coverings was evidence of grout spillage. An area of approximately 3 square feet (.91 square meters) has heavy grout splatter which is a potential indication of grouting issues during construction. Two possible causes of the grout splatter are most likely: grout from venting that was not captured or leakage during grouting. The tendon above this area should be inspected (through invasive drilling and borescope) to determine if voids are present. Figure 5.8 shows the grout splatter on the slope near the abutment.

**Figure 5.8. Grout splatter beneath access hatch**

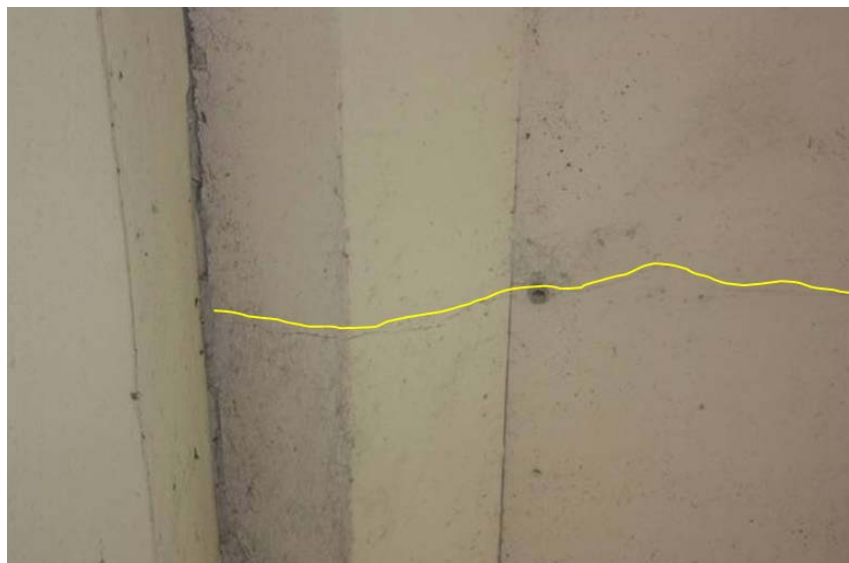
Cracking was observed running along the bottom of the box girders that extended in the longitudinal direction from the abutment into the span. Figure 5.9 shows these cracks along the bottom of the box girders (highlighted in yellow). These cracks may be related to the location of the PT tendon and also can provide access of moisture and other aggressive agents to the duct. When the inspection is done to evaluate the tendon in the area of the grout spill, an inspection of the inside of the box sections should also be conducted with particular focus near the end region cracked area.

**Figure 5.9. Cracking along box girder**

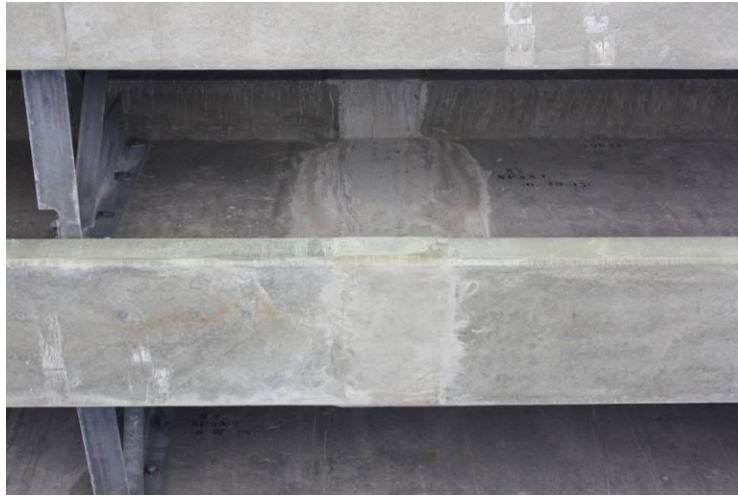
The bridge received an inspection of recommendation of 7 (see section 4.1.11 for justification). The bridge had no major problem indicators, but received this relatively high recommendation since it is one of the few spliced PT bridges in Minnesota. Visual inspection showed no indicators of PT related distress. Figure 5.10 shows one of the splice regions – no problems were noted for any of the splice areas.

**Figure 5.10. Splice region**

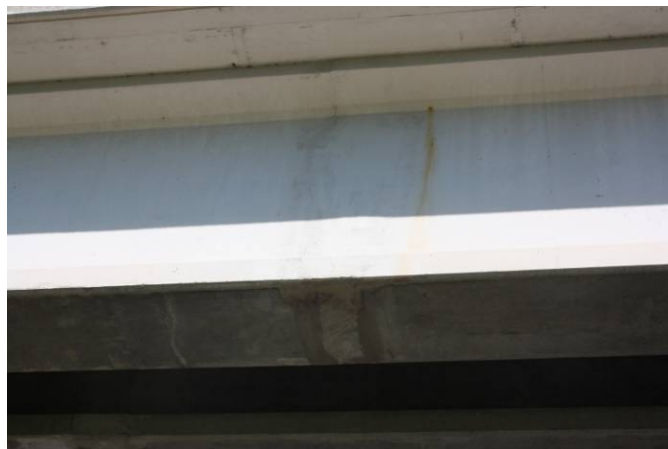
Near the drainage system some light staining was seen. Figure 5.11 shows this staining that was seen on the exterior girder of the structure. Based on the condition of the bridge (visual inspection from the ground and review of documentation), no recommendations for additional inspection are needed at this time.

**Figure 5.11. Moisture staining on exterior girder**

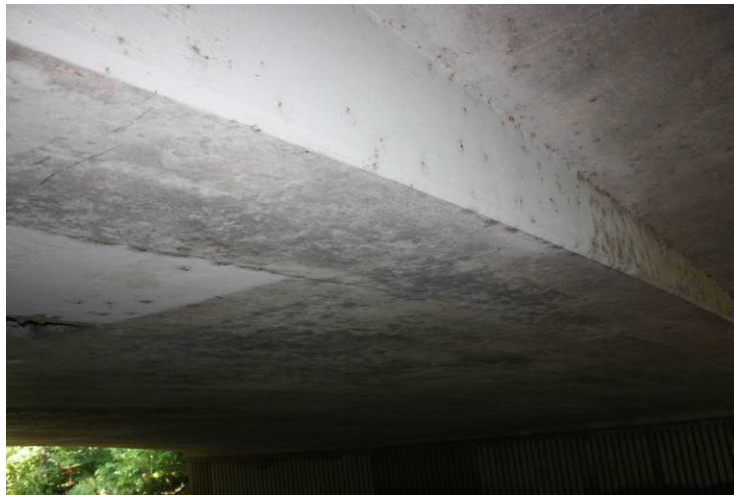
Cracking was seen in various regions along the bottom of the slab span, but none that had direct indications of PT distress in the structure. Figure 5.13 shows the slab span across the underlying creek.

**Figure 5.13. Slab span of bridge 27547**

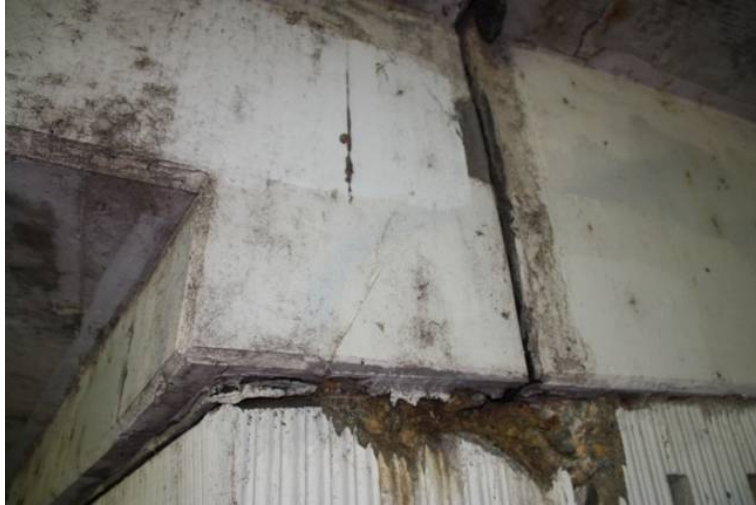
Areas of concrete spalling were seen at various locations of the structure, but this is expected in a structure of this age. The locations of the spalling did not indicate any issues with the PT of the structure. Figure 5.14 shows the spalling and moisture staining at the abutment as well as cracking. The structure's regular inspections are sufficient at this time (no special PT related inspections needed).

**Figure 5.14. Spalling at abutment of bridge 27547**

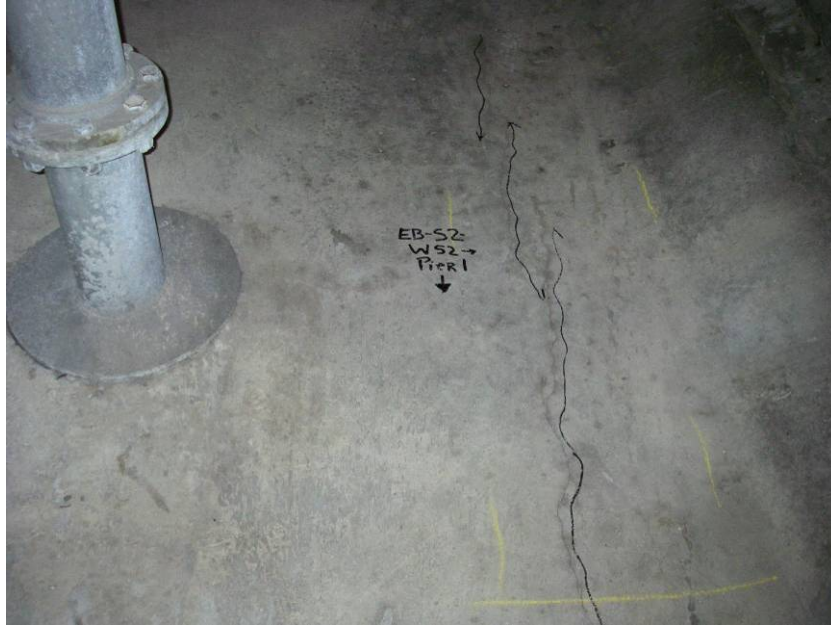
**Figure 6.11. Cracking in span 2 eastbound structure**

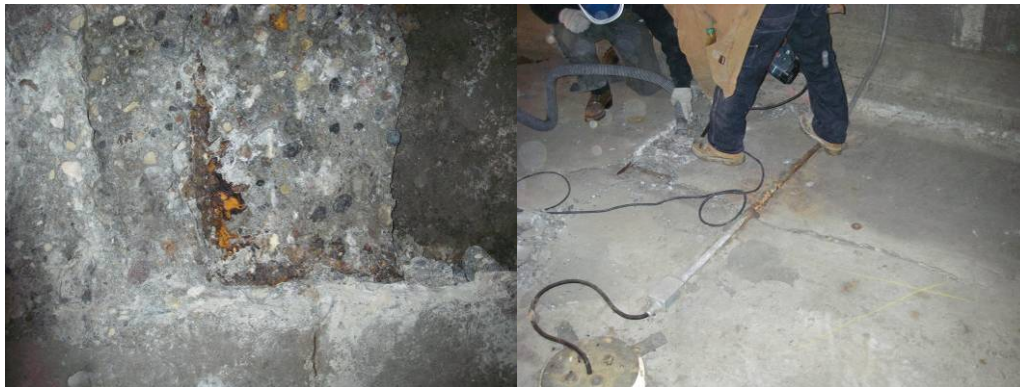
**Figure 6.19. (Left) Corrosion product under spalling area at mid span**

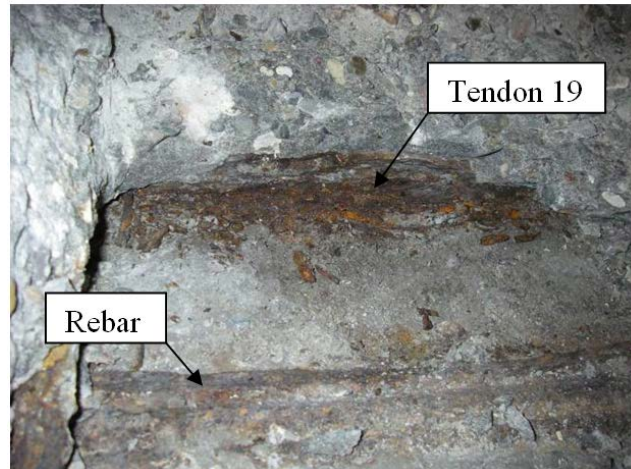
**Figure 6.21. Corroded rebar and tendon 19**

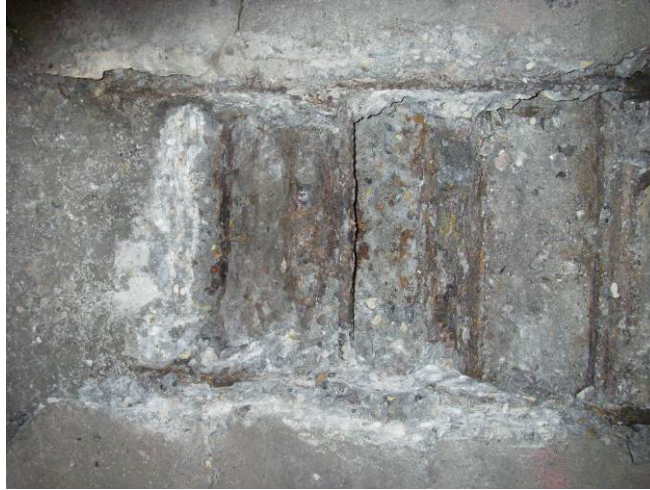
Further removal of the concrete cover exposed tendons B18 and B17 as shown in figure 6.23 below. Like tendon B19, tendons B18 and B17 are corroded to the point that individual wires cannot be identified.

**Figure 6.23. Overall view of opened/chipped area at mid span**

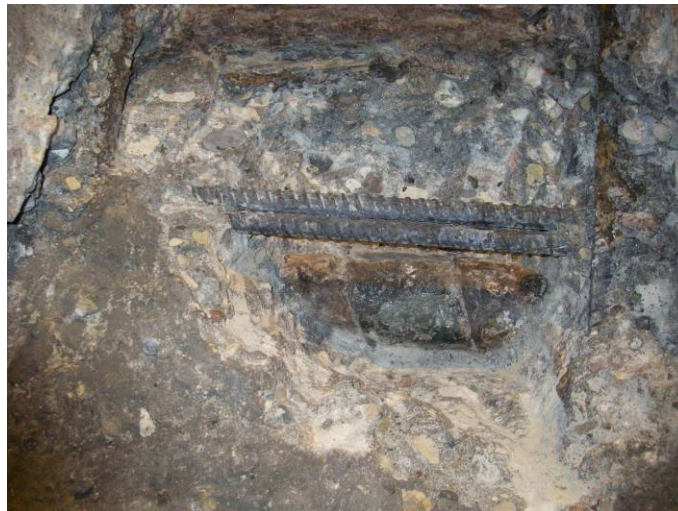
**Figure 6.24. Shows tendon 16 with corroded duct**

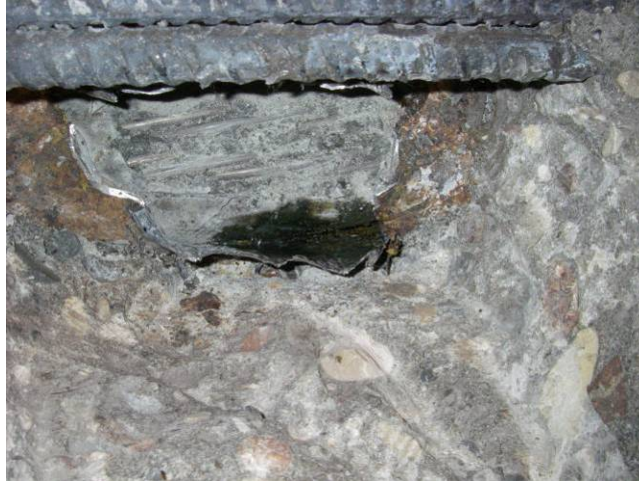
**Figure 6.25. Opened tendon 16 with green corrosion product**

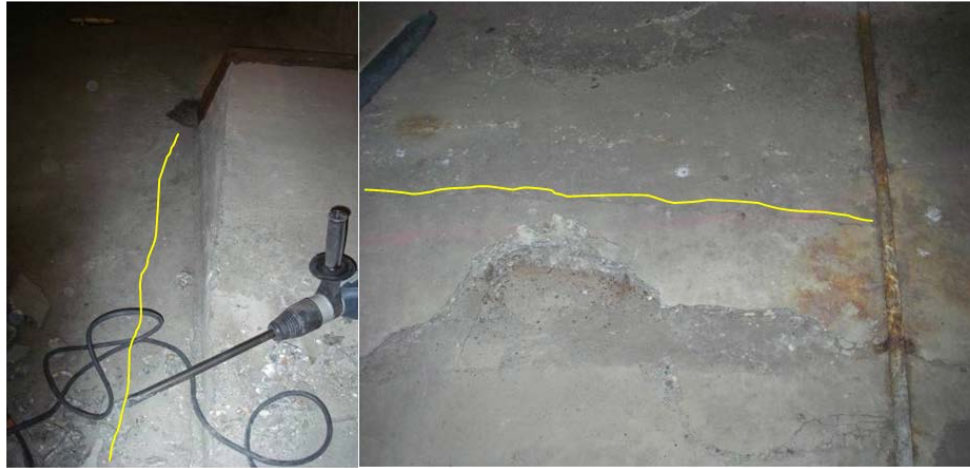
**Figure 6.27. (Left) Crack along anchorage of tendon B28/B24**

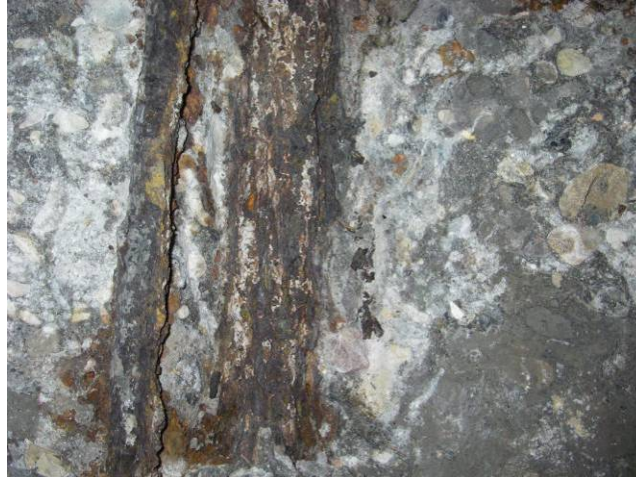
**Figure 6.32. Corrosion on tendon B28**

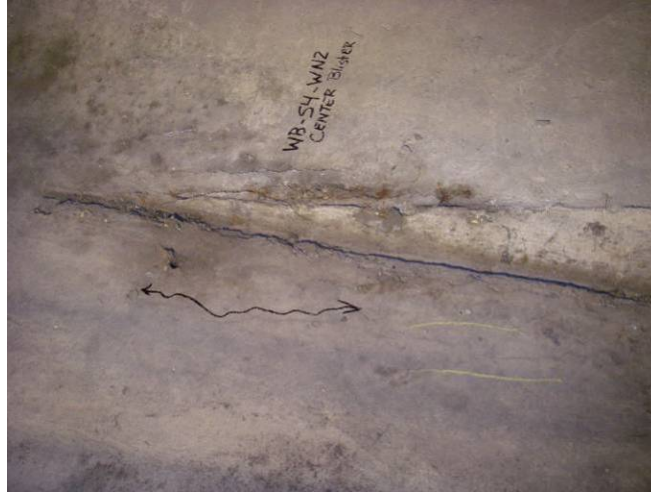
**Figure 6.36. Cracking along anchorage blister in span 4**

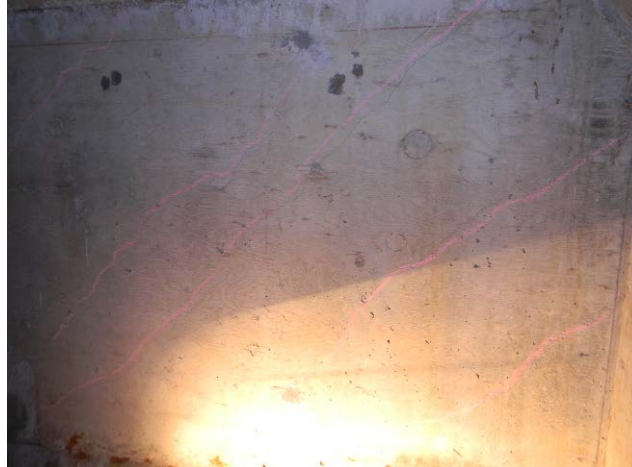
**Figure 7.8. Diagonal cracking on interior of box girder**

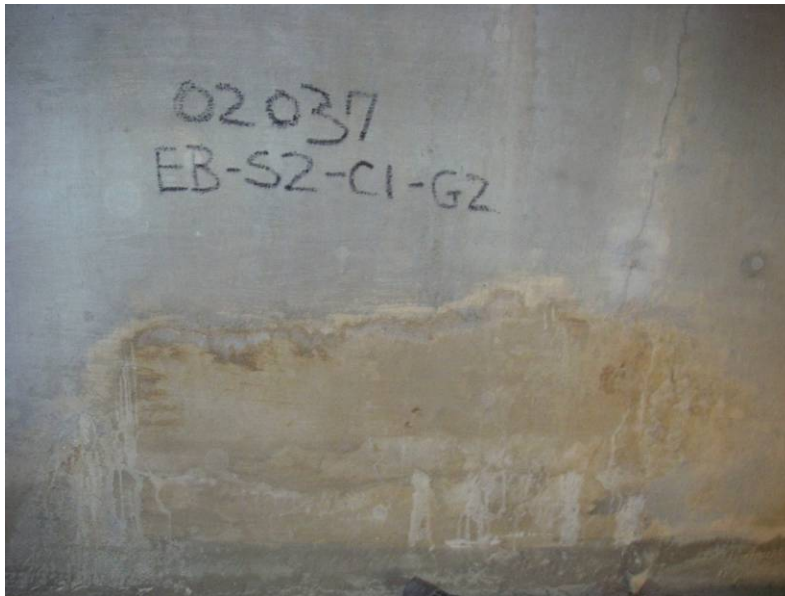
**Figure 8.2. Discolored patchwork at mid span (Span 2)**

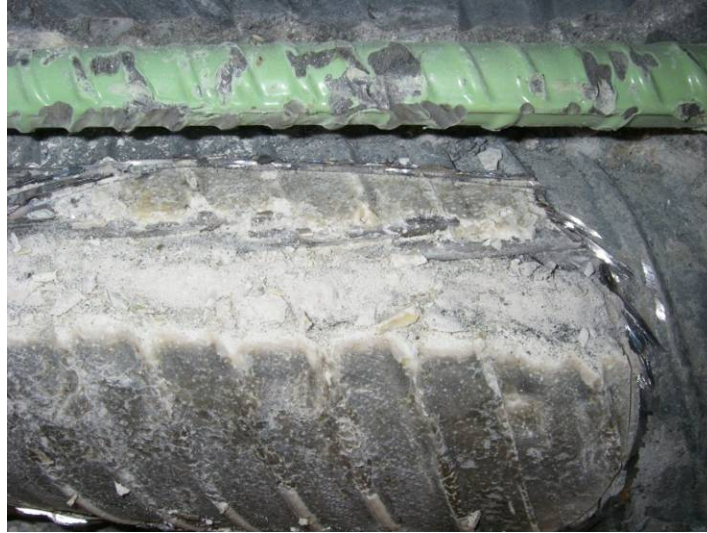
**Figure 8.7. Bleed trail in tendon 2**

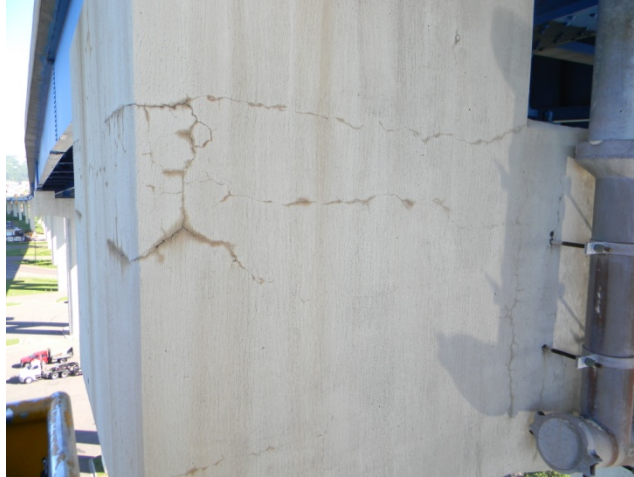
**Figure 9.2. Cracking extending from anchorage on PT pier cap**

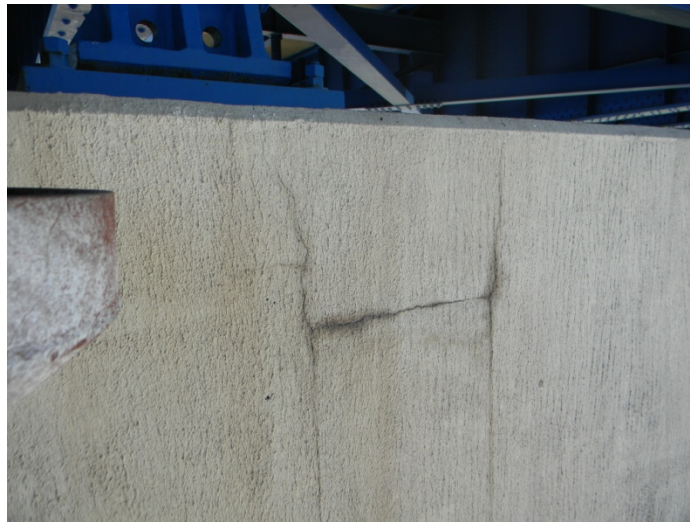
**Figure 9.3. Vertical and horizontal cracking in pier**

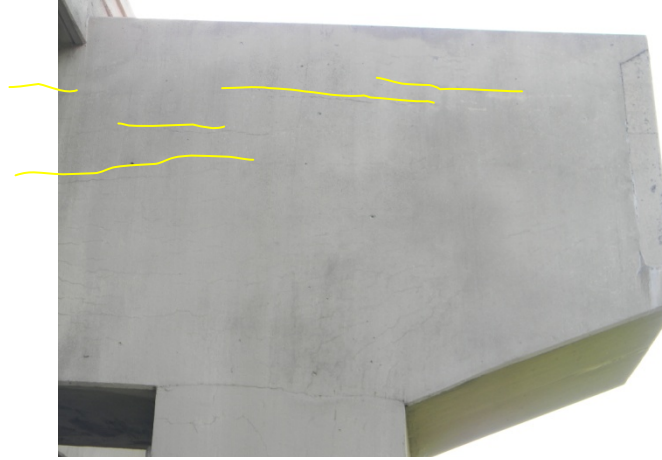
**Figure 10.2. Cracking along straddle bent**
