# **Maintenance Painting for Steel Bridges: Evaluation of Coating Systems Over Minimally Prepared Surfaces to Delay Rehabilitation**

**Daniel J. Zienty, Principal Investigator**  
Short Elliott Hendrickson Inc.

**August 2019**

Research Project  
Final Report 2019-37

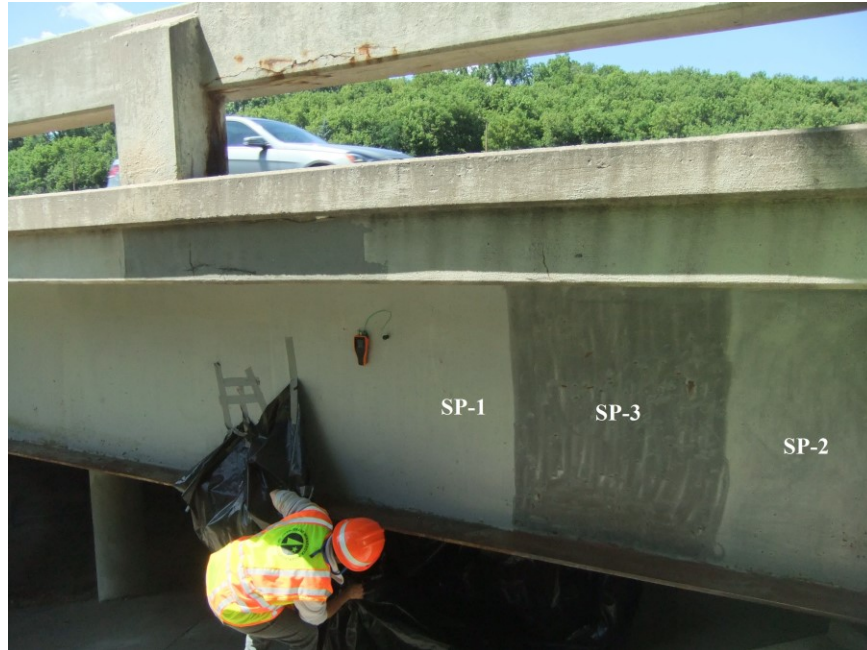
**Figure 4.5 Test Location 1 Surface Preparation**

4.6.1.3 SP3 was accomplished with an electric grinder and wire wheel. Resulting surface profile for SP3 was 2.6 mils. Followed by SP-1 using manufacturer recommended solvent to reduce residual contaminants

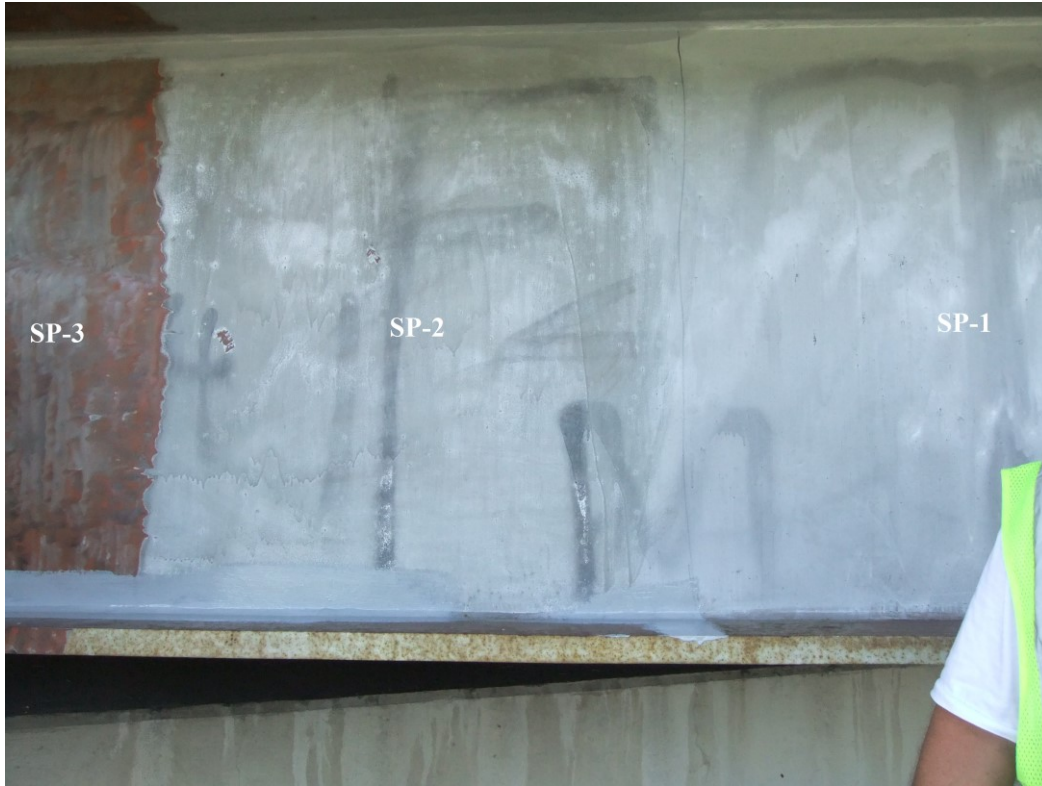
**Figure 4.6 Test Location 2 Surface Preparation**

4.6.2.3 SP3 was accomplished with an electric grinder and wire wheel. The surface profiles following surface preparation was 2.6 mils for areas cleaned to meet SP3. Followed by SP-1 using manufacturer recommended solvent to reduce residual contaminants.

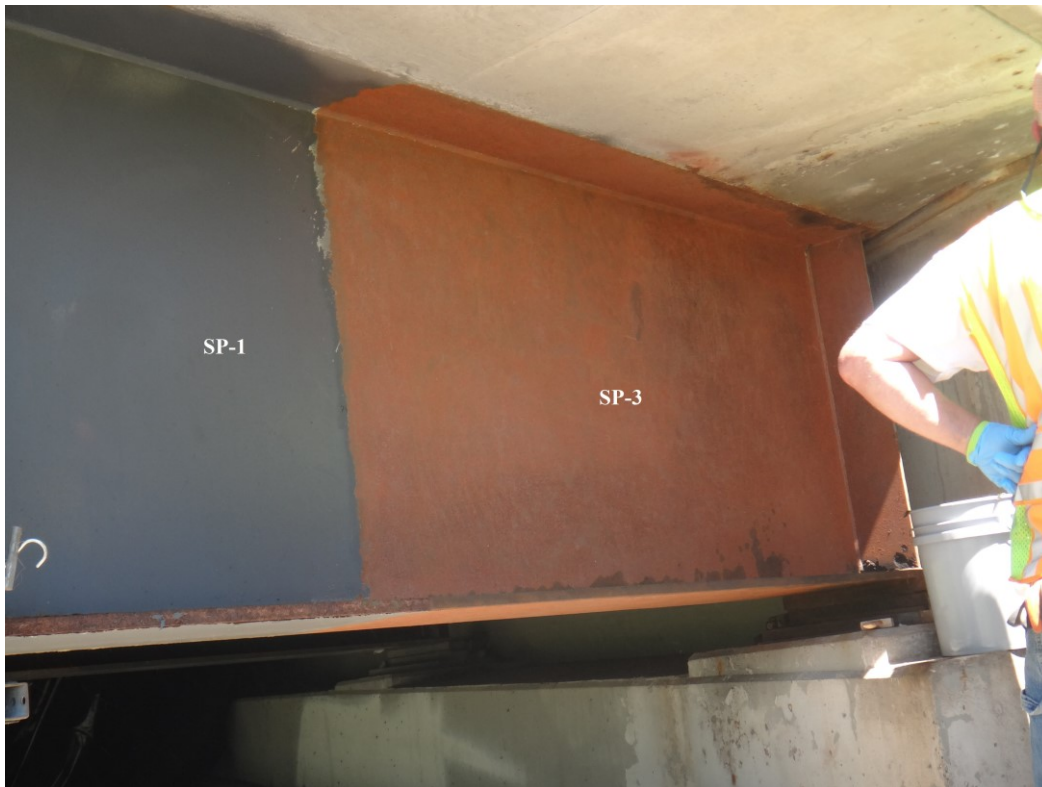
Figure 4.7 Test Location 4 Surface Preparation

4.6.3.2 SP3 removal was accomplished with a needle gun. An average 2.7 mil surface profile was achieved through power tool cleaning. SP2 Hand Tool cleaning was not completed at this location. Followed by SP-1 using manufacturer recommended solvent to reduce residual contaminants.

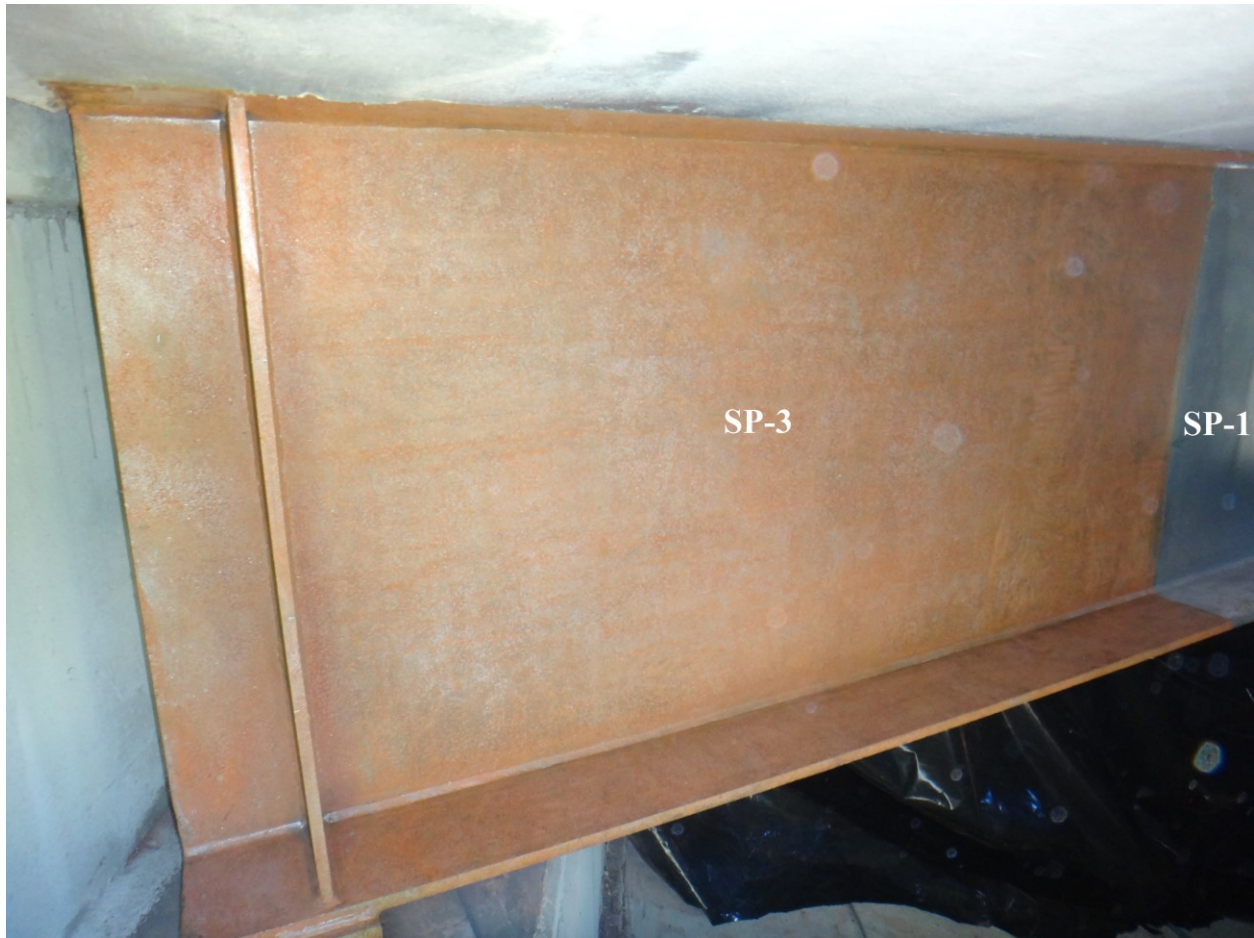
Figure 4.8 Test Location 4 Surface Preparation

4.6.4.2 SP3 was accomplished with an electric grinder and wire wheel, resulting in an average profile of 2.9 mils. Followed by SP-1 using manufacturer recommended solvent to reduce residual contaminants

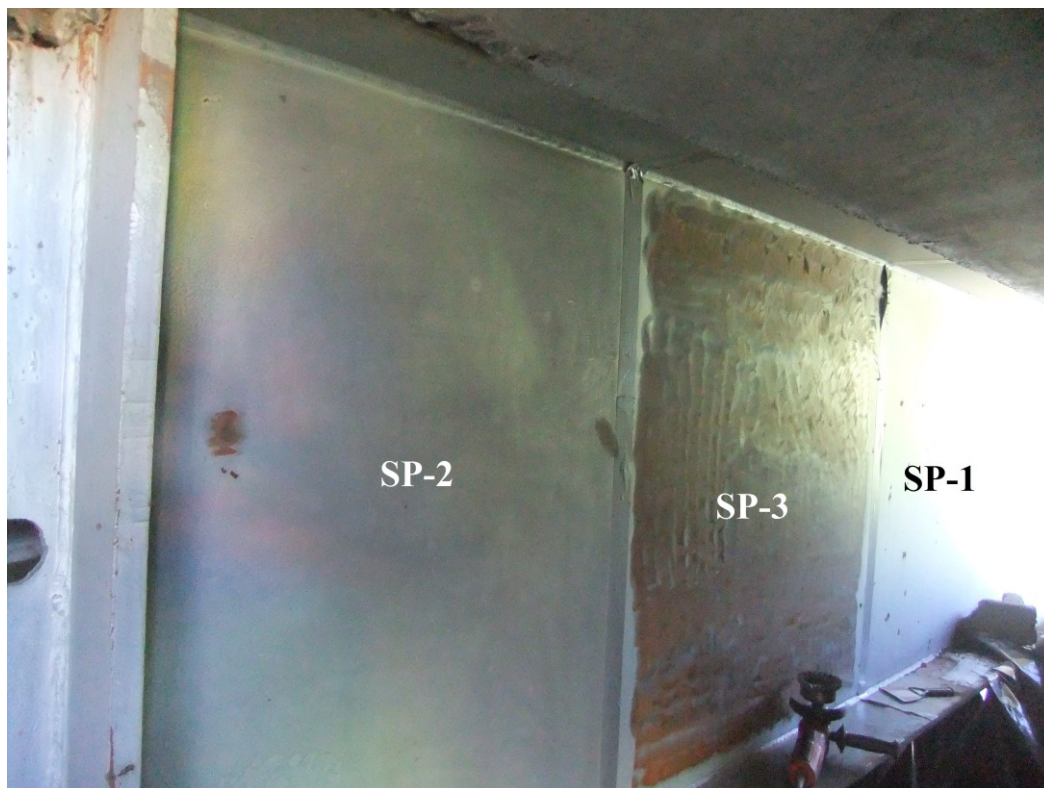
**Figure 4.9 Test Location 5 Surface Preparation**

4.6.5.3 An electric grinder with wire wheel to meet SP3 was complete with a surface profile of 2.4 mils. Followed by SP-1 using manufacturer recommended solvent to reduce residual contaminants.

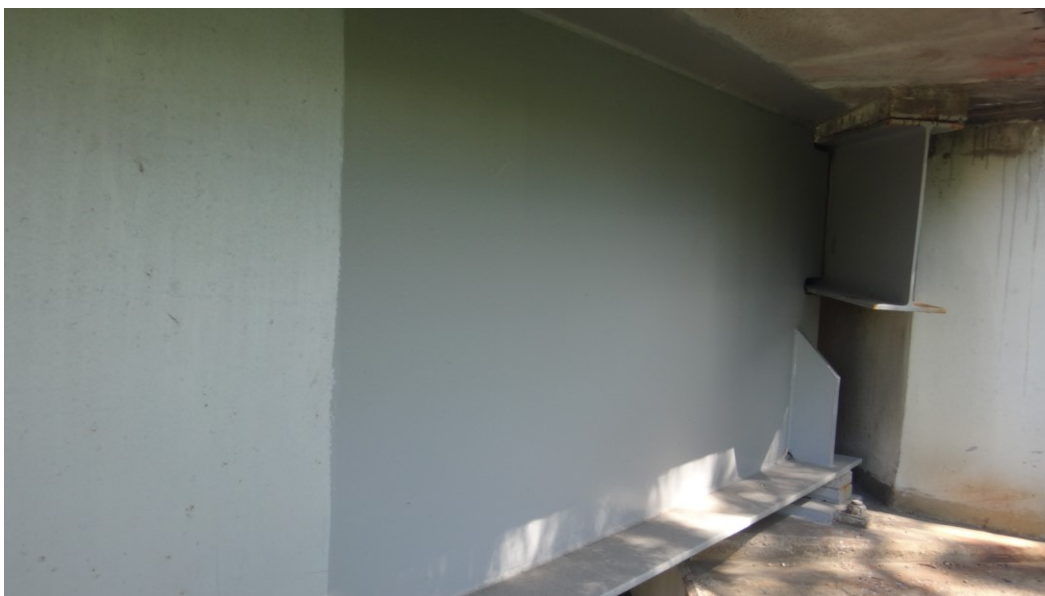
**Figure 7.1 Test Location 1 - One Year Exposure**

Condition	Severe	Poor	Fair	Good
Rusting (ASTM D 610)				X
Blistering (ASTM D 714)				X
Cracking				X
Peeling				X
Pitting (ASTM G-46)				X
Chalking				X
Delamination				X

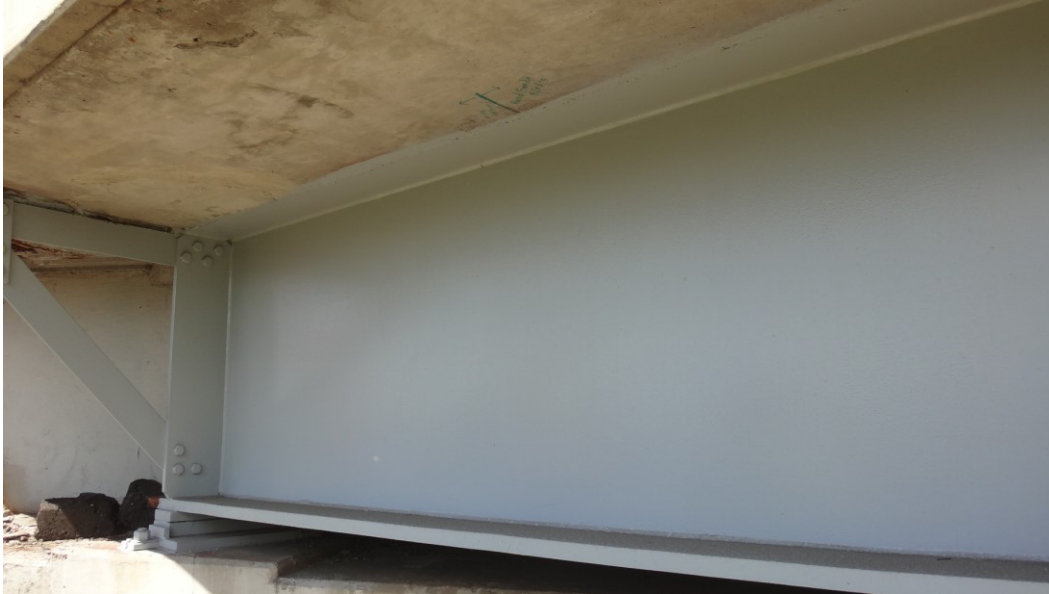
**Figure 7.2 Test Location 2 – One Year Exposure**

Chalking				X
Delamination				X

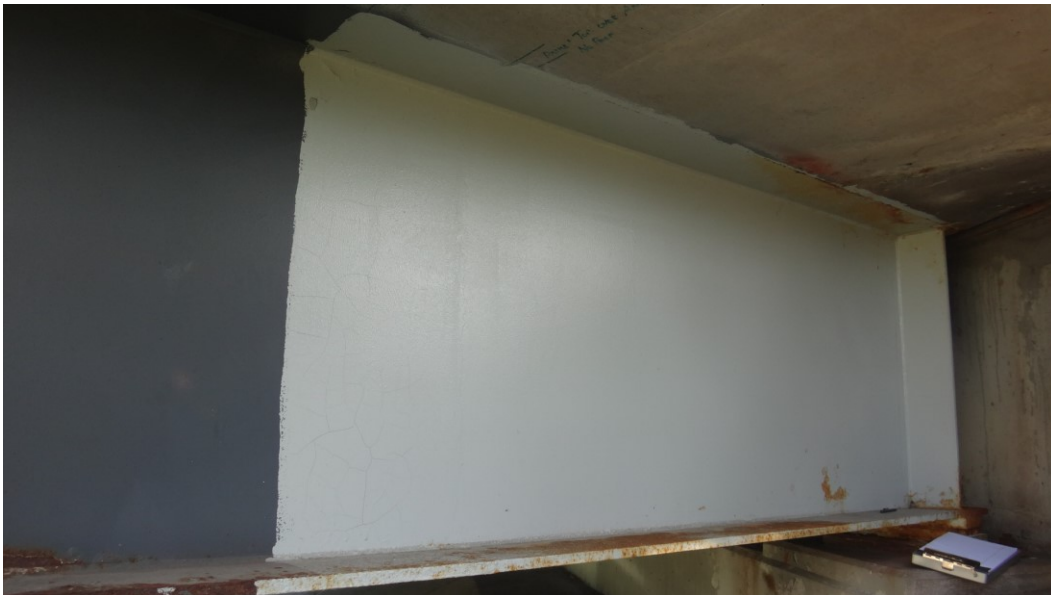
**Figure 7.3 Test Location 3 - One Year Exposure**

Condition	Severe	Poor	Fair	Good
Rusting (ASTM D 610)			X	
Blistering (ASTM D 714)				X
Cracking		X		
Peeling			X	
Pitting (ASTM G-46)				X
Chalking				X
Delamination			X

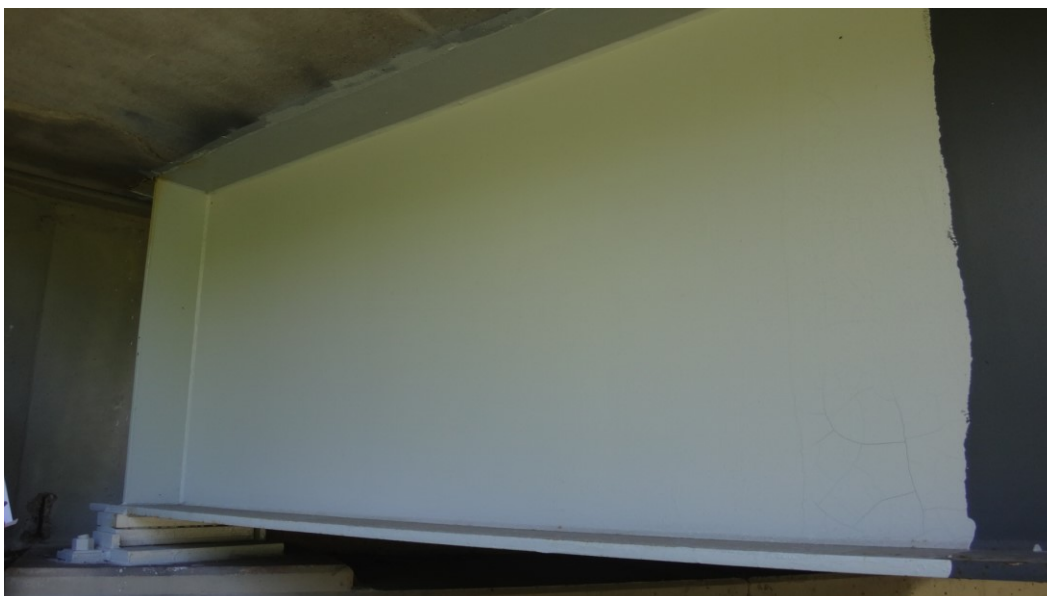
Figure 7.4 Test Location 4 - One Year Exposure

Condition	Severe	Poor	Fair	Good
Rusting (ASTM D 610)				X
Blistering (ASTM D 714)				X
Cracking			X	
Peeling				X
Pitting (ASTM G-46)				X
Chalking				X
Delamination				X

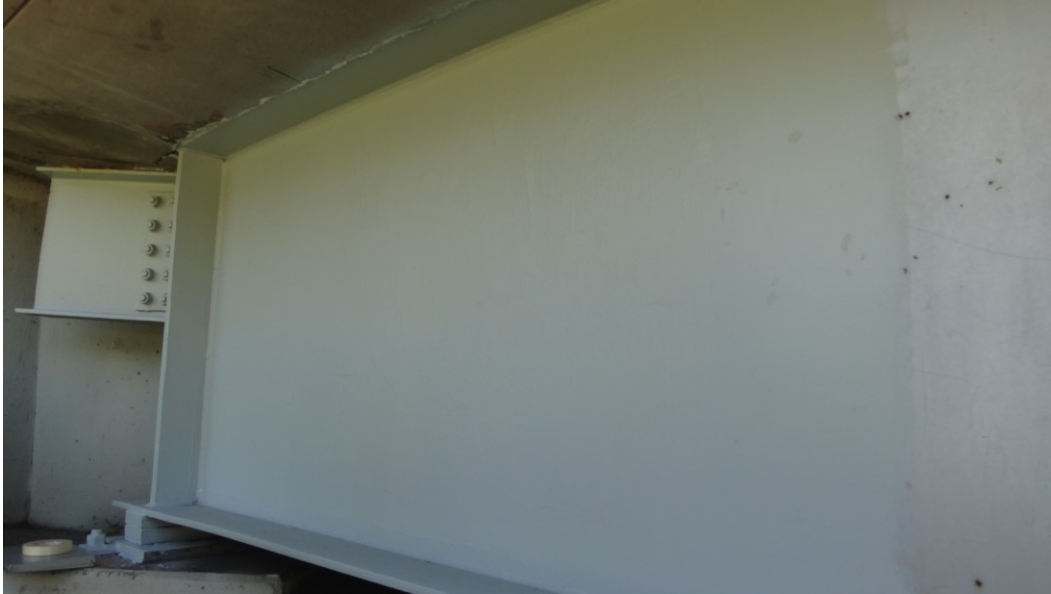
**Figure 7.5 Test Location 5 - One Year Exposure**

Chalking				X
Delamination				X

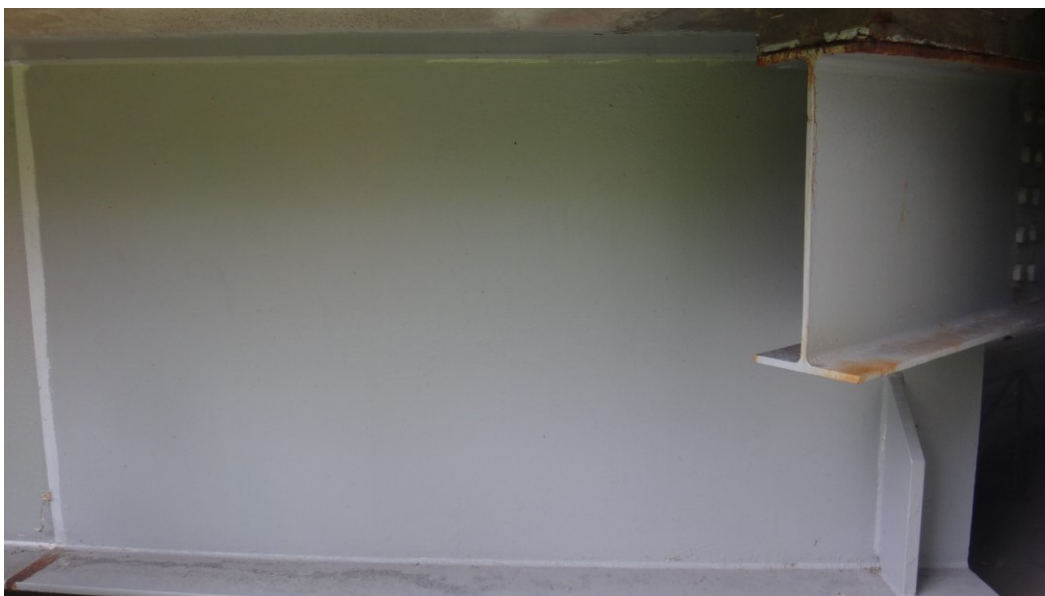
**Figure 9.1 Test Location 1 - Two Year Exposure**

Condition	Severe	Poor	Fair	Good
Rusting (ASTM D 610)				X
Blistering (ASTM D 714)				X
Cracking				X
Peeling				X
Pitting (ASTM G-46)				X
Chalking				X
Delamination				X

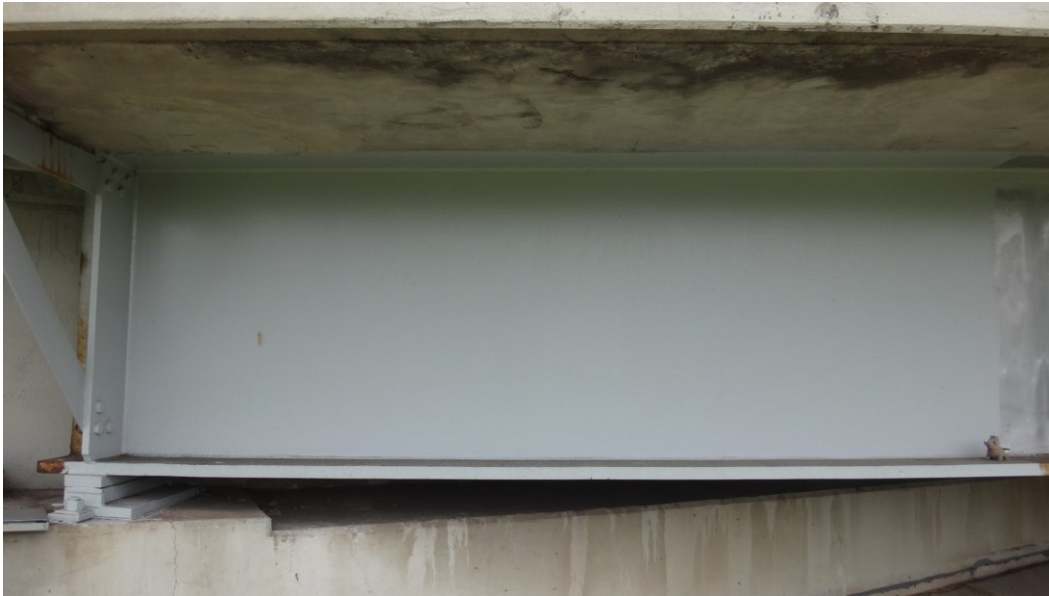
**Figure 9.2 Test Location 2 - Two Year Exposure**

Chalking				X
Delamination			X

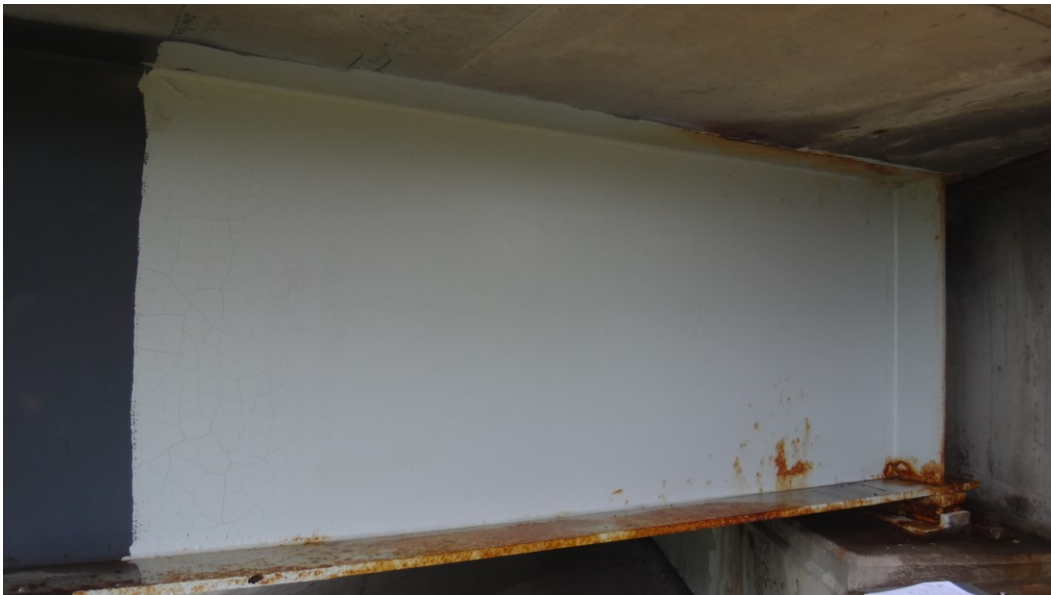
**Figure 9.3 Test Location 3 – Two Year Exposure**

Condition	Severe	Poor	Fair	Good
Rusting (ASTM D 610)		X		
Blistering (ASTM D 714)				X
Cracking		X		
Peeling		X		
Pitting (ASTM G-46)				X
Chalking				X
Delamination		X

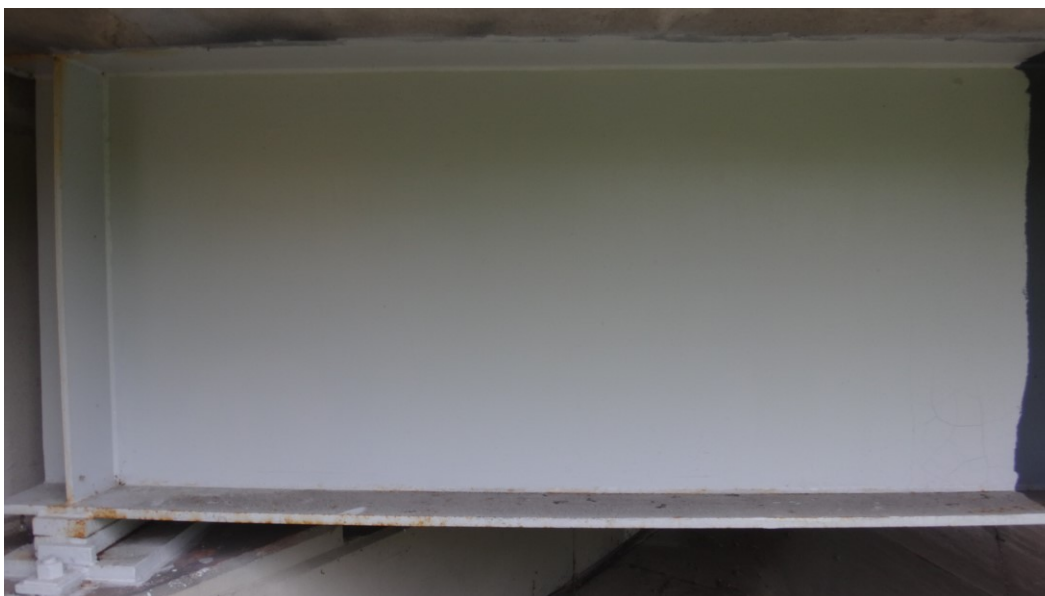
**Figure 9.4 Test Location 4 - Two Year Exposure**

Condition	Severe	Poor	Fair	Good
Rusting (ASTM D 610)				X
Blistering (ASTM D 714)				X
Cracking			X	
Peeling				X
Pitting (ASTM G-46)				X
Chalking				X
Delamination				X

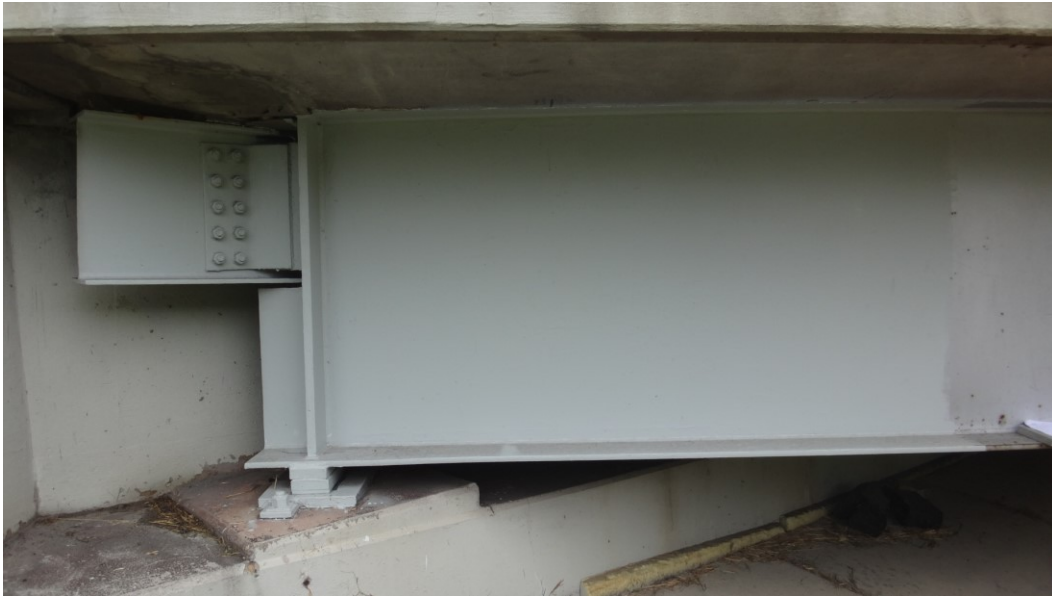
**Figure 9.5 Test Location 5 - Two Year Exposure**

Chalking				X
Delamination				X

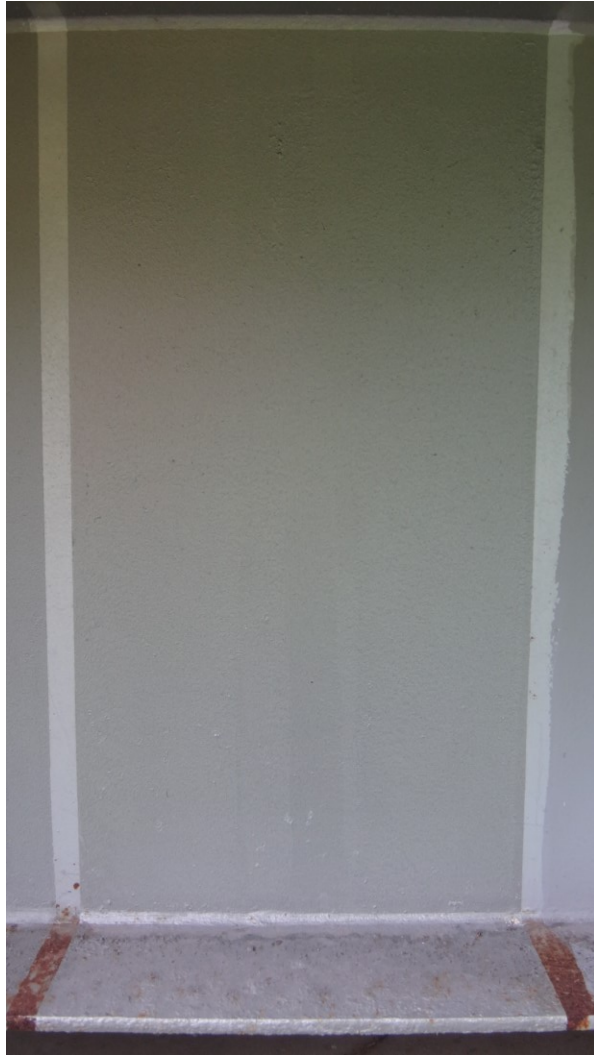
**Figure 10.1 Additional Test Patch Location A - One Year Exposure**

Condition	Severe	Poor	Fair	Good
Rusting (ASTM D 610)			X	
Blistering (ASTM D 714)				X
Cracking				X
Peeling				X
Pitting (ASTM G-46)				X
Chalking				X
Delamination				X

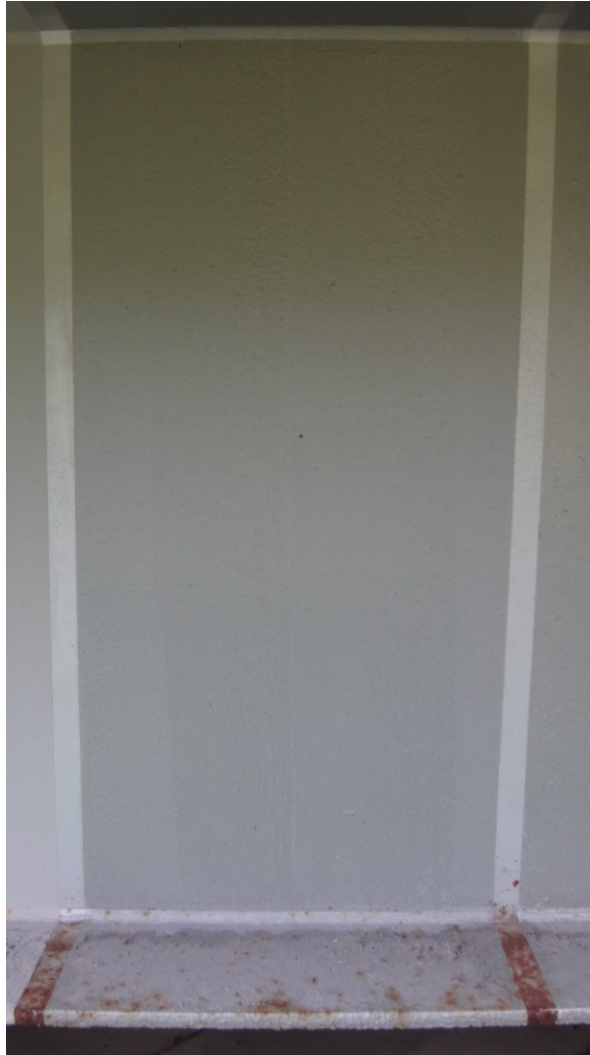
**Figure 10.2 Additional Test Patch Location B - One Year Exposure**

Condition	Severe	Poor	Fair	Good
Rusting (ASTM D 610)			X	
Blistering (ASTM D 714)				X
Cracking				X
Peeling				X
Pitting (ASTM G-46)				X
Chalking				X
Delamination				X

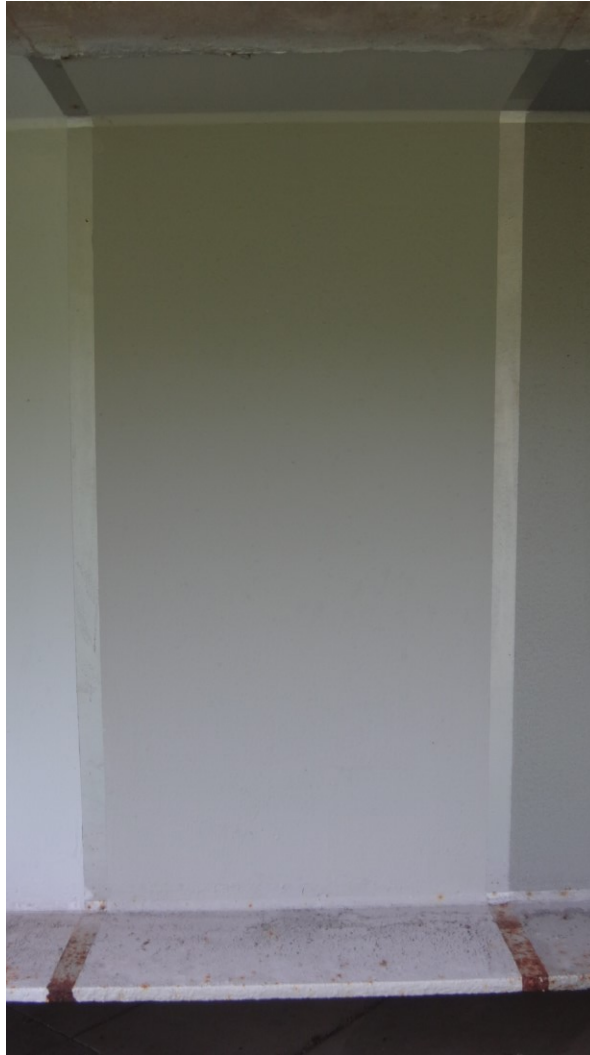
**Figure 10.3 Additional Test Patch Location C - One Year Exposure**

Condition	Severe	Poor	Fair	Good
Rusting (ASTM D 610)			X	
Blistering (ASTM D 714)				X
Cracking				X
Peeling				X
Pitting (ASTM G-46)				X
Chalking				X
Delamination				X

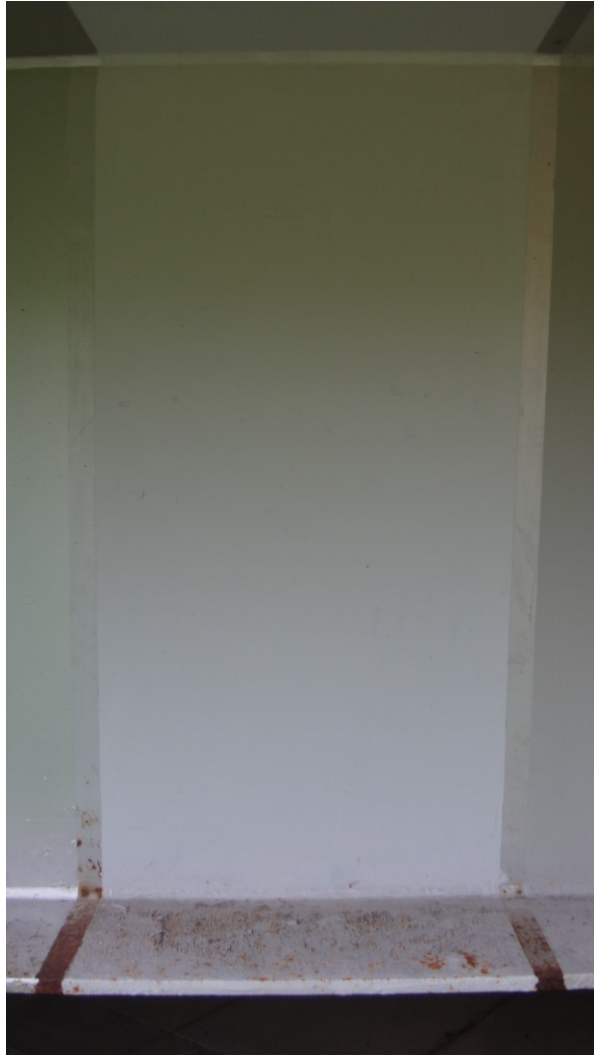
**Figure 10.4 Additional Test Patch Location D - One Year Exposure**

Condition	Severe	Poor	Fair	Good
Rusting (ASTM D 610)			X	
Blistering (ASTM D 714)				X
Cracking				X
Peeling				X
Pitting (ASTM G-46)				X
Chalking				X
Delamination				X

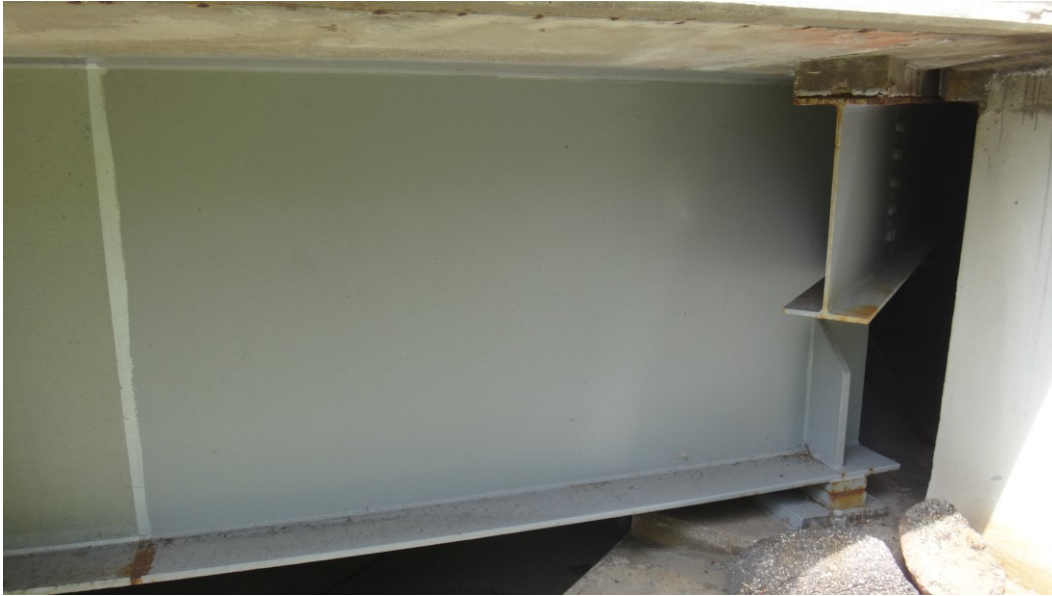
**Figure 11.1 Test Location 1 - Three Year Exposure**

Condition	Severe	Poor	Fair	Good
Rusting (ASTM D 610)				X
Blistering (ASTM D 714)				X
Cracking				X
Peeling				X
Pitting (ASTM G-46)				X
Chalking				X
Delamination				X

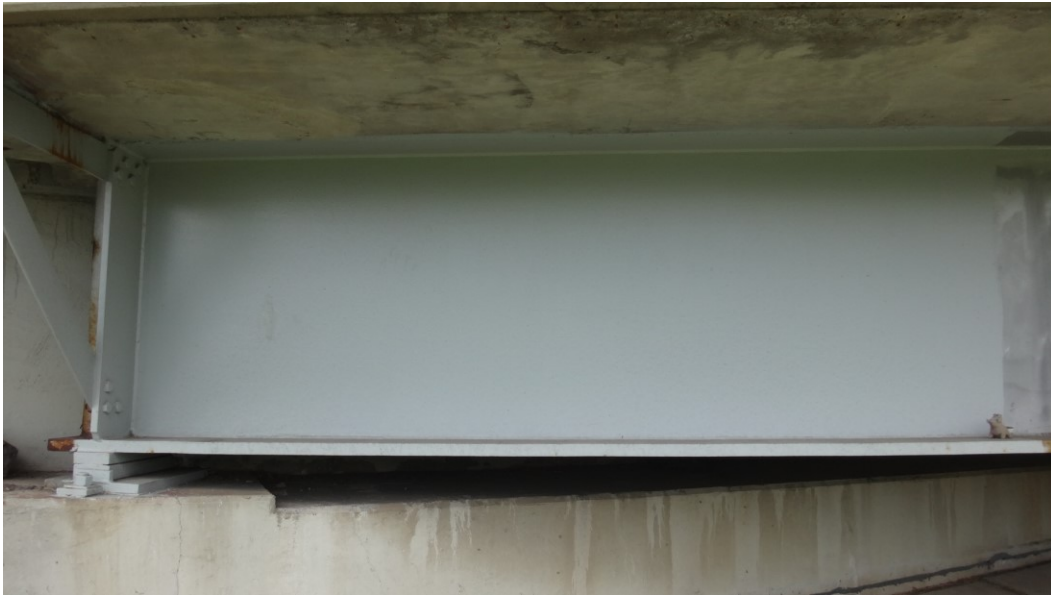
**Figure 11.4 Test Location 2 - Three Year Exposure**

Delamination			X	
--------------	--	--	---	--

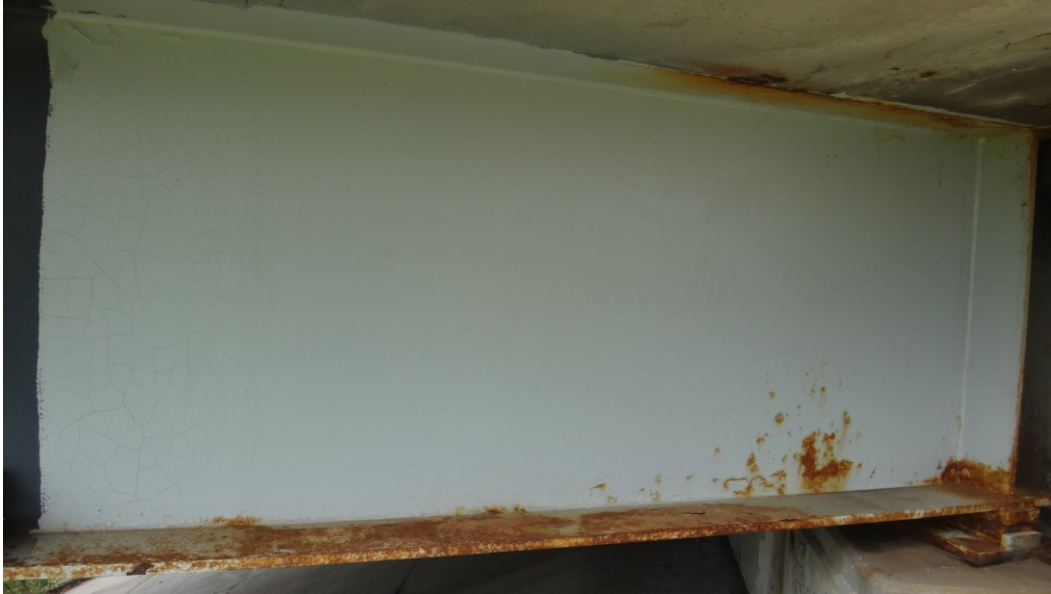
**Figure 11.7 Test Location 3 - Three Year Exposure**

Chalking				X
Delamination		X

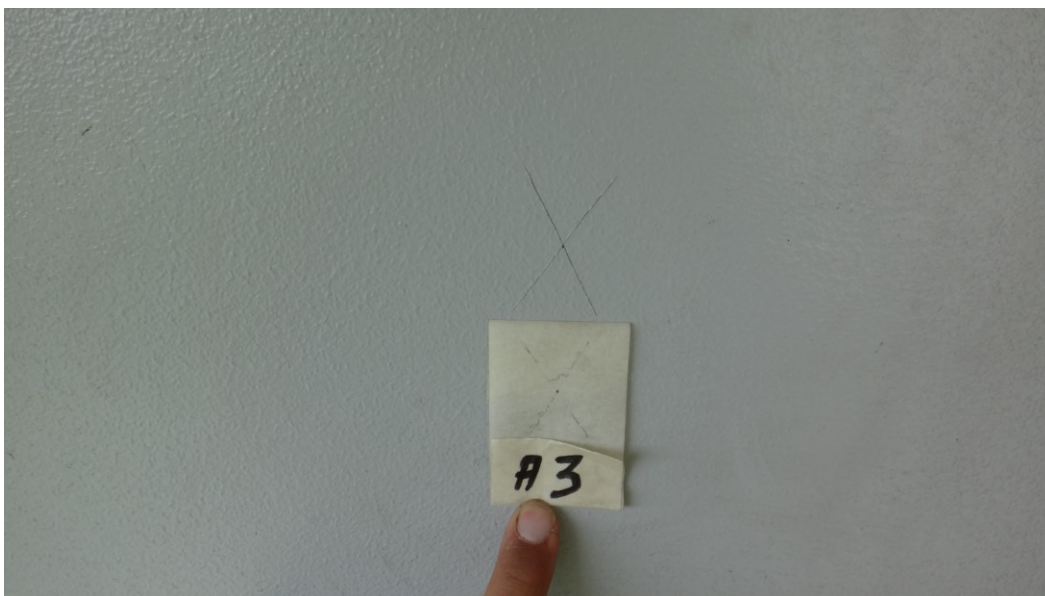
Figure 11.8 Test Location 3 Adhesion Test A3 - Web

Adhesion testing was performed in conformance with ASTM D 3359 on the web. Surface conditions on the top of the bottom flange did not permit an adhesion test due to excessive corrosion. The adhesion test on the web, however, resulted in a 4A (Trace peeling or removal along incisions) result, which is excellent adhesion to the existing substrate.

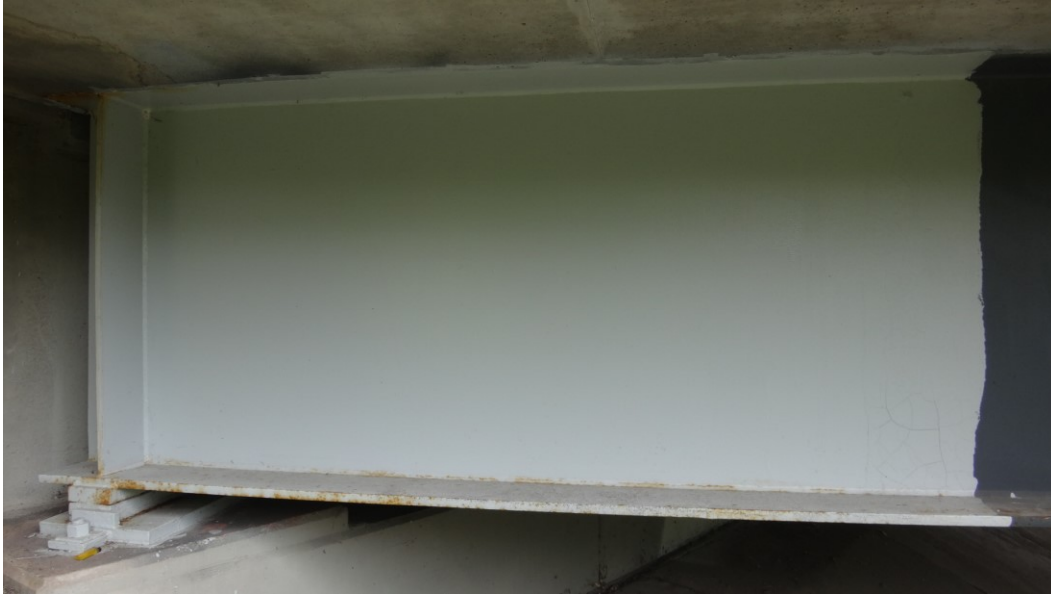
**Figure 11.9 Test Location 4 - Three Year Exposure**

Chalking				X
Delamination				X

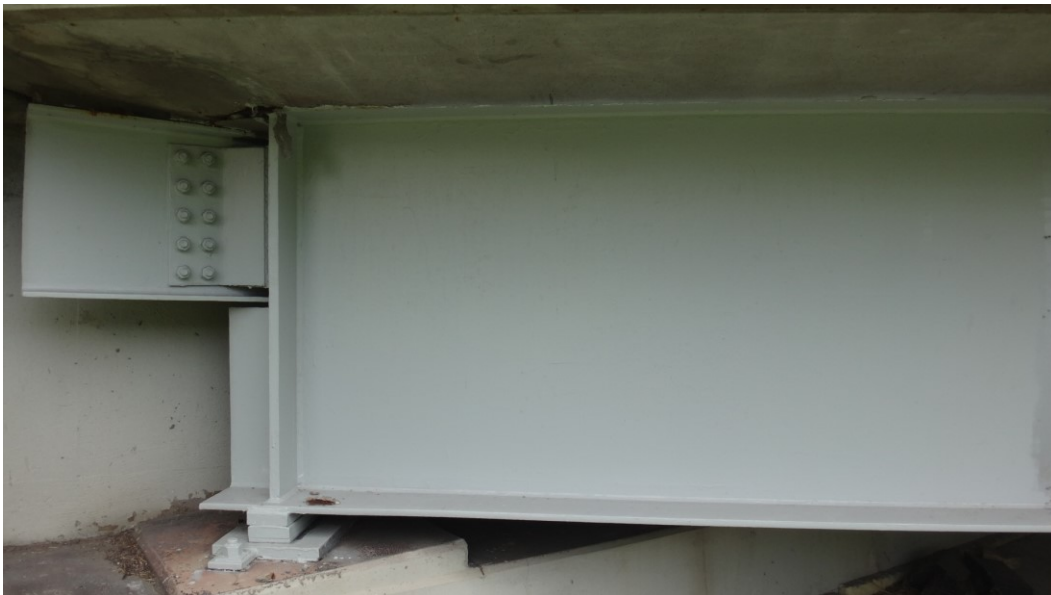
**Figure 11.12 Test Location 5 - Three Year Exposure**

Condition	Severe	Poor	Fair	Good
Rusting (ASTM D 610)				X
Blistering (ASTM D 714)				X
Cracking				X
Peeling				X
Pitting (ASTM G-46)				X
Chalking				X
Delamination				X

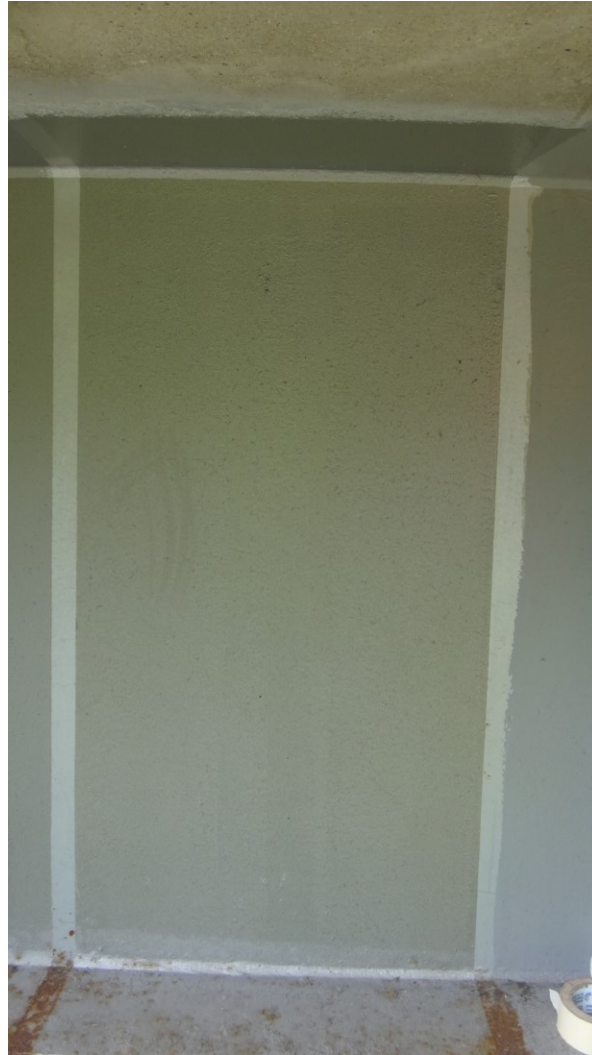
**Figure 12.1 Additional Test Patch Location A - Two Year Exposure**

Condition	Severe	Poor	Fair	Good
Rusting (ASTM D 610)			X	
Blistering (ASTM D 714)				X
Cracking				X
Peeling				X
Pitting (ASTM G-46)				X
Chalking				X
Delamination				X

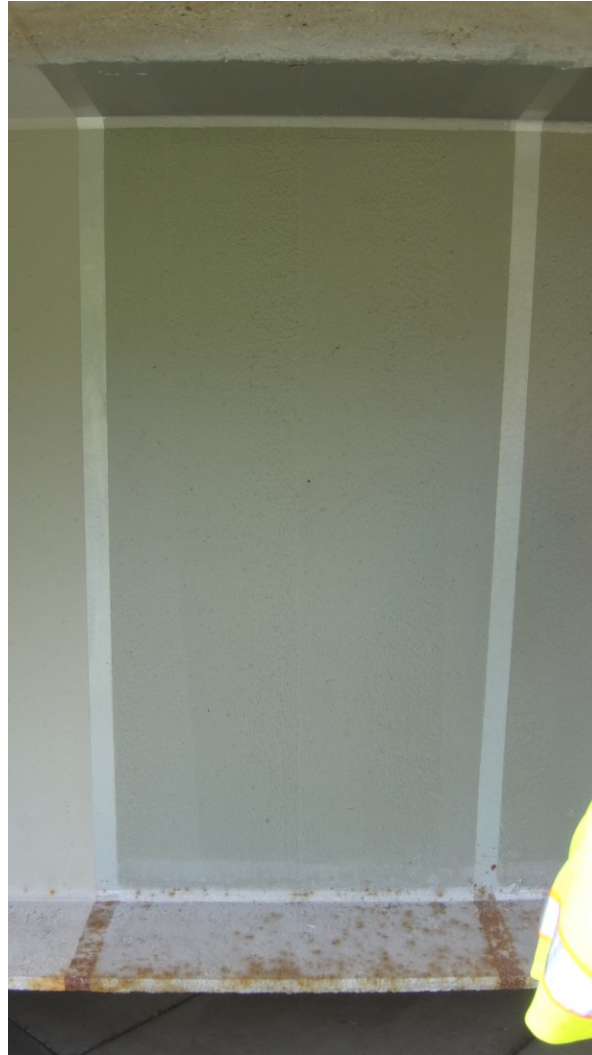
**Figure 12.4 Additional Test Patch Location B - Two Year Exposure**

Condition	Severe	Poor	Fair	Good
Rusting (ASTM D 610)			X	
Blistering (ASTM D 714)				X
Cracking				X
Peeling				X
Pitting (ASTM G-46)				X
Chalking				X
Delamination				X

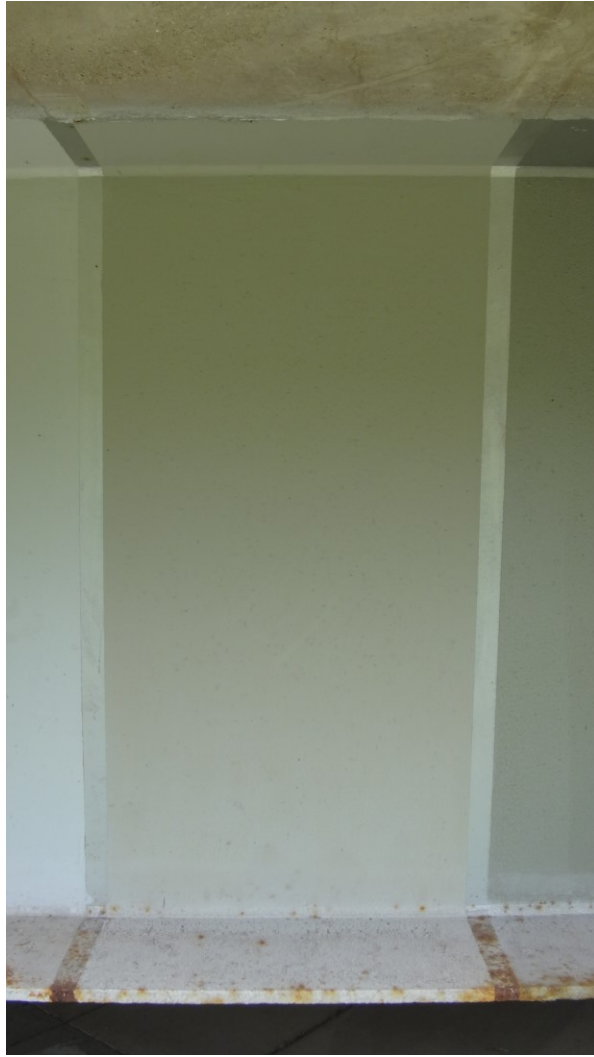
**Figure 12.7 Additional Test Patch Location C - Two Year Exposure**

Condition	Severe	Poor	Fair	Good
Rusting (ASTM D 610)			X	
Blistering (ASTM D 714)				X
Cracking				X
Peeling				X
Pitting (ASTM G-46)				X
Chalking				X
Delamination				X

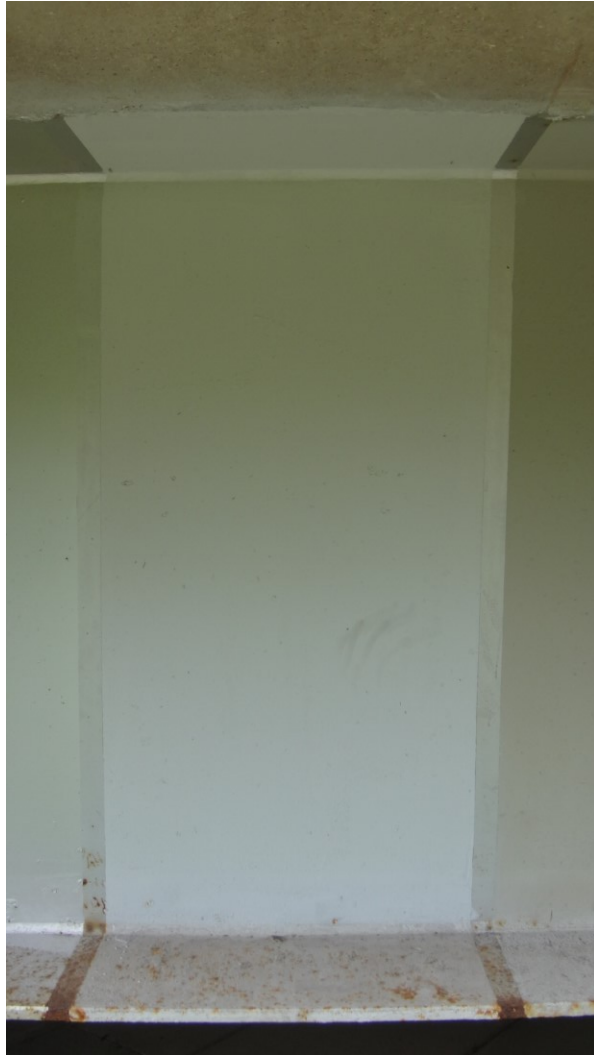
**Figure 12.10 Additional Test Patch Location D - Two Years Exposure**

Condition	Severe	Poor	Fair	Good
Rusting (ASTM D 610)			X	
Blistering (ASTM D 714)				X
Cracking				X
Peeling				X
Pitting (ASTM G-46)				X
Chalking				X
Delamination				X
