Infrared Thermography and the Delamtect: A Comparison of Methods for Locating and Measuring Delaminations

Office of Research and Development Minnesota Department of Transportation

In-Depth Report

BRIDGE # 9340 (SQUIRT BRIDGE)

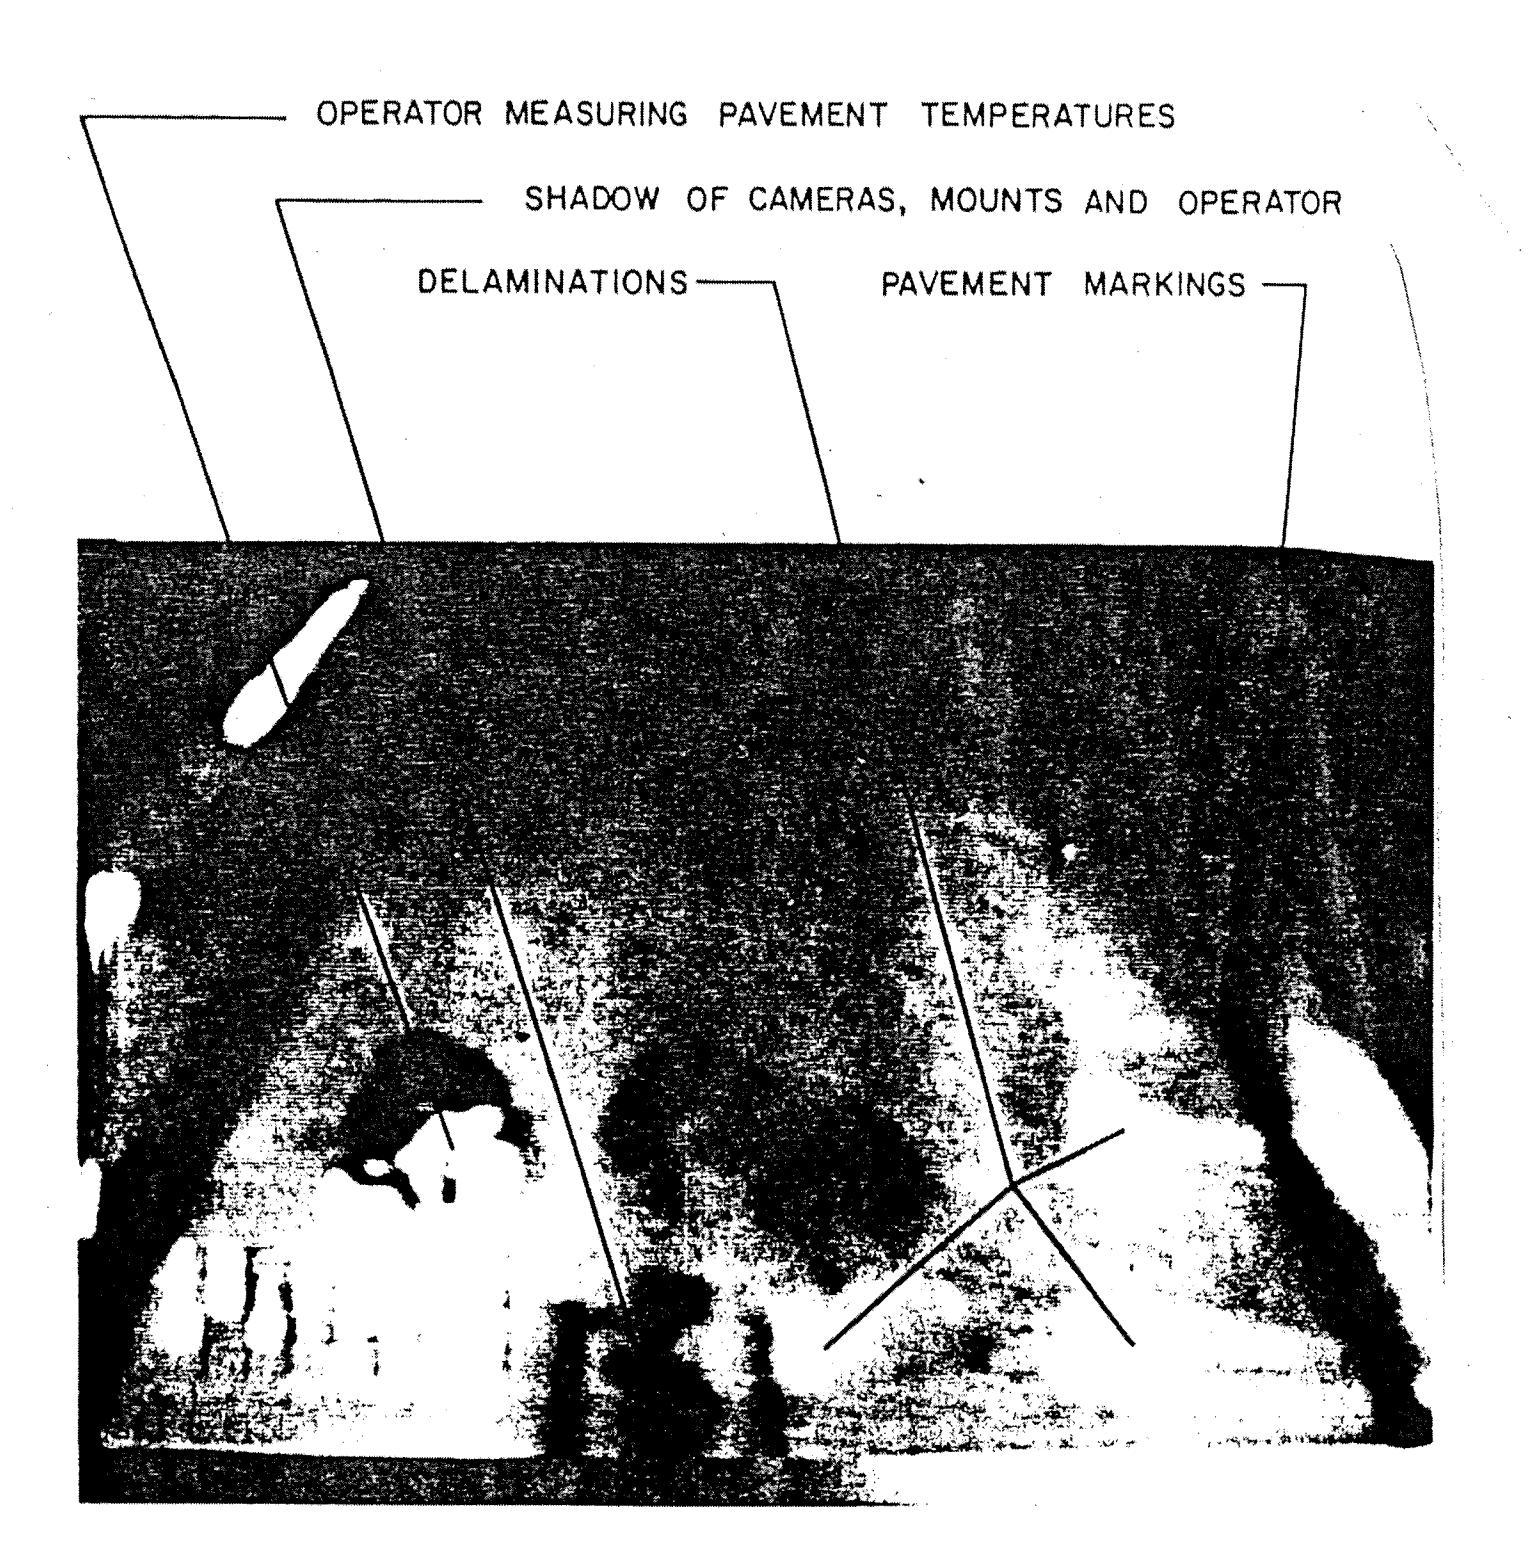
FIGURE 6. INFRARED CAMERA VIEW OF PAVEMENT

The infrared camera produces a black and white image. The solid pavement, being relatively cool, shows up as a dark area. The warmer delaminations are lighter shaded areas. Asphalt patches, oil stains, and loose sand and gravel also show up as light areas. Figure 6 shows the view as seen by the infrared camera.

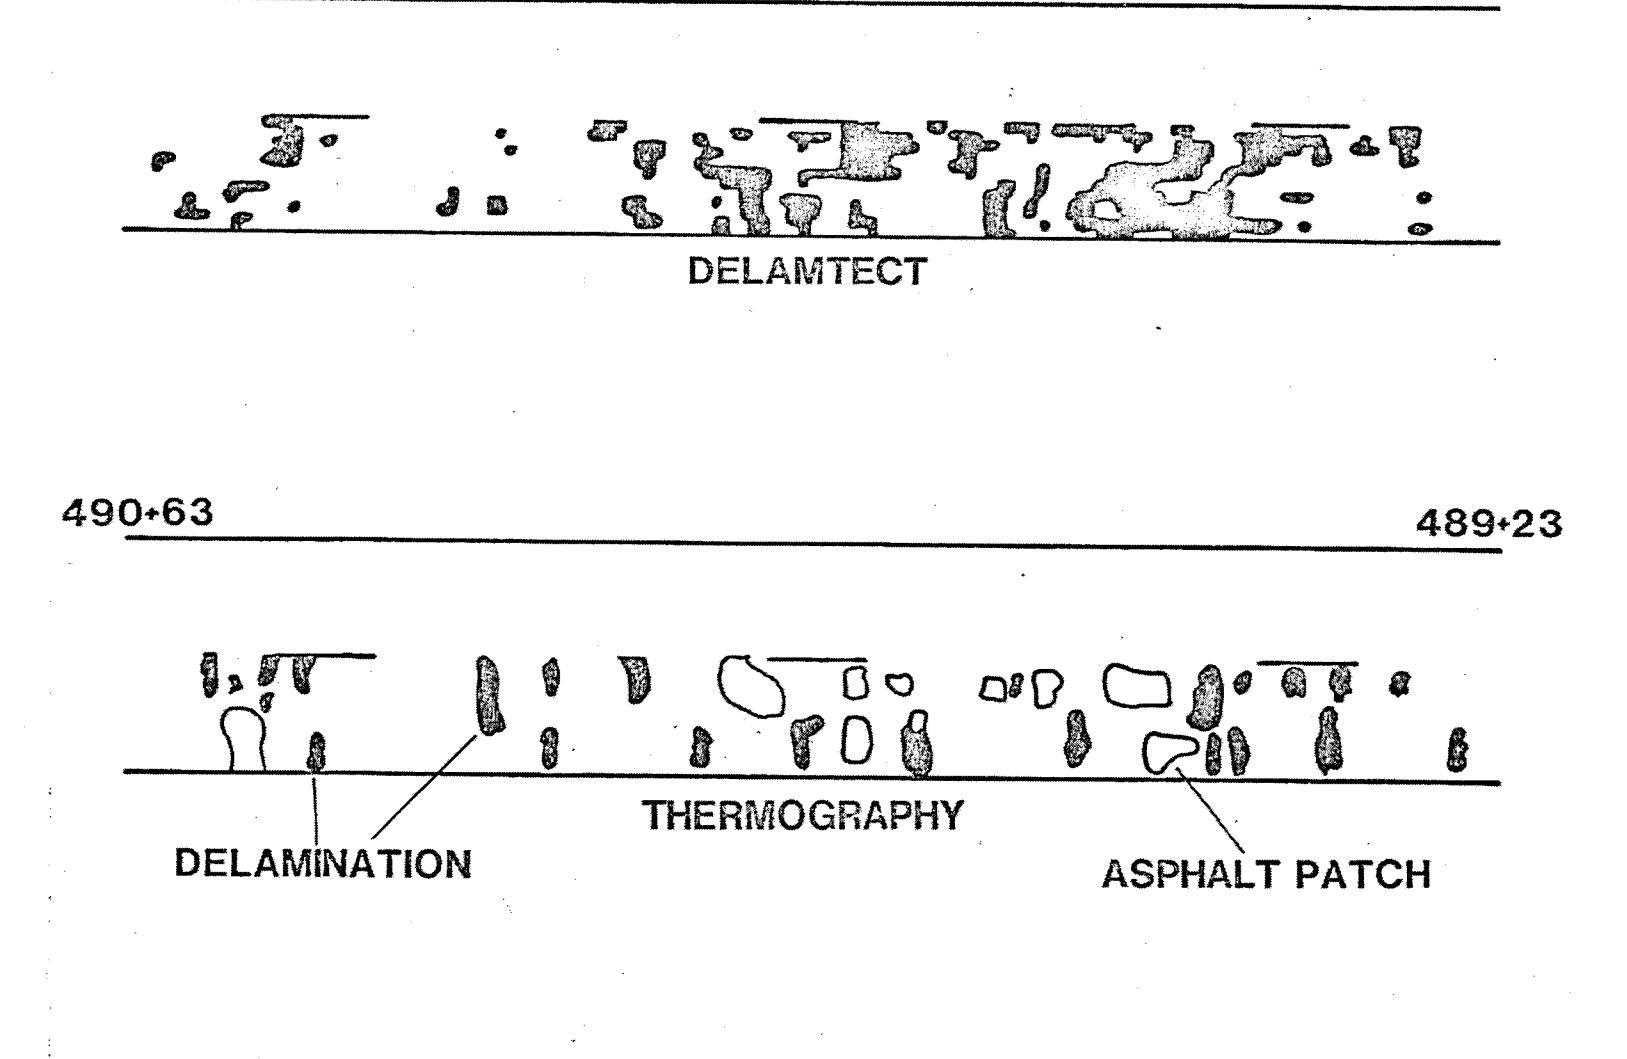
FIGURE 9. I-35W CONTROL SECTION 3

The control section was more extensively delaminated. The Delamtect appears to have found more unsound areas than did thermography. The reason for this is that thermography discriminates patches from delaminations and the Delamtect does not. Asphalt patches are typically read by the Delamtect as being unsound. If the patches are included with the delaminations located by thermography then the two methods match fairly well in this section.

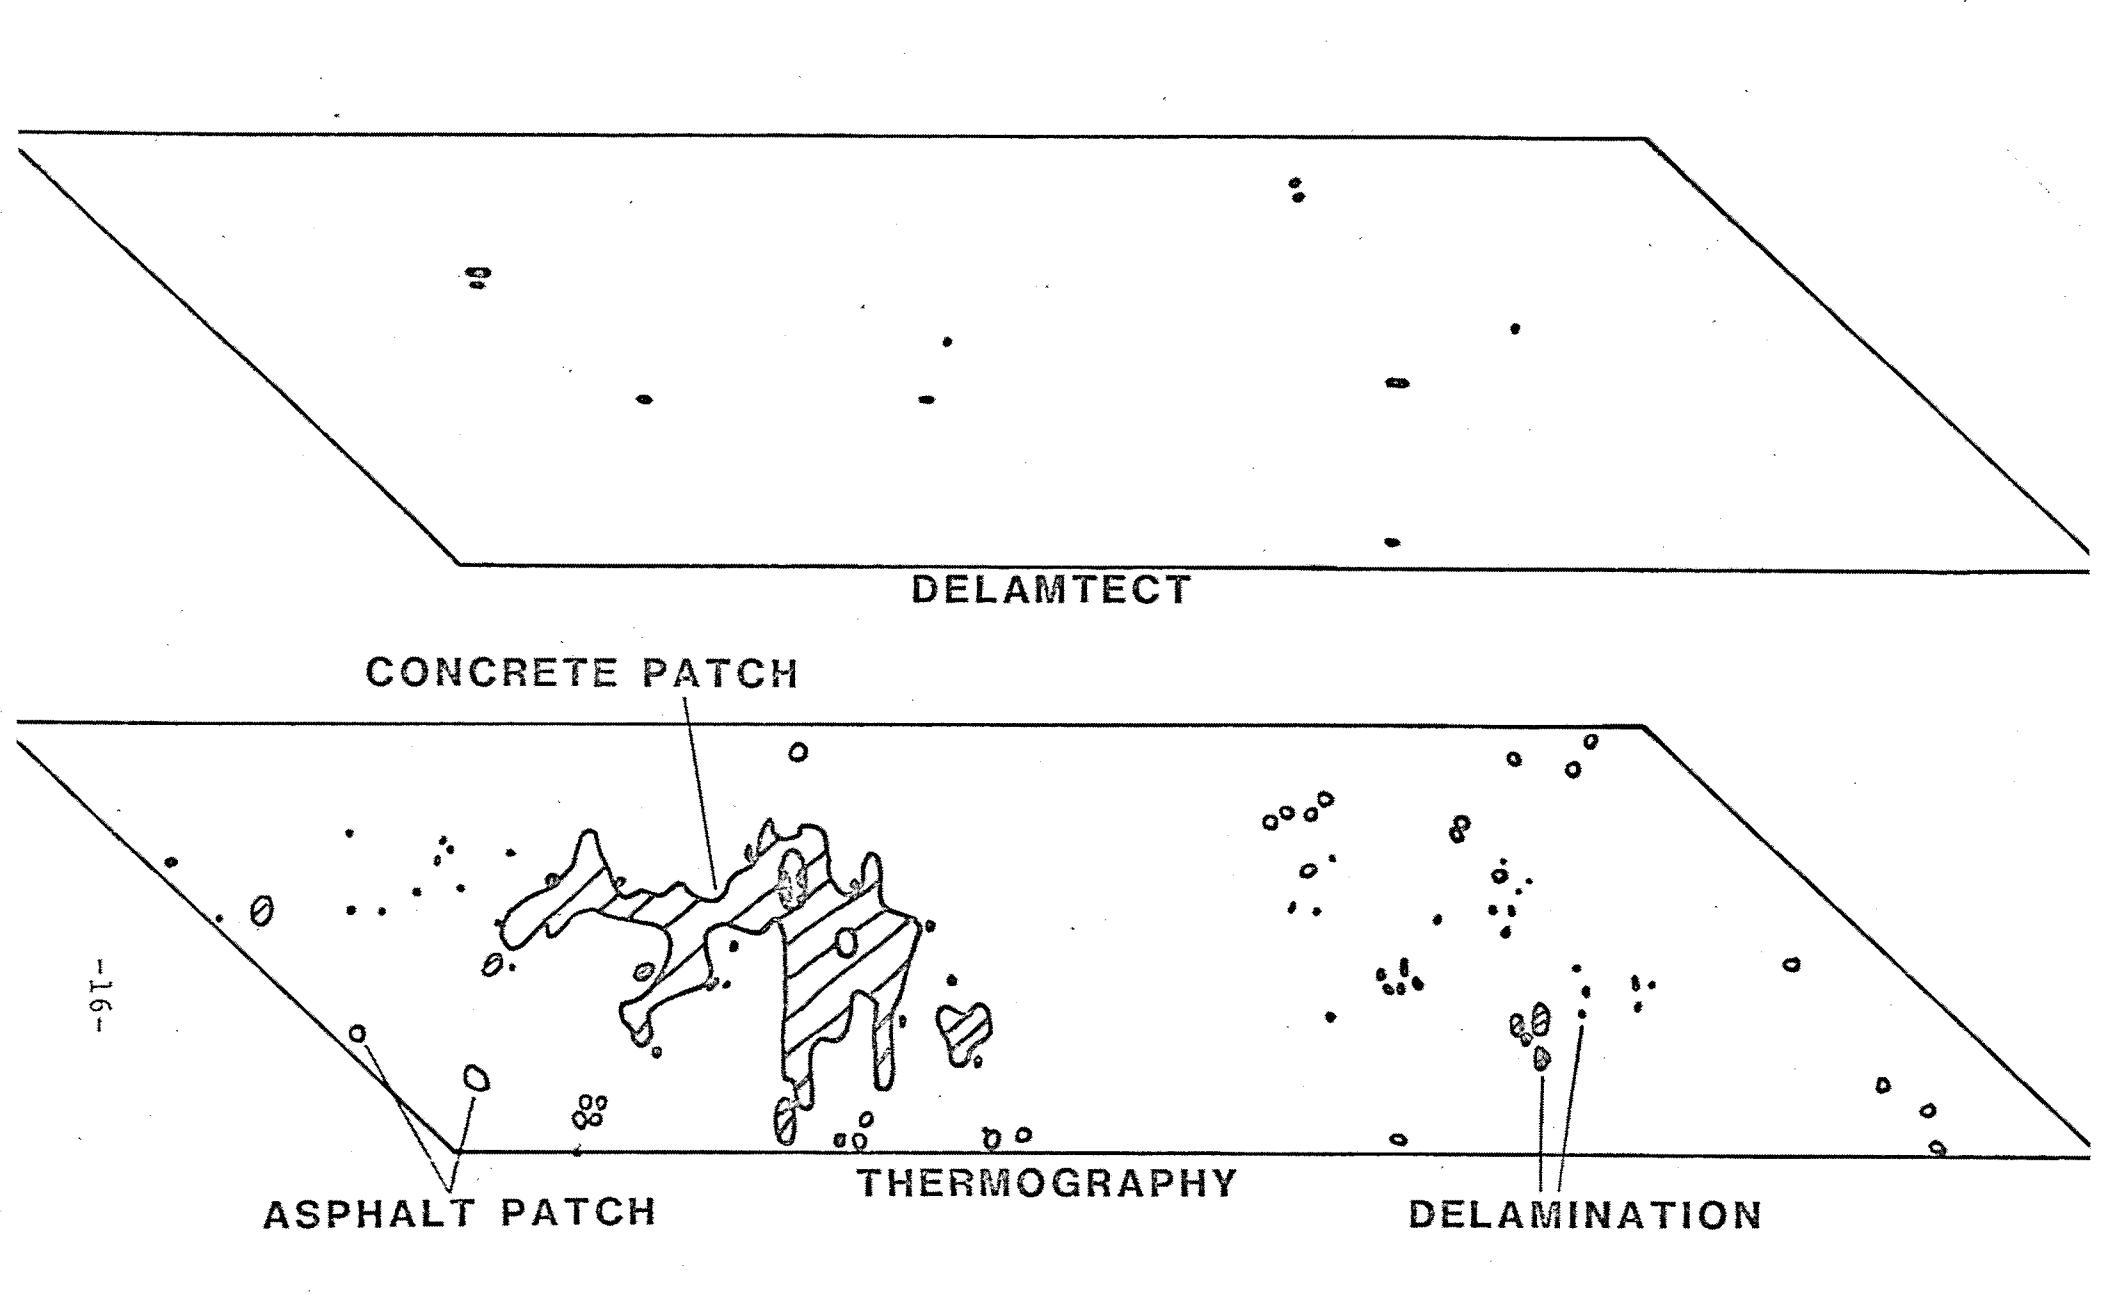
FIGURE 12. FRANKLIN AVENUE OVER I-94

The chain drag and thermography surveys agreed very closely on the amount of delamination present. Both found 0.9% of the total deck area to be delamination, the chain drag locating 70 square feet and infrared thermography 65 square feet. The Delamtect found slightly less, 0.5% and 37 square feet. The results are illustrated in Figure 12.

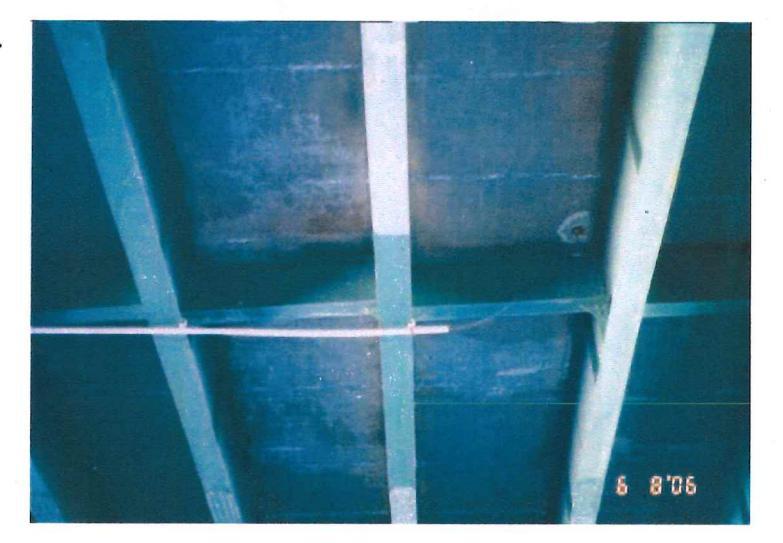
Water Saturation SBL Bays 9 & 10

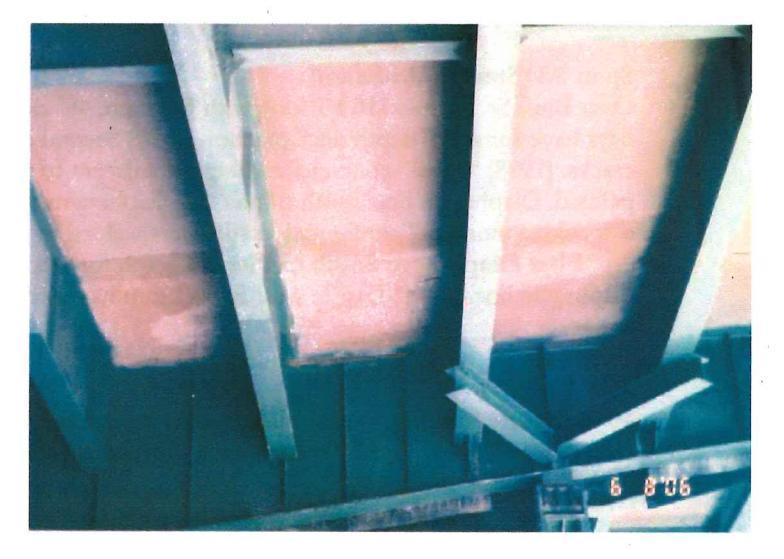
Water Saturation NBL Bays 2, 3 & 4

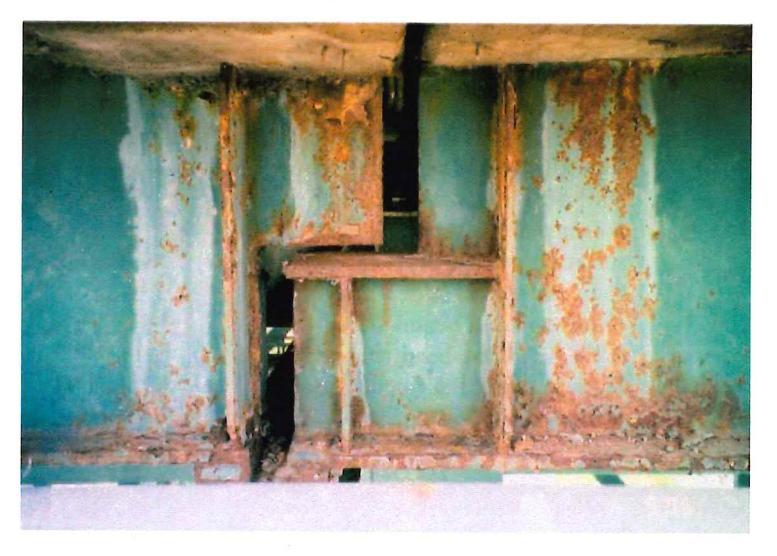
Flaking & Surface Rust Exterior East Truss

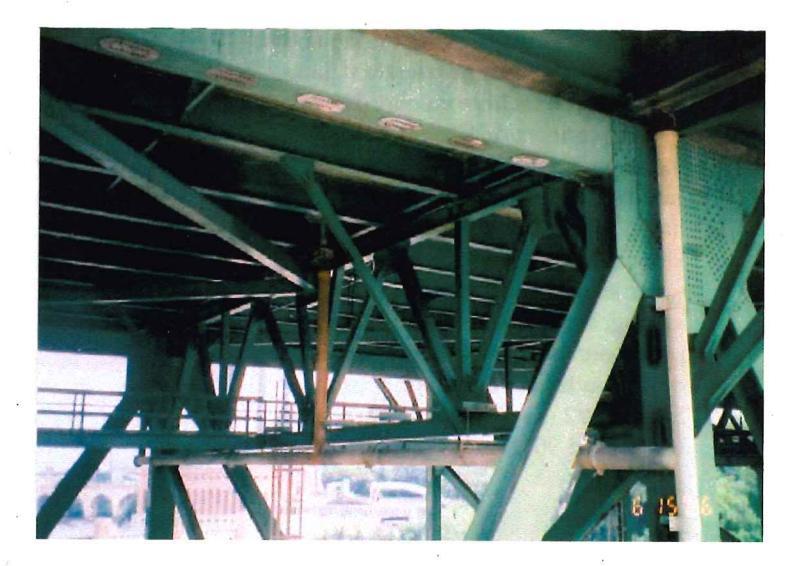
Median Drain Plugged

2006 Bridge Inspection Bridge #9340 -8• The rubber "skirts" sections above the truss end rockers, installed in 1999, tend to fill with debris. These should be flushed out annually. The horizontal drain troughs at pier #6 have inadequate slope, and are clogged.

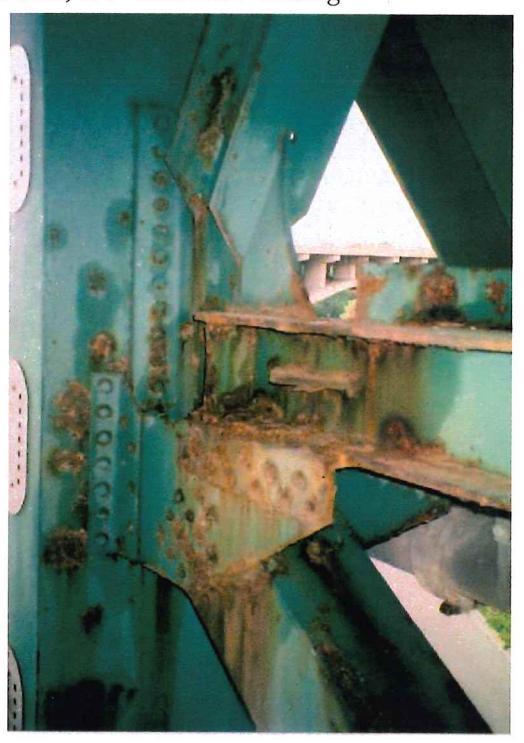
Floorbeam Truss Condition

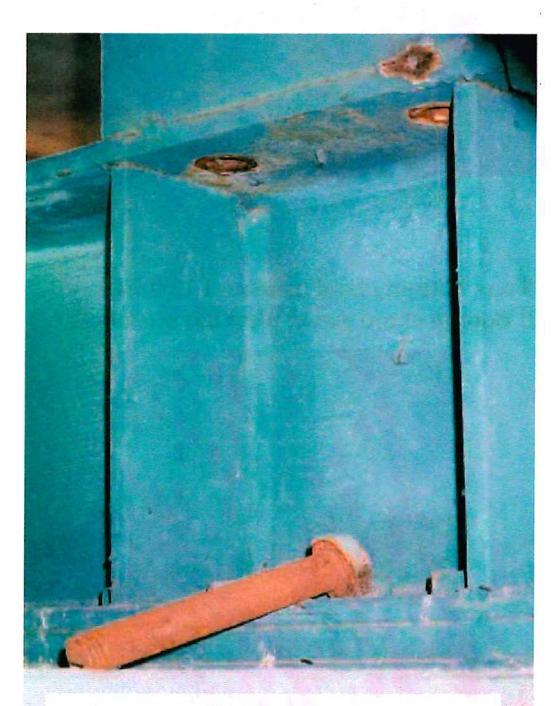
Section loss: at gusset plate bottom chord. [2004] Pitting: inside gusset plate connection at L11 toward L10. [2000/05] Stringer #3 has two bolts missing at the floorbeam connection.

Bolts Missing @ Floorbeam Connection

- Four-stringer connection bolts, all in the NBL, need replacement. At panel point #8, stringer #2 has 2 loose bolts, and the bearing block has rotated. This will likely require jacking the superstructure. Stringer bolts also need replacement at panel point #8, stringer #4, south side, and at panel point #11, stringer #3.

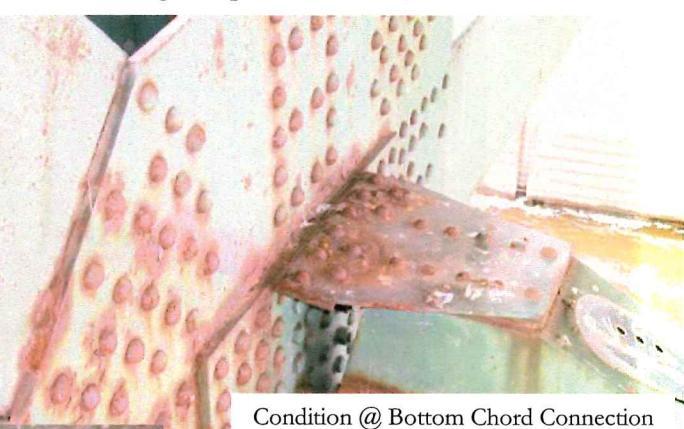
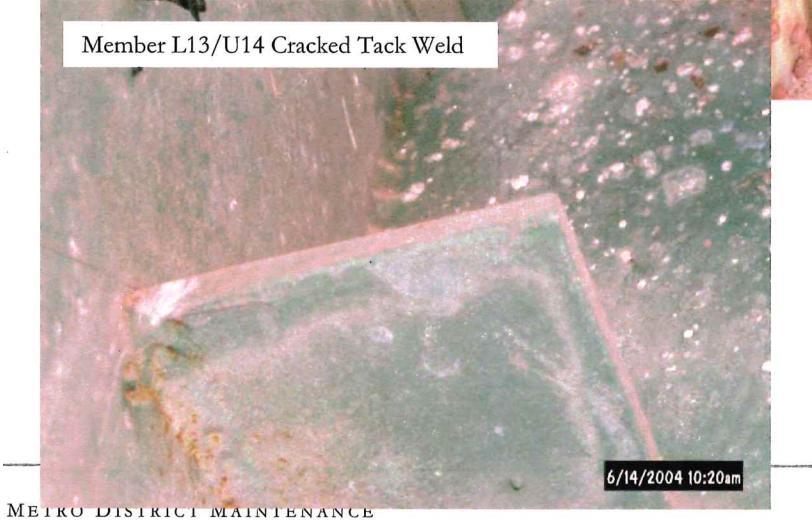
flaking & pack rust. [2004] Bottom chord member L13/L14 has cracked tack weld at diaphragm tab. Cracked tack weld at diaphragm tab member L13/U14. See photos. [2006] Bottom chord member L13/L14 has a missing bird cover.

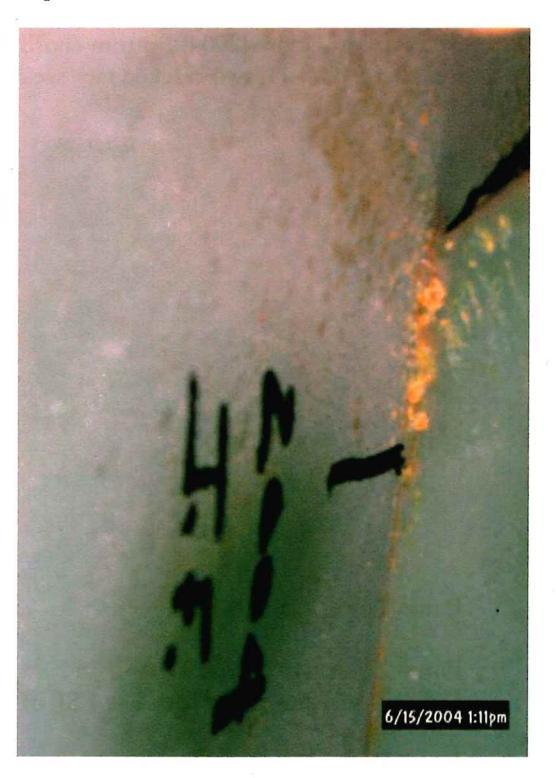
L14/L13' has a cracked tack weld at an interior stiffener. [2002/03] Floorbeam bottom chord & middle bracing connection plate has ½" pack rust. Underside of the deck has 4 SF of delamination. [2004] Bottom chord member L14/L13' cracked tack weld at diaphragm tab.

Member L14/L13' Cracked Tack Weld

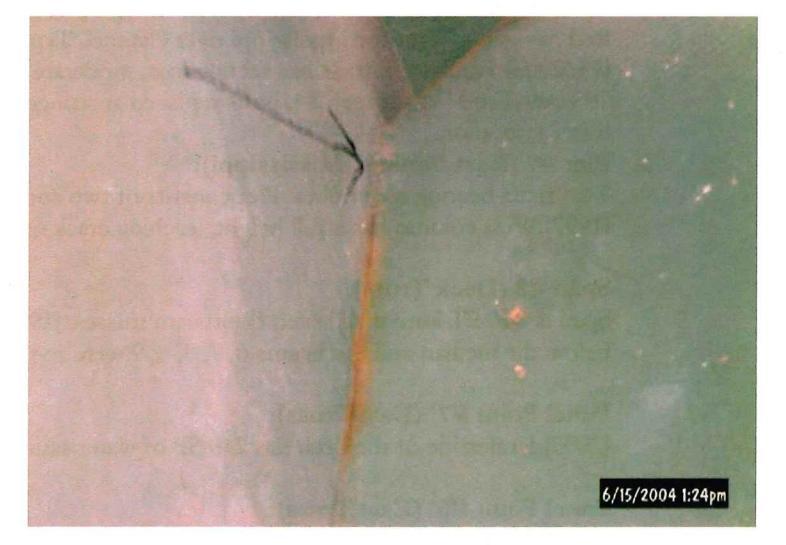
member L13'/L12' has a cracked tack weld at an interior stiffener. [2003] Truss bottom chord connection plate has ½" pack rust. Underside of the deck has 20 SF of water saturation. [2004] Bottom chord member L13'/L12' has cracked tack weld at diaphragm tab.

Member L13'/L12' Cracked Tack Weld

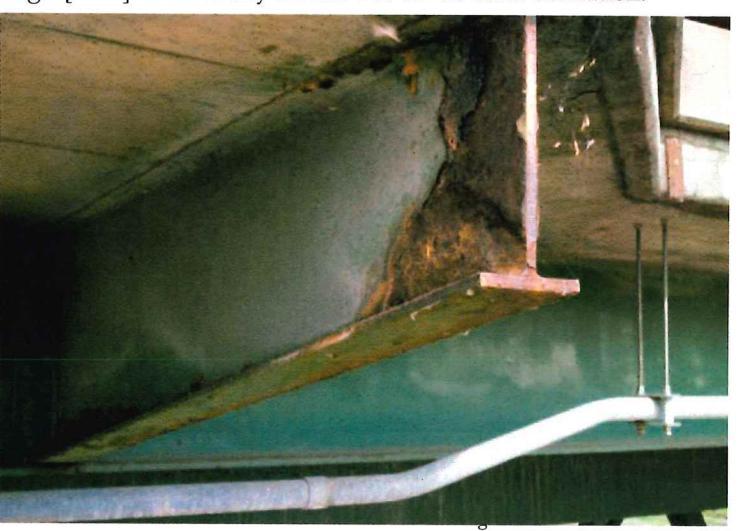
Bottom Floorbeam Truss Condition

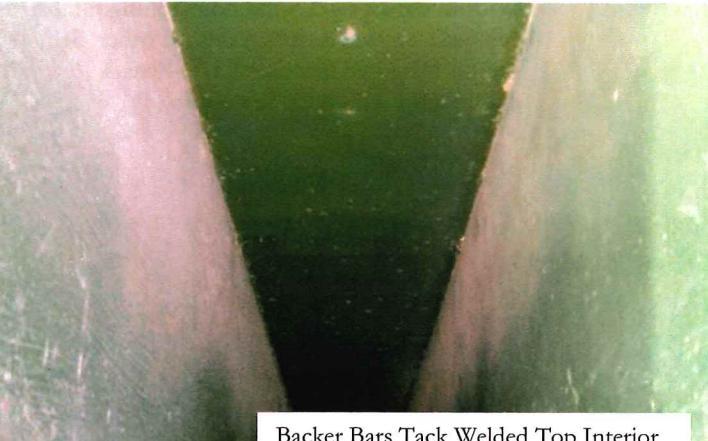
connection has moderate flaking rust. Truss top chord has flaking rust. Floorbeam top chord, stiffener under stringer #10 has cracked tack weld & is working. Top chord U4/U5 has backer bars tack welded along the top interior corners of member. See photo. Bottom chord L4/L5 has no diaphragm tabs, full weld on side and tack welds on other. See photo.

Backer Bars Tack Welded Top Interior

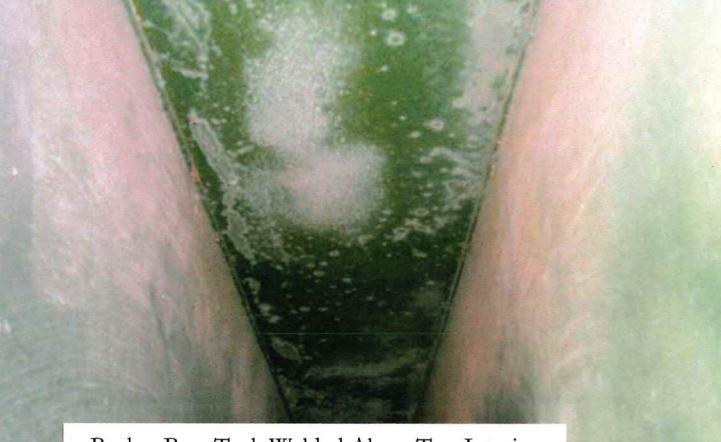
Top chord U5/U6 has backer bars tack welded along the top interior corners of member. [2004] Truss bottom chord, bottom lateral connection plates have spread 3/16" from pack rust.

Backer Bars Tack Welded Along Top Interior

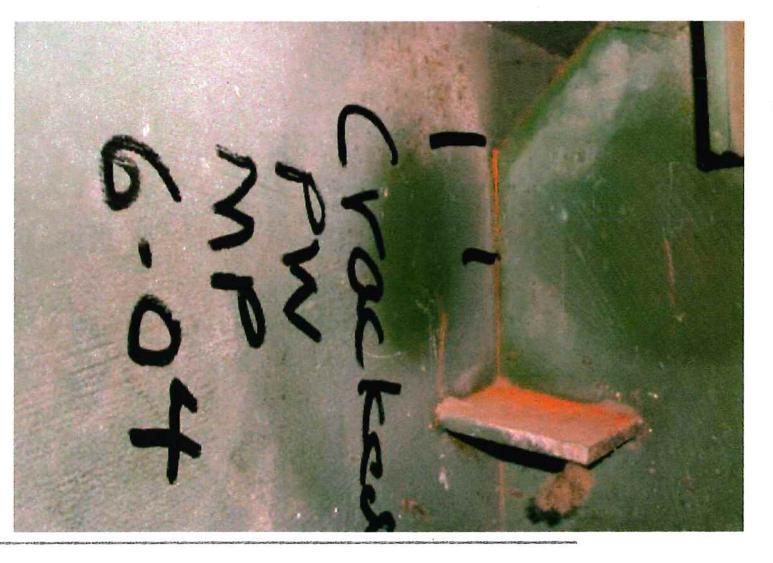
Bottom chord member L12/L13 has a cracked tack weld (diaphragm #2), (not at diaphragm tab). See photo.

Cracked Tack Weld @ Diaphragm #2

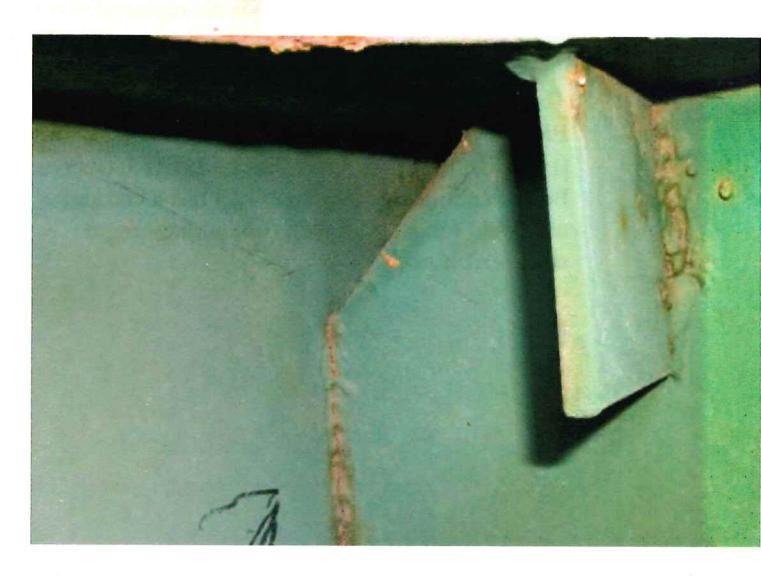
Cracked Tack Weld @ Diaphragm #2

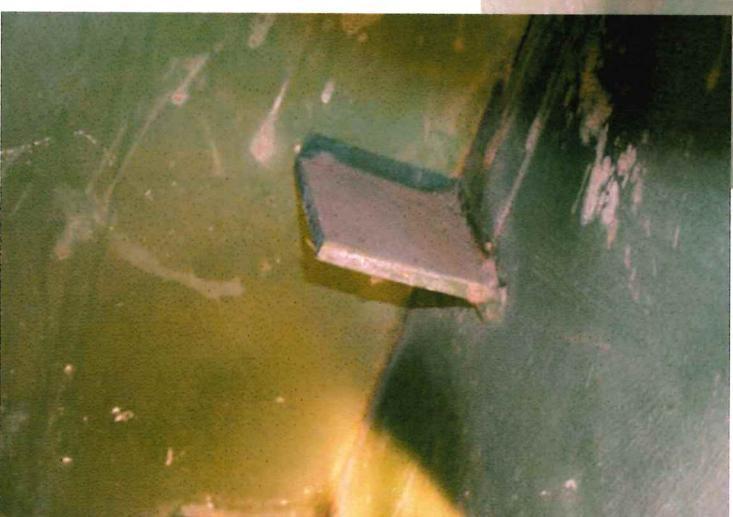
length) one side only. Bottom chord member L13'/L12': cracked tack weld (diaphragm #1), (not at diaphragm tab), (clean break). See photo #2.

Cracked Tack Weld @ Diaphragm #1

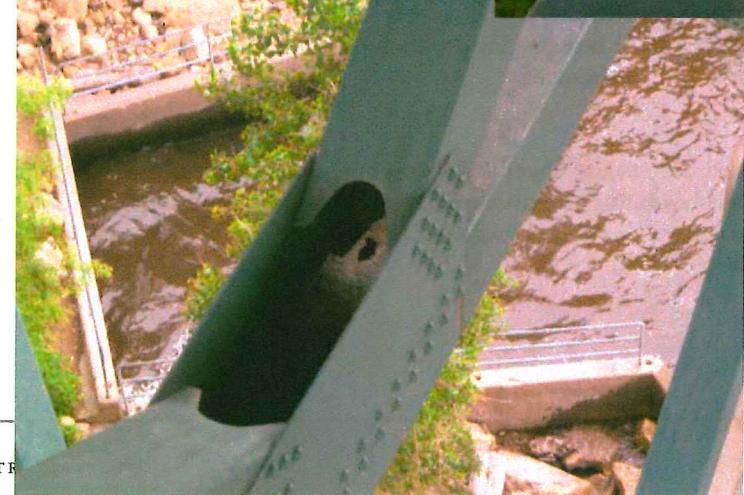
Hole in Bottom Member of Sway Bracing

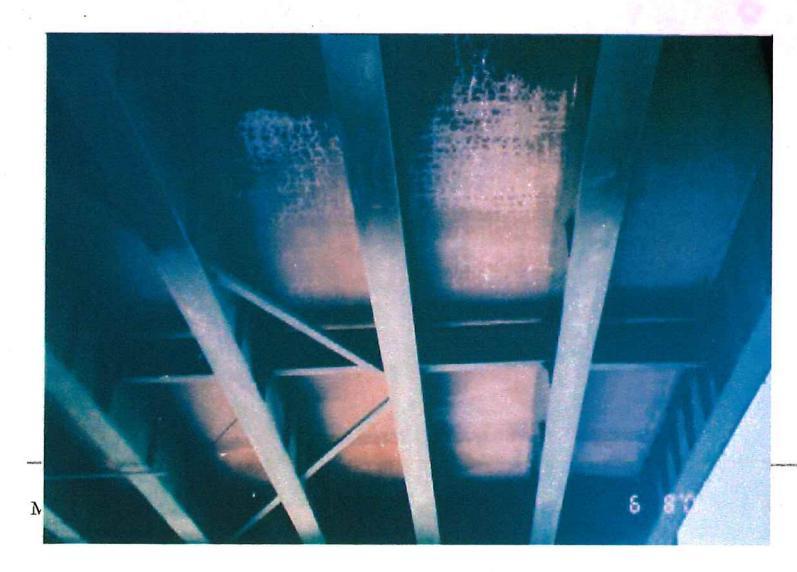
Water Saturation SB Bays 12, 13 & 14

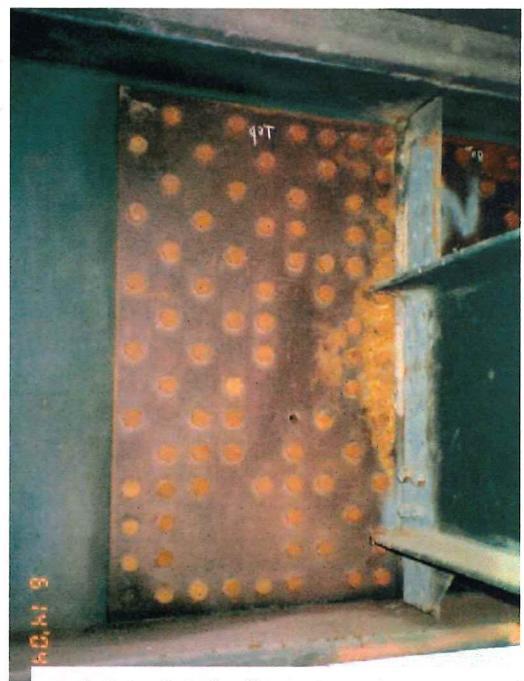
Web "Tear" G #3 @ Diaph Looking East

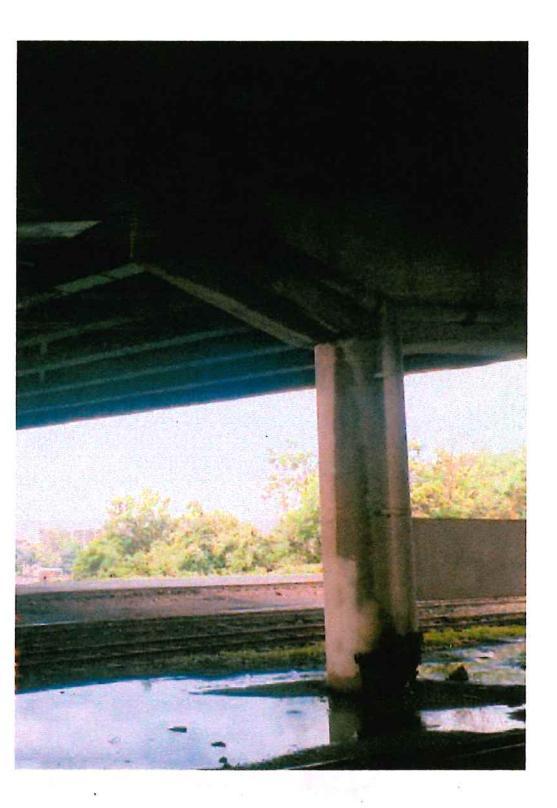
Plate bearing assemblies have 13 fixed, and four sliding. Pier consists of four columns and cap, with a railroad crash strut between the columns. 2 Deck drain: downspouts. [1969] East column damaged by train derailment: the column has minor scrapes and spalls, downspout had to be reconnected. [1999] Bearings 9, 10, 11, &. 12 were repainted. [2004/05] West vertical & median deck drain plugged.

Median Drain Plugged Pier 9

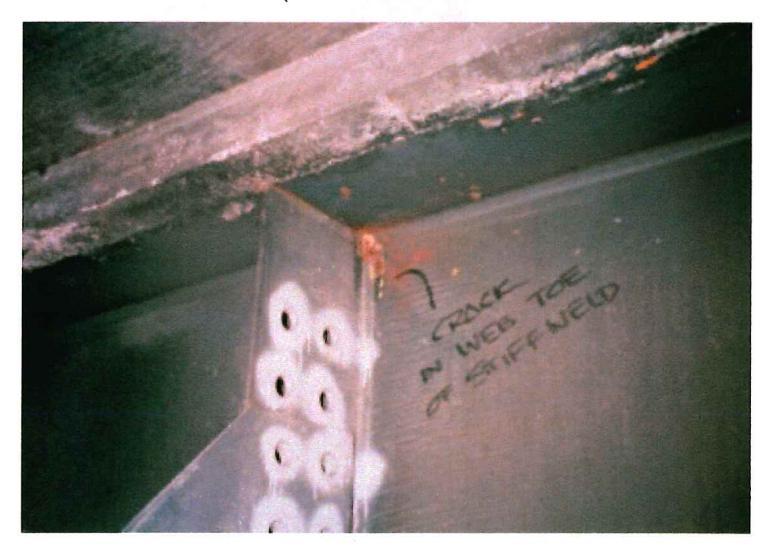
Girder #10 Vertical Stiffener/Girder Web

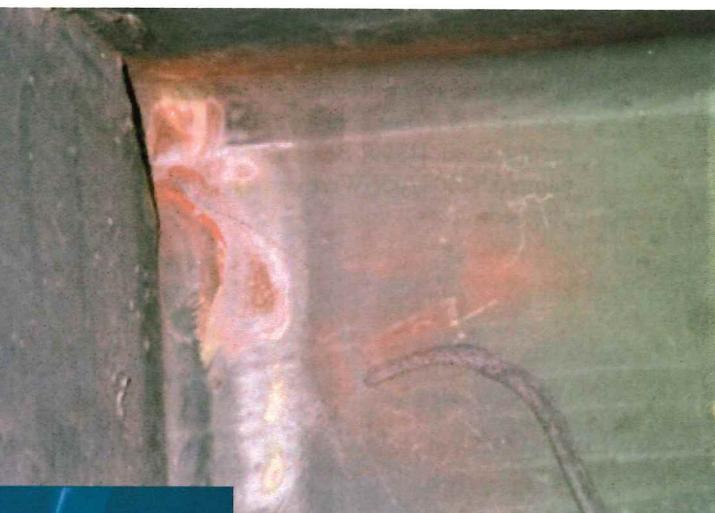
Girder #10 Vertical Stiffener/Girder Web

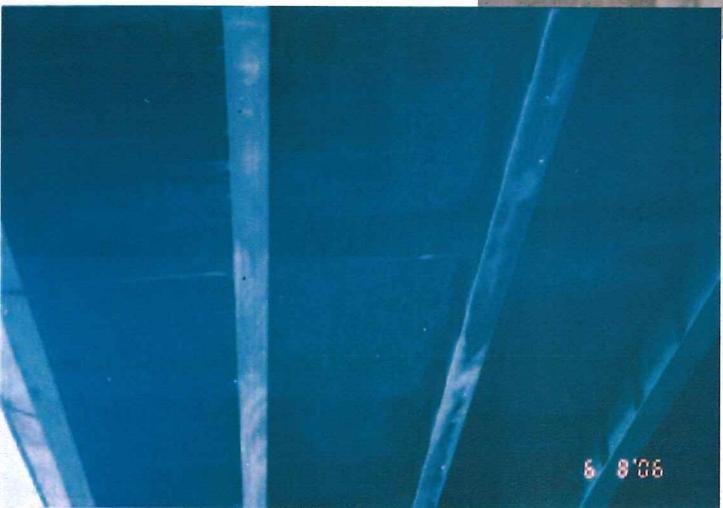
Water Saturation SB Bays 12, 13 & 14

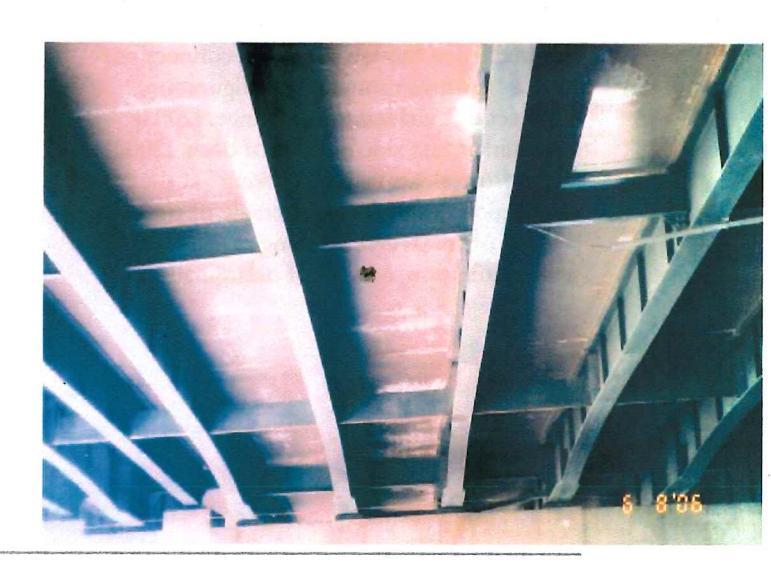
Water Saturation NB Bays 5, 6 & 7

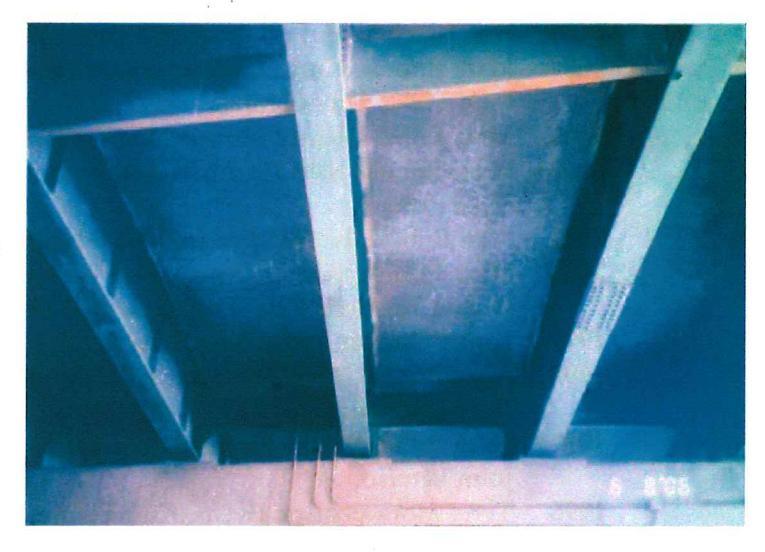
Span is 68 ft. long with 18 steel beams. Northbound has 11 beams; southbound has 7 beams, and the parking lot below. [1999] Beams 9, 10, 11, & 12 were re-painted. Connections welded to top flange. Diaphragms were inverted & lowered, even though the beam connections have "positive moment" configuration. [2003] Conduit: east side bottom of deck. [2004] 50 SF of water saturated deck underneath.

Water Saturation SB bays 15 & 16
