## DEPARTMENT OF TRANSPORTATION

# Comprehensive Field Evaluation of Asphalt Patching Methods and Development of Simple Decision Trees and a Best Practices Manual

## June 2017

Research Project Final Report 2017-25 To request this document in an alternative format, such as braille or large print, call <u>651-366-4718</u> or <u>1-800-657-3774</u> (Greater Minnesota) or email your request to <u>ADArequest.dot@state.mn.us</u>. Please request at least one week in advance.

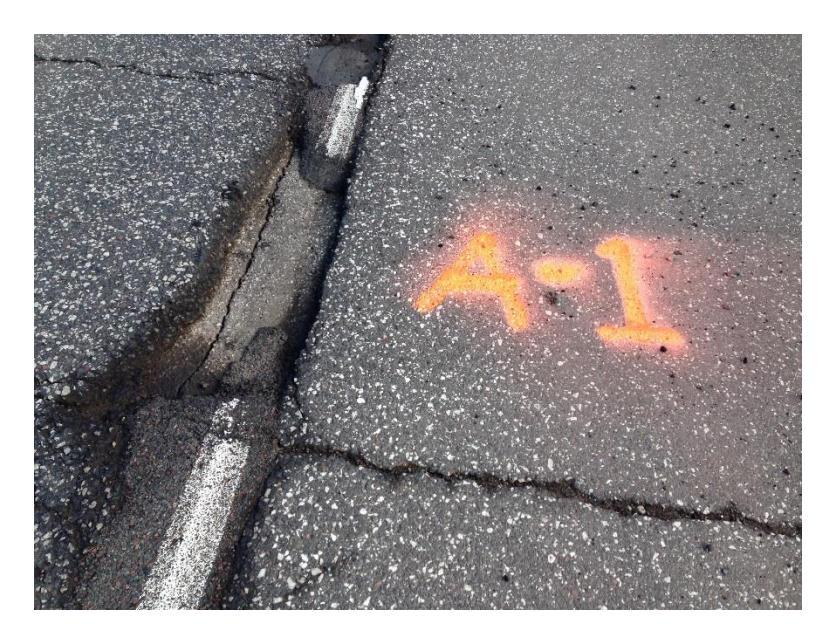
Figure 3.1 Pothole A-1 prior to Patching (After Cleaning).

Pothole A-1: This pothole was located along the shoulder joint of the roadway. The pothole lies in between two reflective transverse cracks and has a longitudinal crack running along the bottom of the pothole as shown in Figure 3.1. The pothole was prepped by sweeping the area. The size of the pothole was 40 inches x 14 inches x 2 inches.

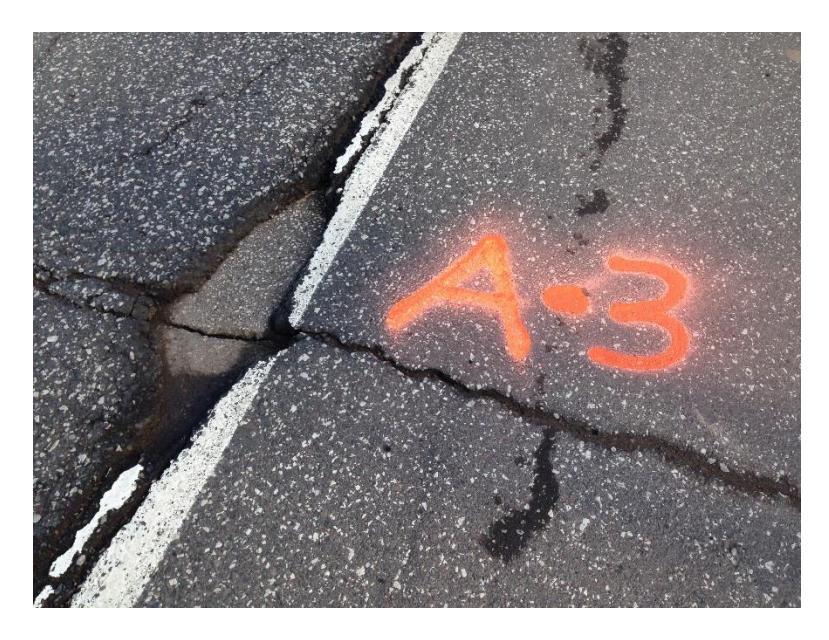
Figure 3.3 Pothole A-3 prior to Patching (After Cleaning).

Pothole A-3: This pothole was located along the shoulder joint. The pothole lies along an existing longitudinal crack in the overlay with a reflective transverse crack crossing through the pothole as shown in Figure 3.3. The pothole was prepped using compressed air. The size of the pothole was 37 inches x 13 inches x 2 inches.

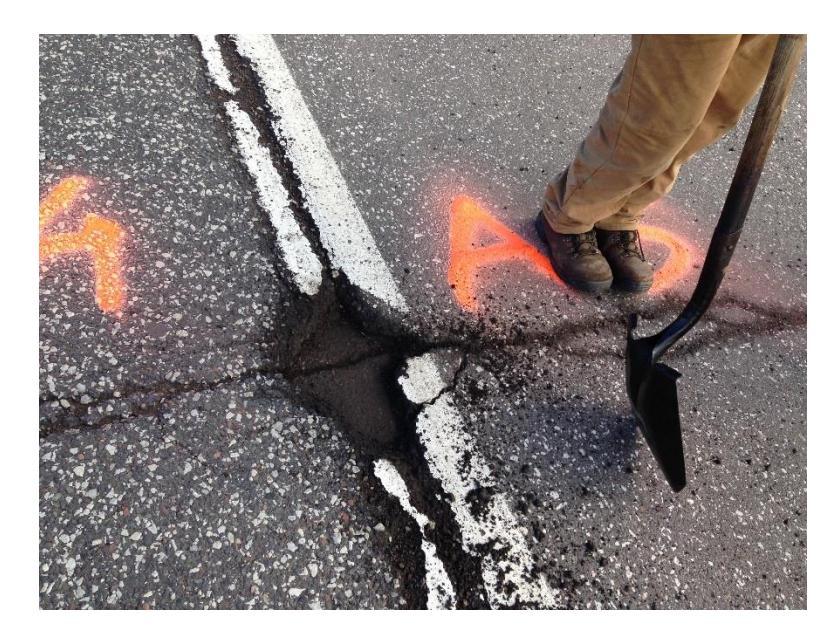
Figure 3.5 Pothole A-5 prior to Patching (After Cleaning).

Pothole A-5: This pothole was located along the shoulder joint. The pothole lies along an existing longitudinal crack in the overlay with a reflective transverse crack crossing through the pothole as shown in Figure 3.5. The pothole was prepped using compressed air. The size of the pothole was 17.5 inches x 13 inches x 1.5 inches.

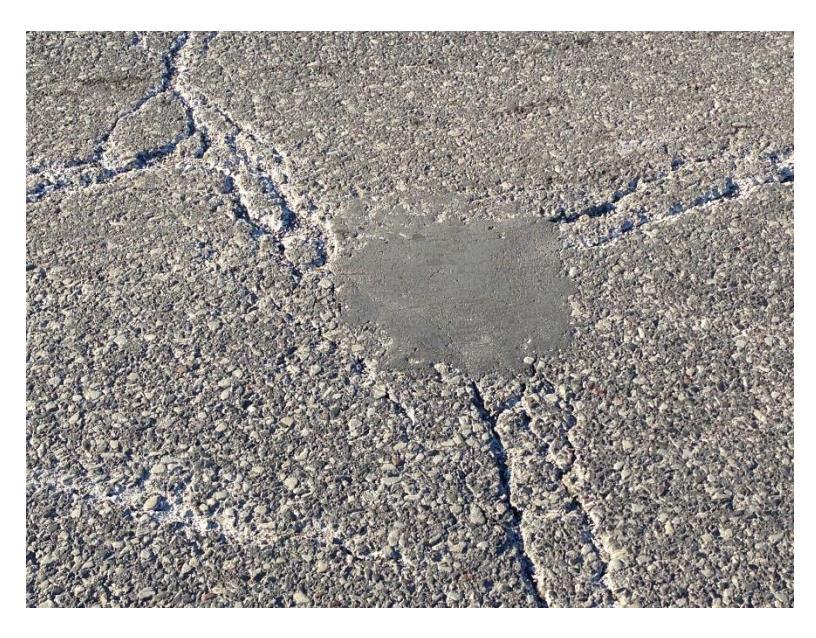
Figure 3.19 Pothole A-4 (240 days after installation) with Snow Plow Abrasion.

Although the cold mix patches had a hard compacted layer on the top of the patch, underneath that layer was pliable material that still had an oily shine consistent with the day the pothole was patched. Based on the last visit conducted on December 4, 2014, the conditions of the patches were found to be somewhat similar to the previous visits. The only noticeable difference was some abrasion on the patch material from snow plow blades. This abrasion was most noticeable in patch A-4 (Figure 3.19). Also on

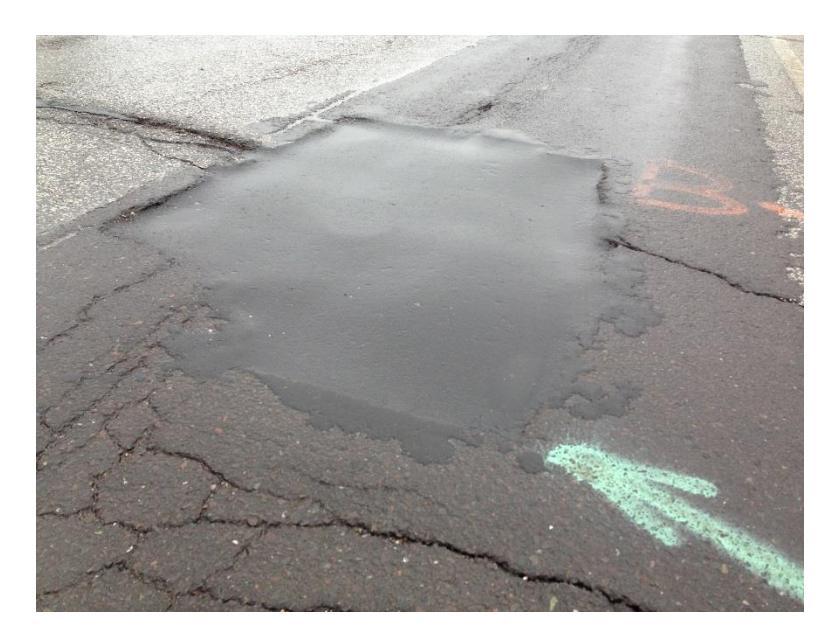
One of the main concerns regarding dishing distresses is the accumulation of water. Pooled water on a roadway provides areas that facilitate hydroplaning during wet conditions as well as icy surfaces in cold conditions (Figure 3.41). Dished areas along patch edges may provide areas for water to infiltrate increasing the deterioration rate of both the roadway and patch material. Dished areas also provide a lower ride quality and potential hazard areas for snow plows.

Figure 3.41 Water Accumulation in Dished Areas of Patch B-3 (18 Days after Patching).

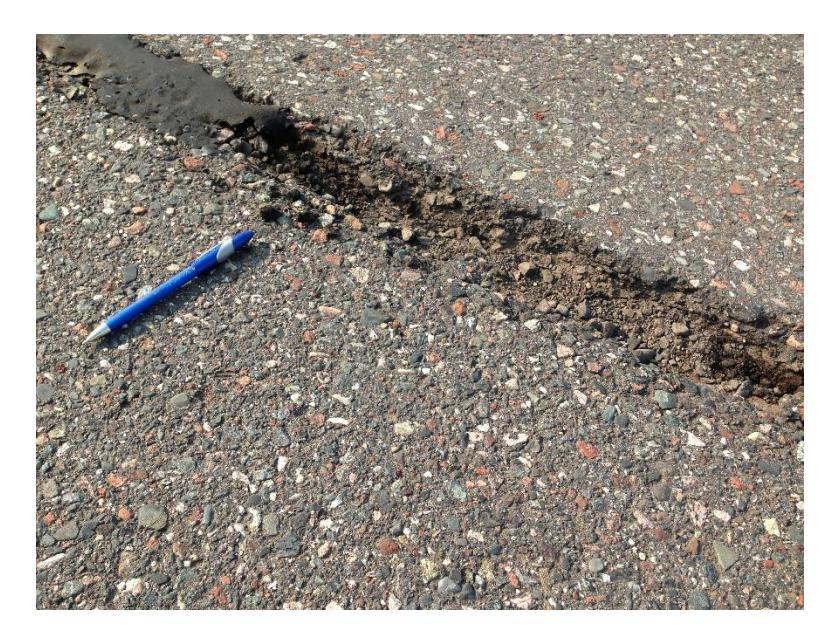
Figure 3.56 Section of Longitudinal Crack with Sealer Missing.

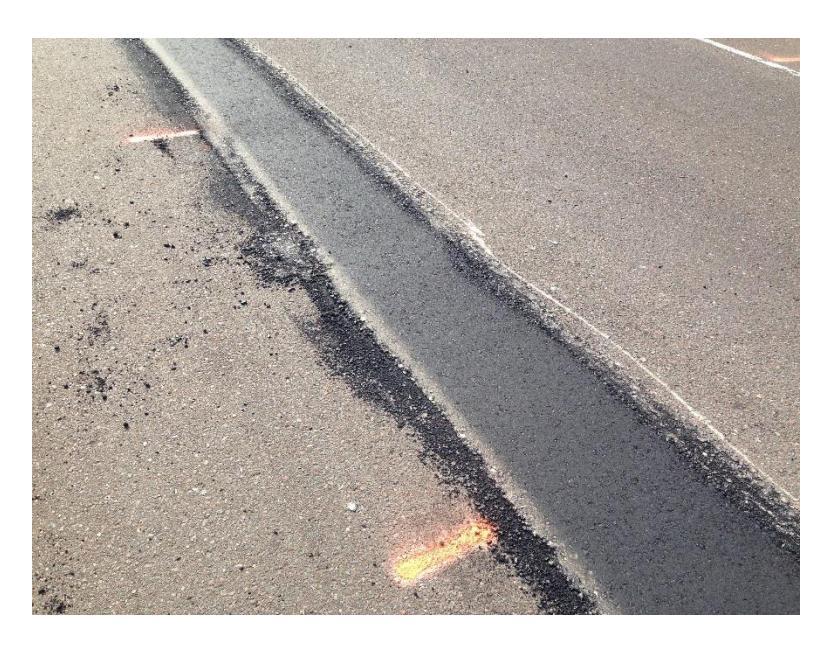
difference between excess material placement (Figure 3.59) and proper placement (Figure 3.60) is illustrated below. Placing the proper amount of material leaves a much cleaner looking product as well as reduces the amount of waste material. Figure 3.61 Shows finished patching work at Pothole D-3.

Figure 3.59 Pothole D-1 after Compaction (Excess Fill Material on Roadway).

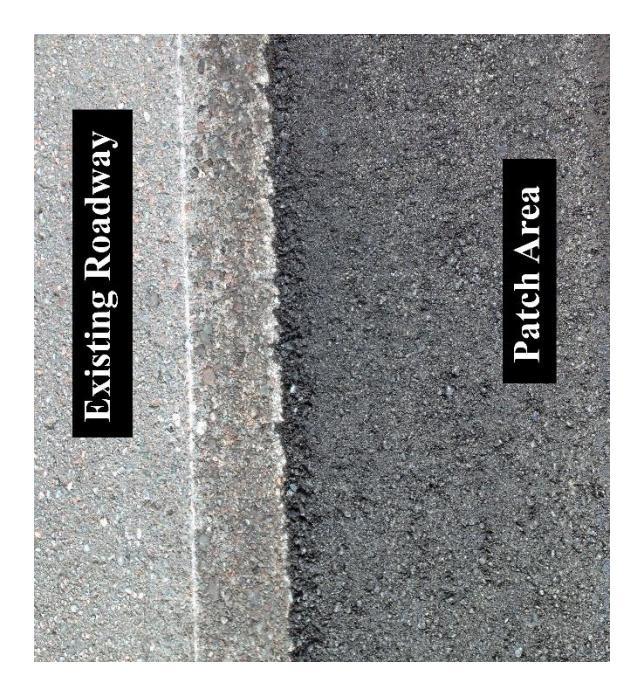
One issue with a mill and fill operation is the compaction along the edge of a patch. A closer look along the edge (Figure 3.62) shows that steel drum rollers, used to compact the fill material, are unable to completely compact the fill material. Since rollers are wider than the patch, the steel drum sits on the existing roadway preventing the compaction of material near the edge. This area of lesser compacted material may lead to a higher rate of water infiltration or patch material raveling.

Figure 3.62 Interface between Patch Area and the Existing Roadway.

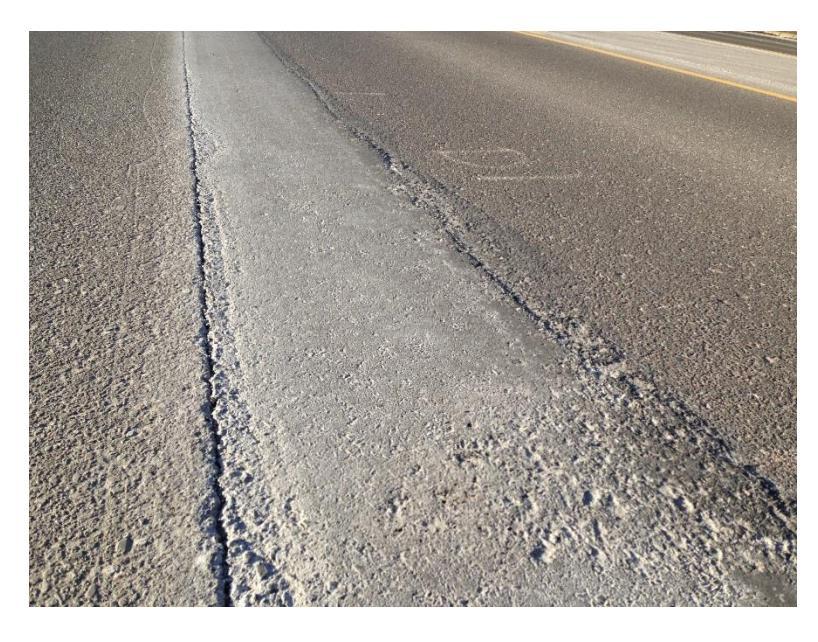
The site visit on December 4, 2014 indicated that Both D-1 and D-2 had significant raveling of material along the interface of the patch and existing roadway (Figure 3.67). It is also shown in Figure 3.67 that some distresses have occurred along parts of the patch surface. The crack running underneath Patch D-3 has propagated through the patch and has a width varying between ¼ and ½ inch.

Figure 3.67 Pothole D-1 (126 Days after Installation) with Deterioration along the Patch Interface.

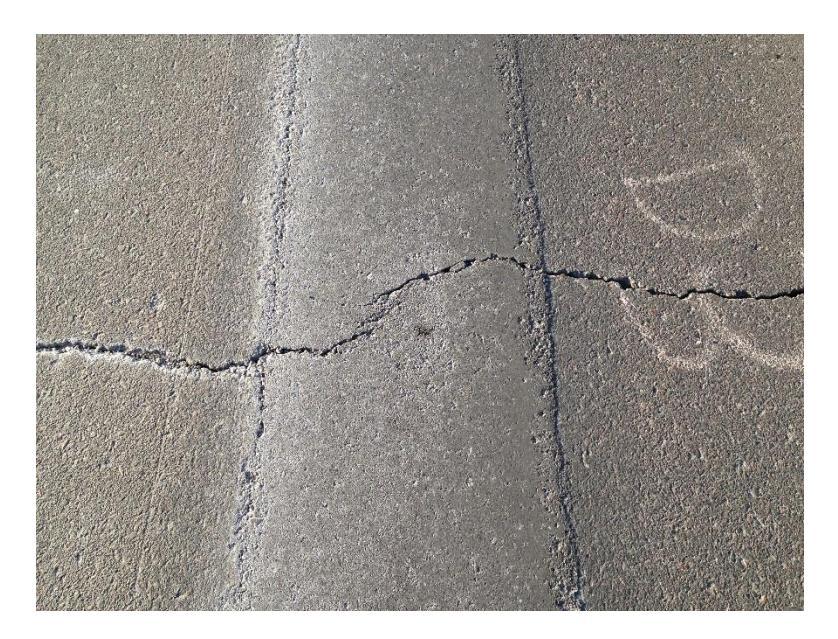
Figure 3.68 Pothole D-3 (126 Days after Installation) with Crack Running Through Patch.

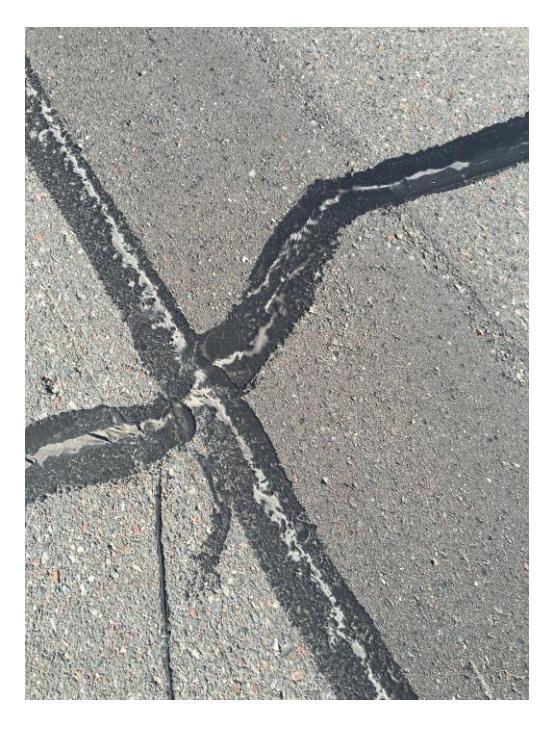
Site visits conducted on July 29, 2015 and October 20, 2015 revealed that severity of the raveling did not increase in second year of service. See Figure 3.69 and Figure 3.70. It was also discovered that the cracks that had propagated through and along the edges of the patches had been sealed sometime during the summer of 2015 (Figure 3.70 and Figure 3.71). This probably helped in arresting the raveling in the year two.

Figure 3.71 Pothole D-3 (446 Days after Installation) with Crack Running Through Patch.

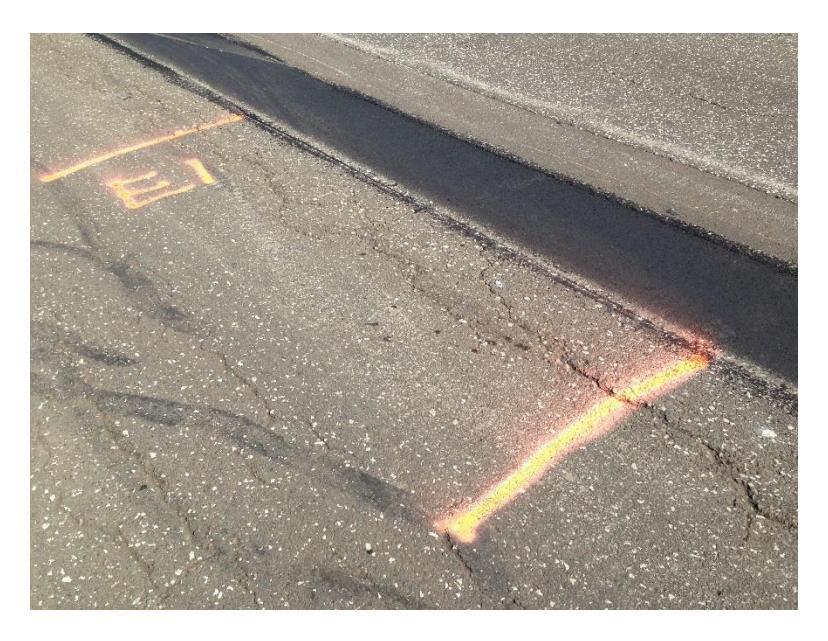
Figure 3.72 Pothole E-1 with Parallel Longitudinal Cracking.

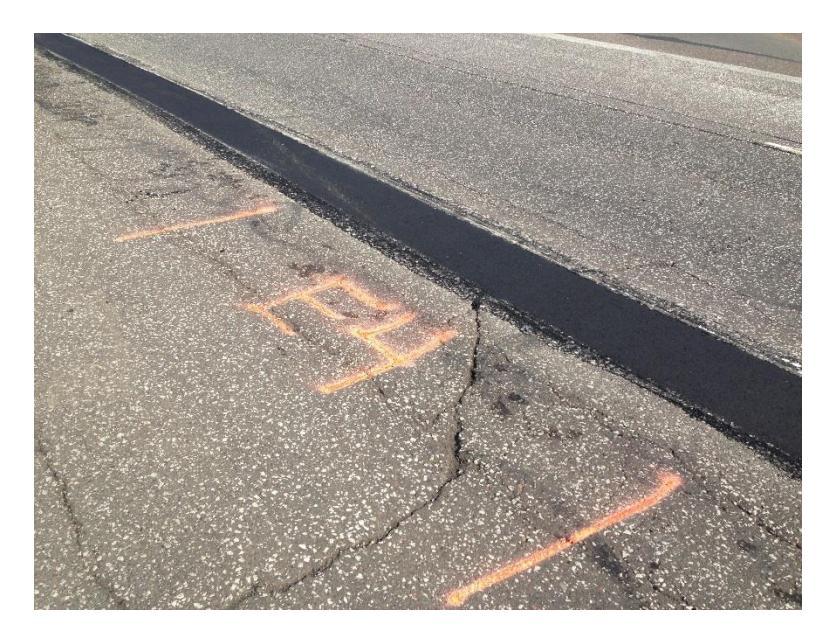
Figure 3.75 Pothole E-4 with Transverse Crack.

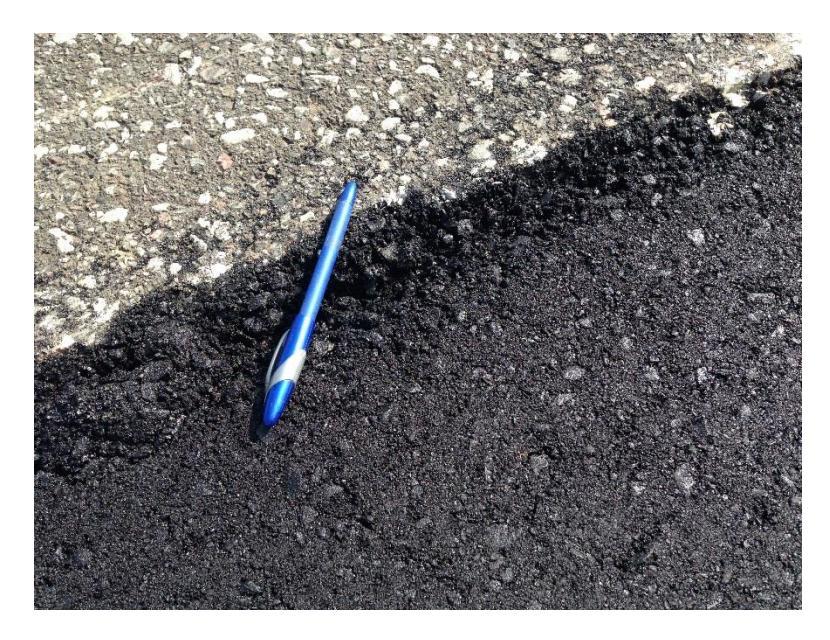
The lack of compaction issue near the interface of the pothole and roadway discussed above in Site D section also existed at this site. The issue however was more prevalent and also included some raveled material right after compaction (Figure 3.77).

Figure 3.77 Lack of Compaction and Material near Interface of Patch Material and Roadway.

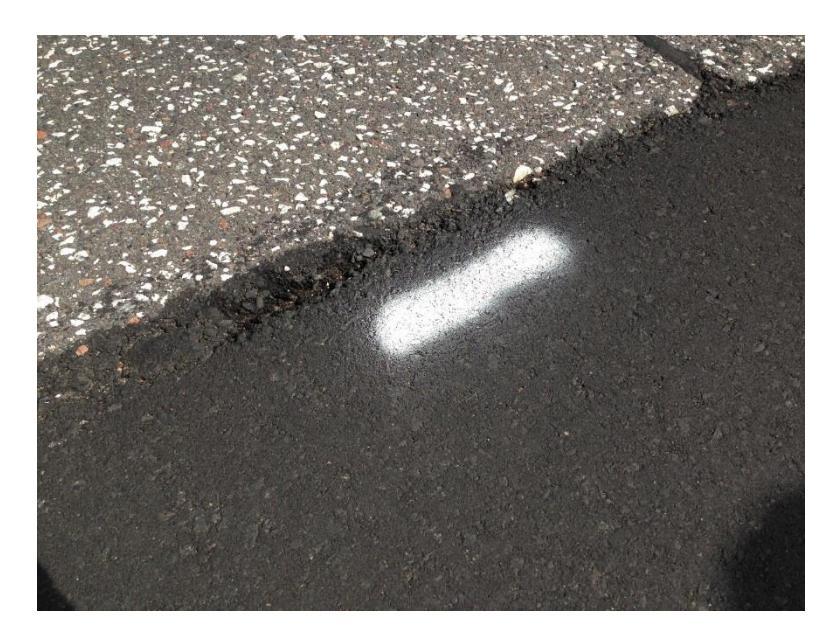
Figure 3.80 Poorly Compacted Interface (28 Days after Patching).

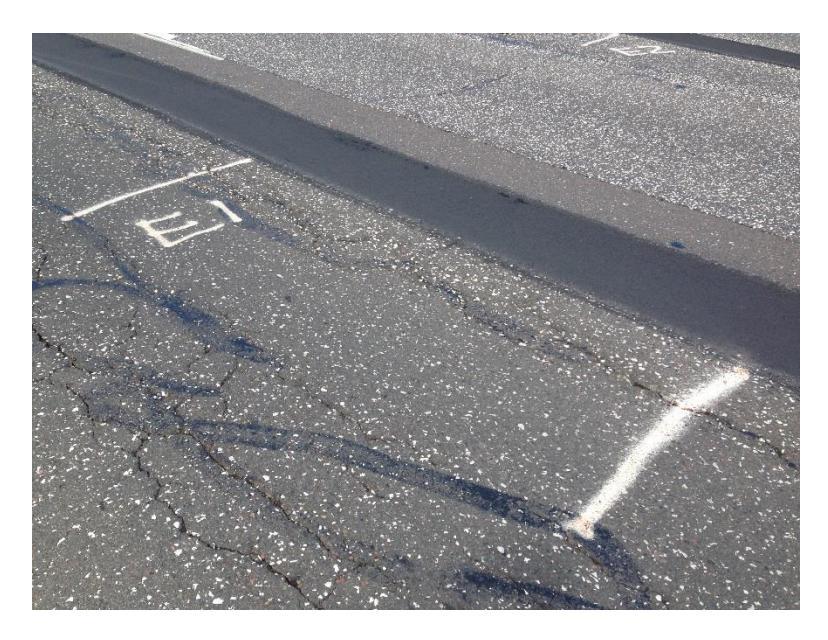
Figure 3.81 Patch E-1 Parallel to Existing Distresses (28 Days after Patching).

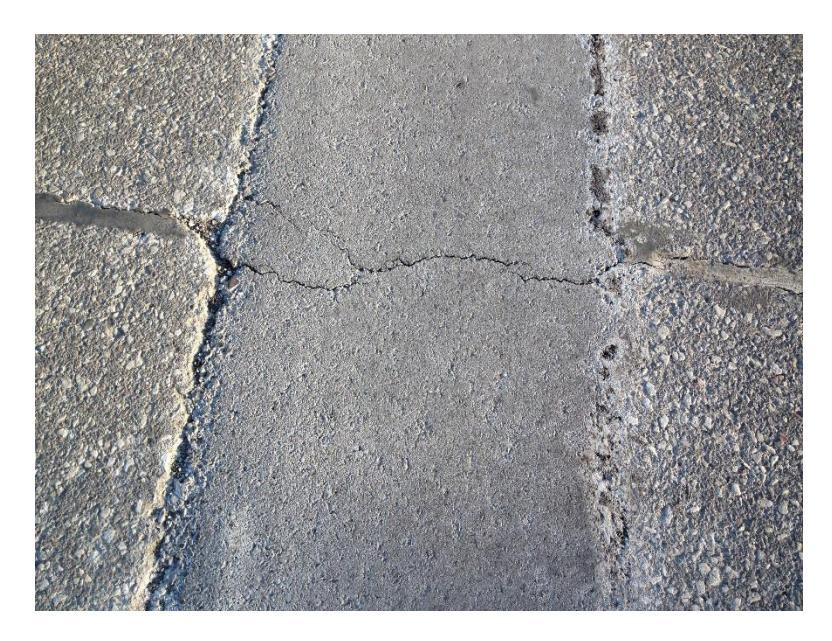
the year was made on December 4, 2014. Figure 3.82 to Figure 3.85 show that a significant amount of damage had occurred to the patch material including cracks and raveling along the patch interface.

Figure 3.82 Cracking of Pothole E-3 (119 Days after Installation).

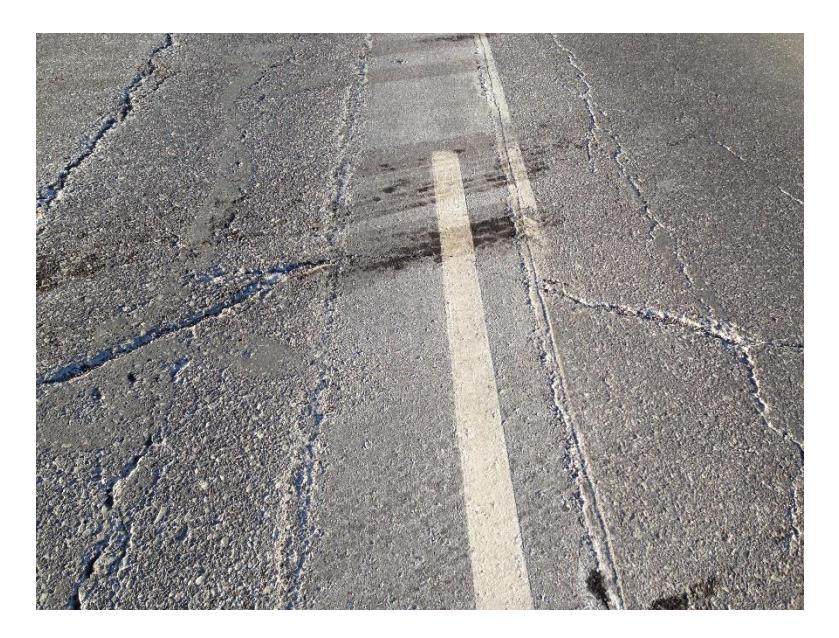
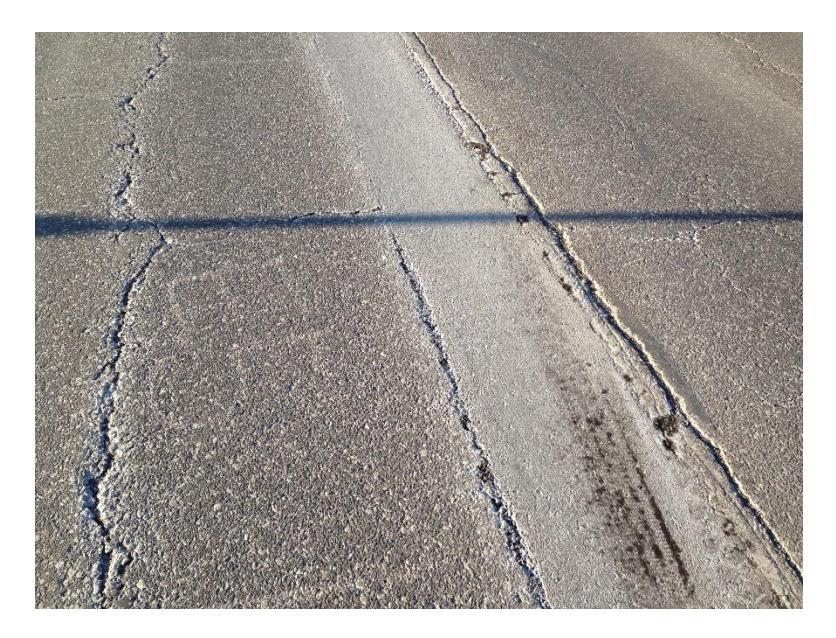
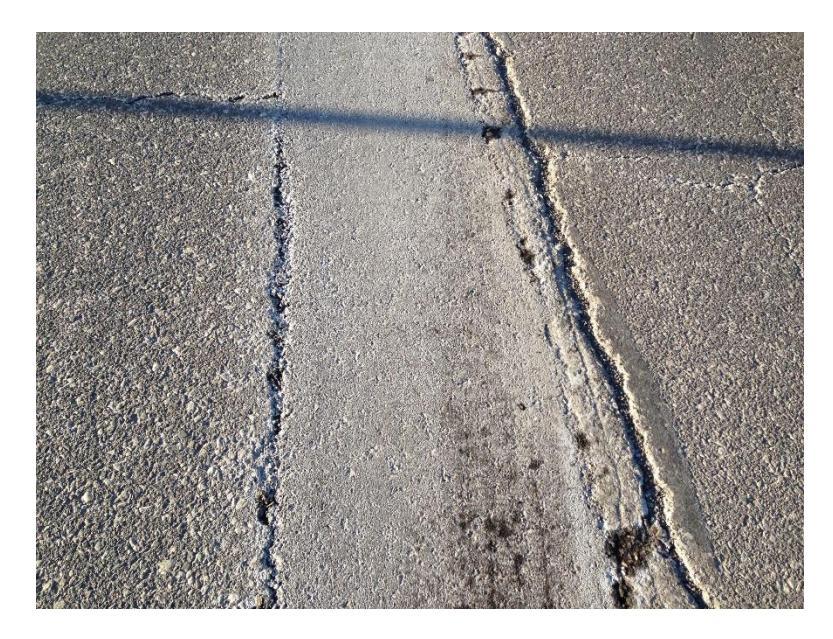
Figure 3.83 Pothole E-4 (119 Days after Installation).

Figure 3.84 Pothole E-5 (119 Days after Installation).

Figure 3.85 Close View of Distresses on Pothole E-5 (119 Days after Installation).
