TECHNICAL SUMMARY

GFRP Rebar Shows Promise for Use in Bridge Decks

This Technical Summary pertains to Report 2020-05, “Field Investigation of Bridge Deck Reinforced With Glass Fiber Reinforced Polymer (GFRP) Rebar,” published February 2020. The full report can be accessed at mndot.gov/research/reports/2020/202005.pdf.

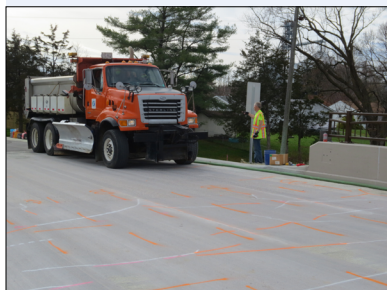
Researchers used this loaded dump truck to conduct load testing on the Dry Creek bridge.

Before the deck was opened to regular traffic, the research team conducted live load tests in November 2016 with a three-axle dump truck loaded with sand and driven slowly over the structure. Load tests were conducted again in November 2017 and in late October 2018.

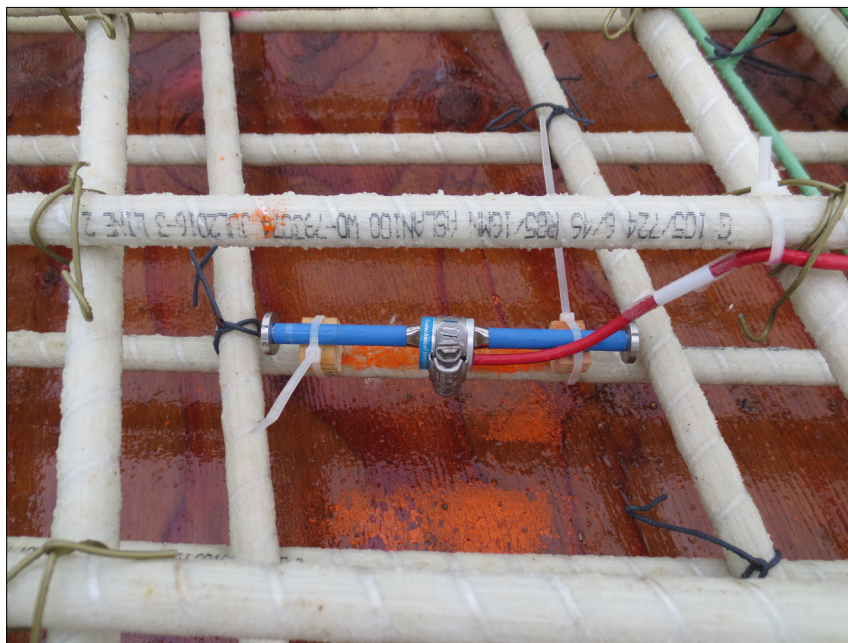
Researchers attached strain and temperature gauges to the GFRP reinforcement bars before concrete was poured on the bridge deck.

After reviewing research on GFRP performance in the lab and field, investigators placed an array of strain and temperature gauges on the GFRP rebar at the Dry Creek bridge before the concrete deck was placed and connected the gauges to the monitoring equipment mounted beneath the deck. Temperature and stress response data were collected every hour for the three-year period of this study.
