Pedestrian User Experience at Roundabouts

Ranjit Godavarthy, Principal Investigator
Upper Great Plains Transportation Institute
North Dakota State University

Research Project
Final Report 2023-01

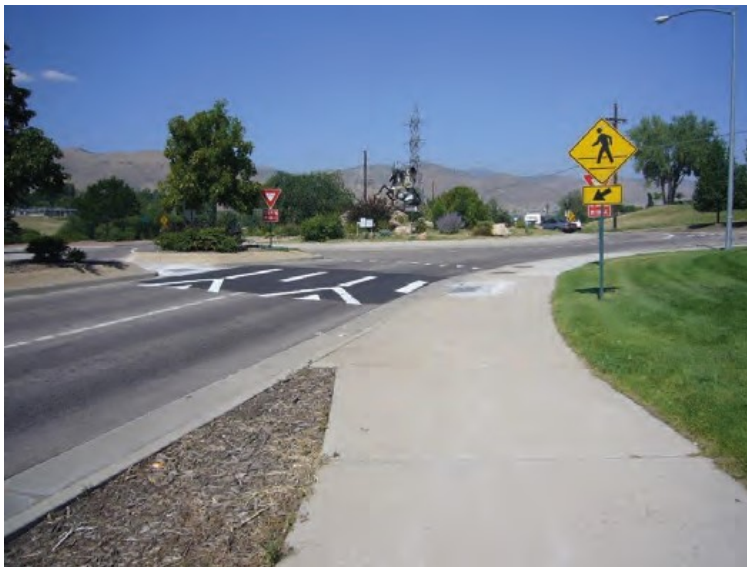
Figure 1.3 Raised crosswalk at a two-lane roundabout

Non-signalized treatments such as raised pedestrian crossings introduce a vertical deflection for drivers to help reduce speeds and improve the likelihood of drivers yielding to pedestrians (Schroeder, et al., 2016). This traffic calming treatment could cost anywhere between \$8,000 and \$39,000 not including drainage improvements. Care must be taken to make sure the speed reduction does not significantly reduce the lane capacity and outweigh the benefits attained by speed reduction. Figure 1.3 illustrates a raised pedestrian crosswalk installed at an approach for a two-lane roundabout. Raised pedestrian crossings can be potentially combined with signalized treatments such as a yellow flashing beacon or rectangular rapid-flashing beacon (RRFB) to alert drivers to pedestrians and encourage them to yield (Schroeder, et al., 2016).

It also has to be noted that raised crosswalks present vertical obstructions for emergency vehicles and snowplows, although there are snowfall locations with raised pedestrian crossing treatments (Schroeder, et al., 2016).

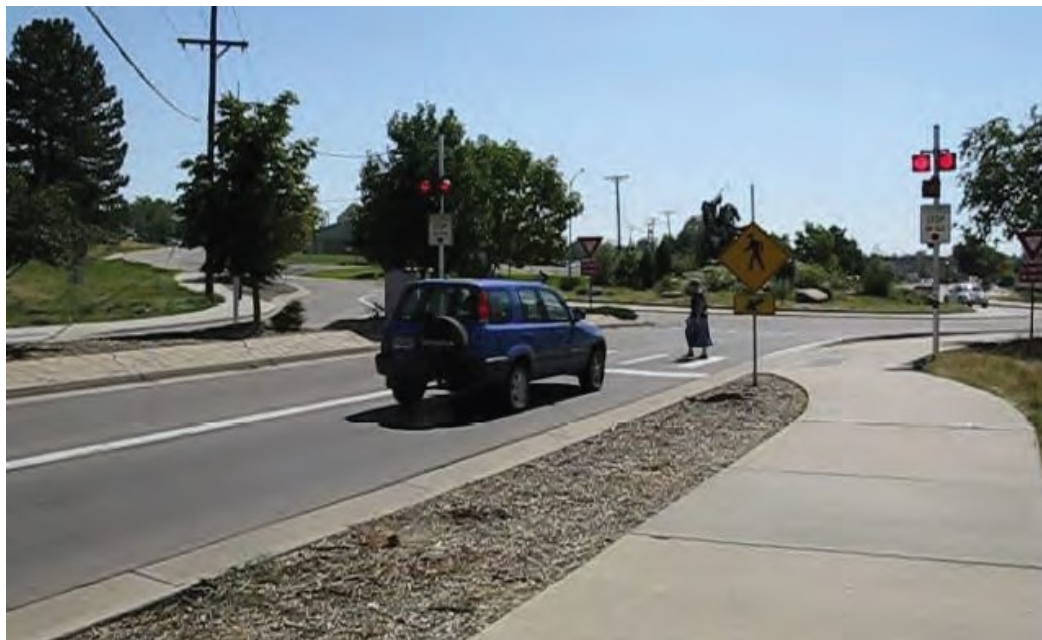
Figure 1.4 Pedestrian hybrid beacon at roundabout in Golden, Colorado

A pedestrian hybrid beacon (PHB), or HAWK signal as it is commonly called, is a traffic-control device to provide drivers information as to when to stop when a pedestrian is present and activates the signal (Schroeder, et al., 2016). Figure 1.4 illustrates a PHB signal at a roundabout crossing in Golden, Colorado, and Figure 1.5 illustrates the sequence of PHB displays for drivers and pedestrians. When compared to regular red/yellow/green signals, PHBs are efficient in that they allow vehicles to move on the pedestrian flashing do-not-walk interval when pedestrians are not in the crosswalk. The cost of installing a PHB is anywhere between \$68,000 to \$133,000 for the initial leg, and anywhere between \$29,000 and \$80,000 for each subsequent leg (Schroeder, et al., 2016).

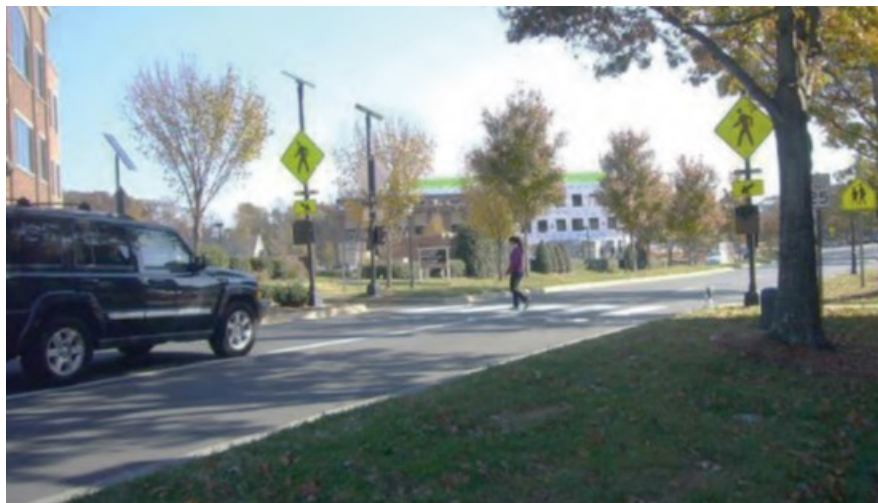
Figure 1.6 RRFB at a two-lane roundabout

A rectangular rapid-flashing beacon (RRFB) is a visually enhanced driver-warning device activated by the pedestrian and provided as a supplement for static warning signs (Schroeder, et al., 2016). RRFBs do not have solid-red indicators for motorists or walk indicators for pedestrians, both of which are important characteristics with standard pedestrian signals and PHBs. Figure 1.6 shows an RRFB installed at a two-lane roundabout.

An RRFB's primary function is to increase driver awareness of pedestrians crossing or preparing to cross. One of the unique advantages of RRFBs is that they achieve driver-yielding rates similar to traditional signals or PHBs but are much more affordable to install. RRFBs cost anywhere between \$26,000 and \$49,000 per leg (Schroeder, et al., 2016). As of March 2018, RRFBs received interim approval status from the FHWA for optional use as a pedestrian-actuated, conspicuity enhancement for pedestrian and school crossing warning signs under certain limited conditions (FHWA, 2018).

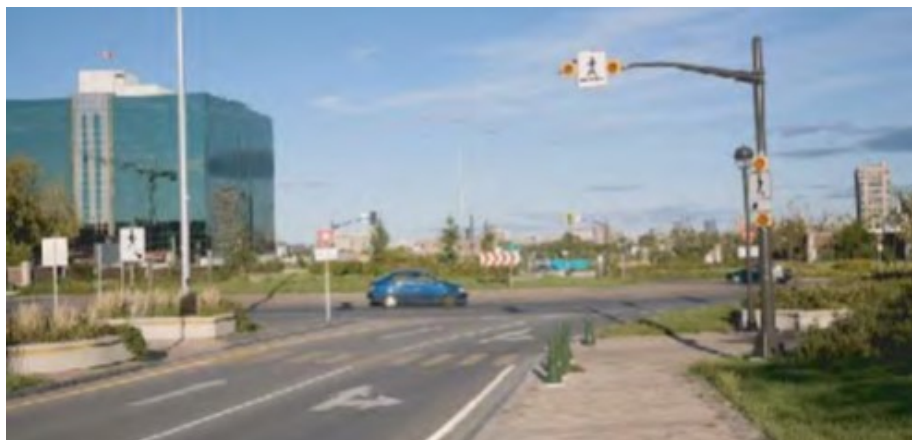
Figure 1.7 Traditional yellow warning beacon at a roundabout in Canada

A flashing beacon is a driver improvement treatment provided in combination with static warning signage. Flashing beacons are installed on overhead signs, in advance of the crosswalk, or on signs at the crosswalk to make the beacon more visible to drivers. Yellow flashing beacons improve driver-yielding rates to pedestrians, and therefore pedestrians can benefit from installations at roundabout crossings. While a flashing beacon improves driver-yielding rates, it is less than what is possible with a RRFB because an RRFB is much more visible to drivers than flashing beacons. Figure 1.7 shows a yellow flashing beacon at a roundabout in Canada.

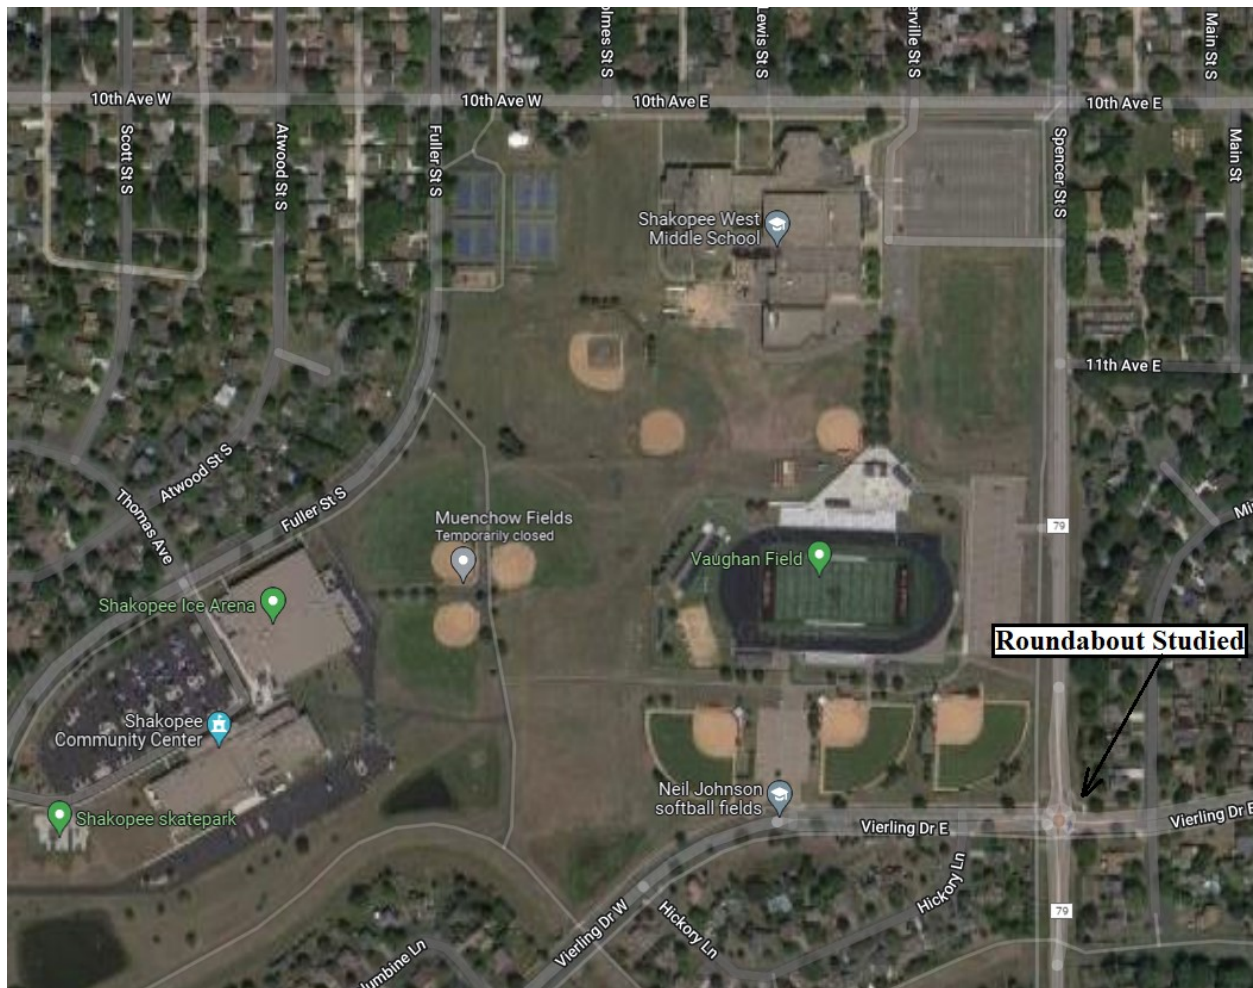
Figure 4.2: Roundabout on Spencer St. and Vierling Dr. in Shakopee, Minnesota; Source: Google Maps

A single-lane roundabout (Figure 4.2) on Spencer Street and Vierling Drive in Shakopee, Minnesota, was studied for this case study. The roundabout has a single-lane for the circulatory roadway and all the four approaches have single entry lane and single exit lane (Figure 4.3). All the four approaches have marked pedestrian crosswalks. It was noted that the roundabout is located in a school zone. Adjacent to this roundabout location, at the north-west corner of the roundabout, there is a middle school as well as a high school sporting events field. Apart from the north-west corner, the roundabout could be generally classified as being located in a residential area (Figure 4.2).

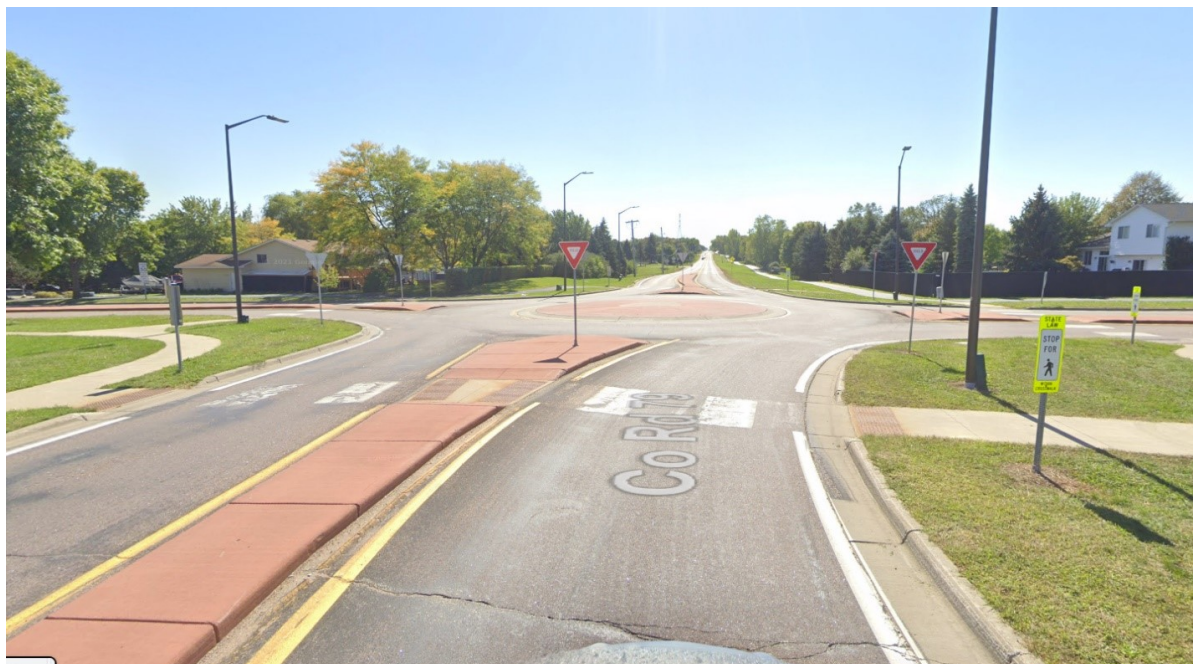
Figure 4.4: Paddle sign at the beginning of the crosswalk for entry and exit lanes; Source: Google Maps

treatments, and therefore it was categorized as base case roundabout. However, instead of placing a typical pedestrian yield sign that is generally used at roundabout crosswalks, all the four approaches for this roundabout have pedestrian paddle signs installed at the beginning and end of the crosswalk – as shown in Figure 4.4.

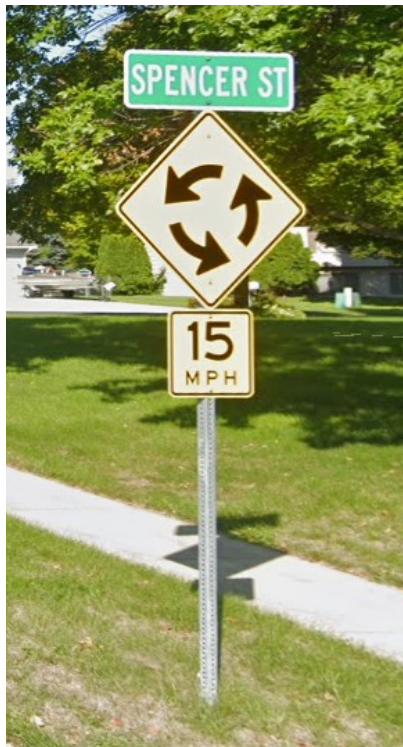
Figure 4.5: Advisory speed for roundabout on Spencer St.

The speed limit for both the south and north approaches of the roundabout on Spencer Street is 45 mph, and the speed limit for both the west and east approaches of the roundabout on Vierling Drive is 30 mph (Figure 4.3). The advisory speed for the roundabout was posted as 15 mph (Figure 4.5).

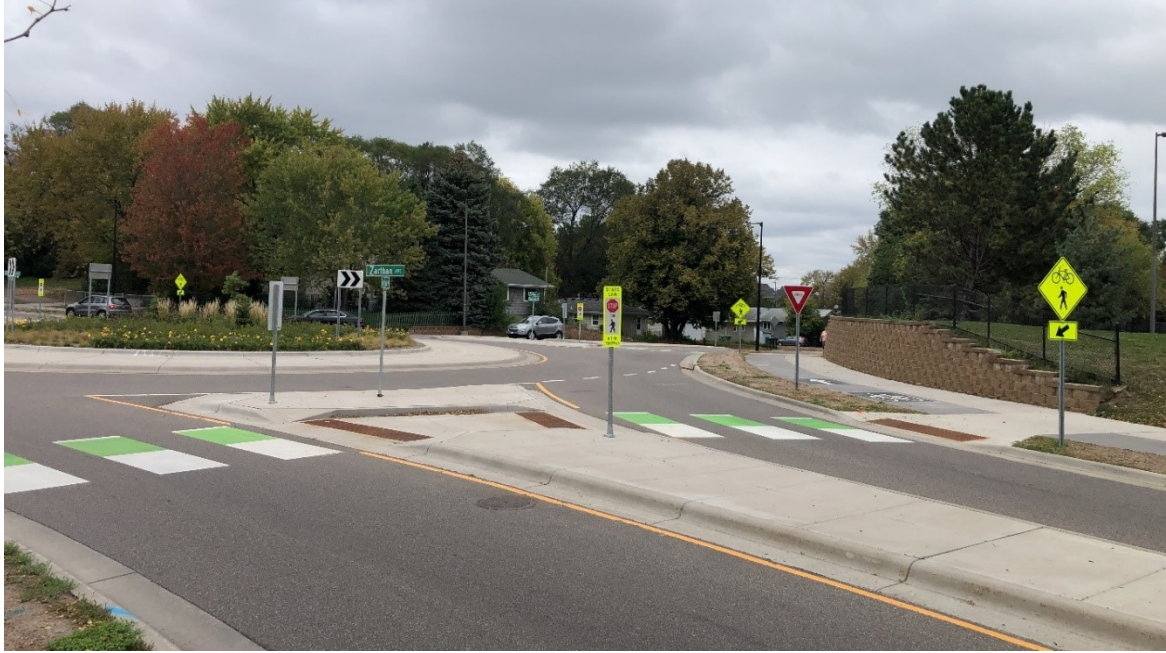
Figure 4.7: South-east leg of roundabout on roundabout on Zarthan Ave. S. and Cedar Lake Rd. showing pedestrian crosswalk with in-roadway signs

A single-lane roundabout (Figure 4.6) at Zarthan Avenue South and Cedar Lake Road, St Louis Park, Minnesota, was studied for this case study. The roundabout has a single-lane for the circulatory roadway and all the four legs have a single-lane for entry and exit for each leg (Figure 4.7). The roundabout can be categorized as being located in a combination of business and residential area, and it is reported from the initial survey findings that a lot of pedestrian activity is generated between the residential area and businesses located in the southbound of the location. All four legs of the roundabouts have pedestrian crosswalks, and all the crosswalks have in-roadway signs installed at the splitter island (refer Figures 4.6, 4.7, and 4.8).

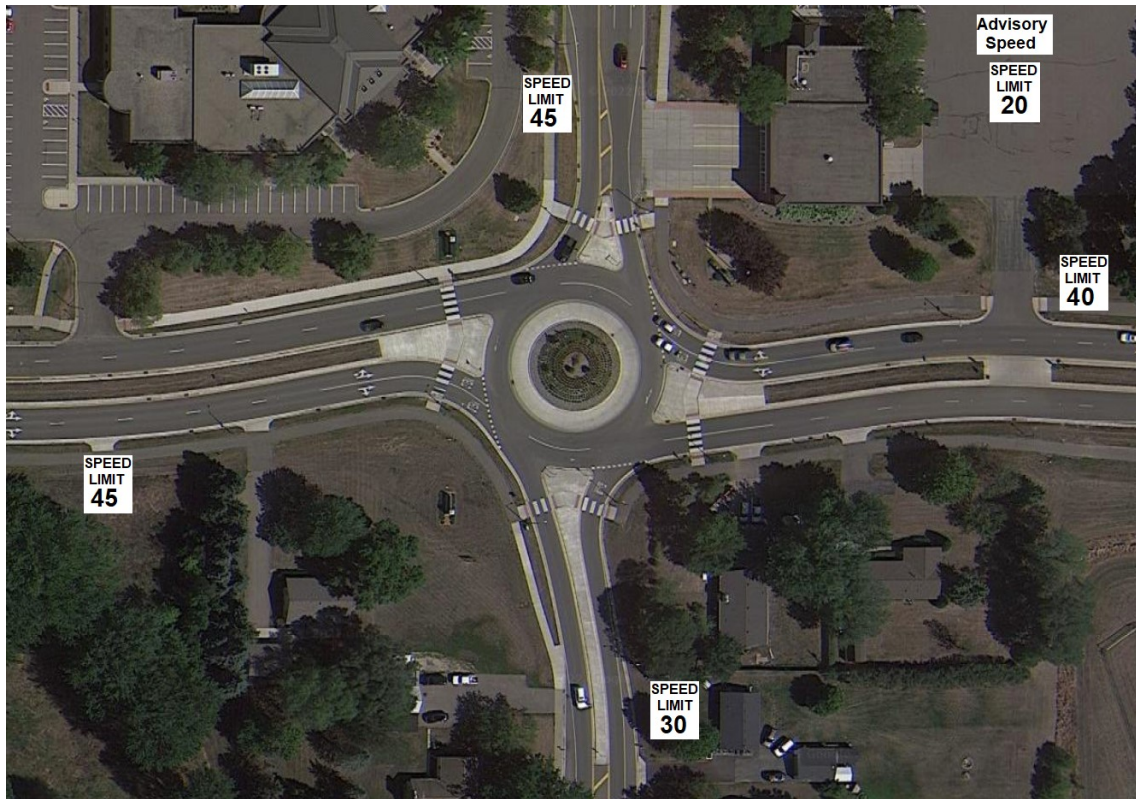
Figure 4.10: Multi-lane roundabout at Dakota County Rd. 50 and Holyoke Ave., Lakeville, Minnesota – Close-up view along with speed limits marked

For the roundabout, the approaching speed limit is 45 mph for the west leg, 40 mph for east leg, 45 mph for north leg and 30 mph for south leg (Figure 4.10). The advisory speed for the roundabout was posted as 15 mph. In can be seen from Figure 4.10 that the east leg of the roundabout has two entry lanes and two exit lanes, the west leg (Figure 4.11) has two entry lanes and two exit lanes, the north leg has one entry lane and one exit lane, and the south leg (Figure 4.12) has one entry lane and one exit lane (Figure 4.10). Four cameras were installed at the roundabout, one at each leg.

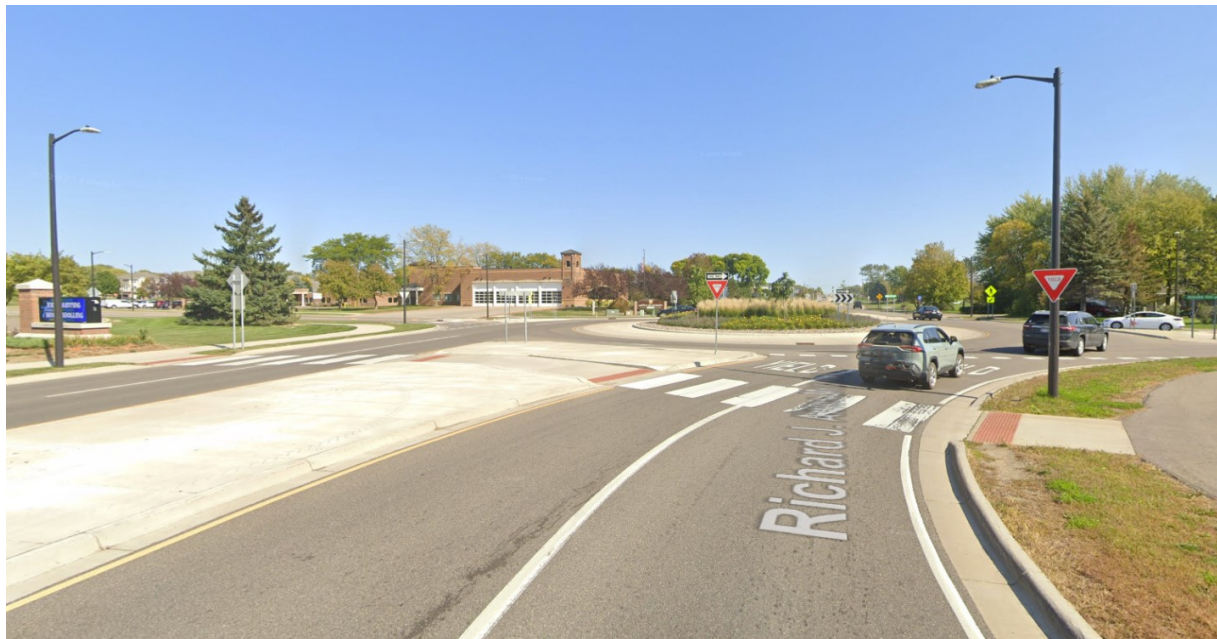
Figure 4.11: View of west leg of the roundabout showing two entry lanes and two exit lanes

average yielding rate of 77.8% for the overall leg. For the west leg of the roundabout (Dakota County Road 50 west leg), which has two entry lanes and two exit lanes, 70.6% of vehicles yielded in the entry lane and 52.4% of the vehicles yielded in the exit lane which resulted in an average yielding rate of 60.5% for the overall leg. For all the three legs, while the yielding rates for entry lanes is observed to be higher (although not in the 90's%), yielding rates for the exit lanes were observed to be lower. For the west leg, which specifically had two entry lanes and two exit lanes, vehicle-yielding rate was lower (60.5%) with the yielding rate being lowest (52.4%) at the exit lanes.

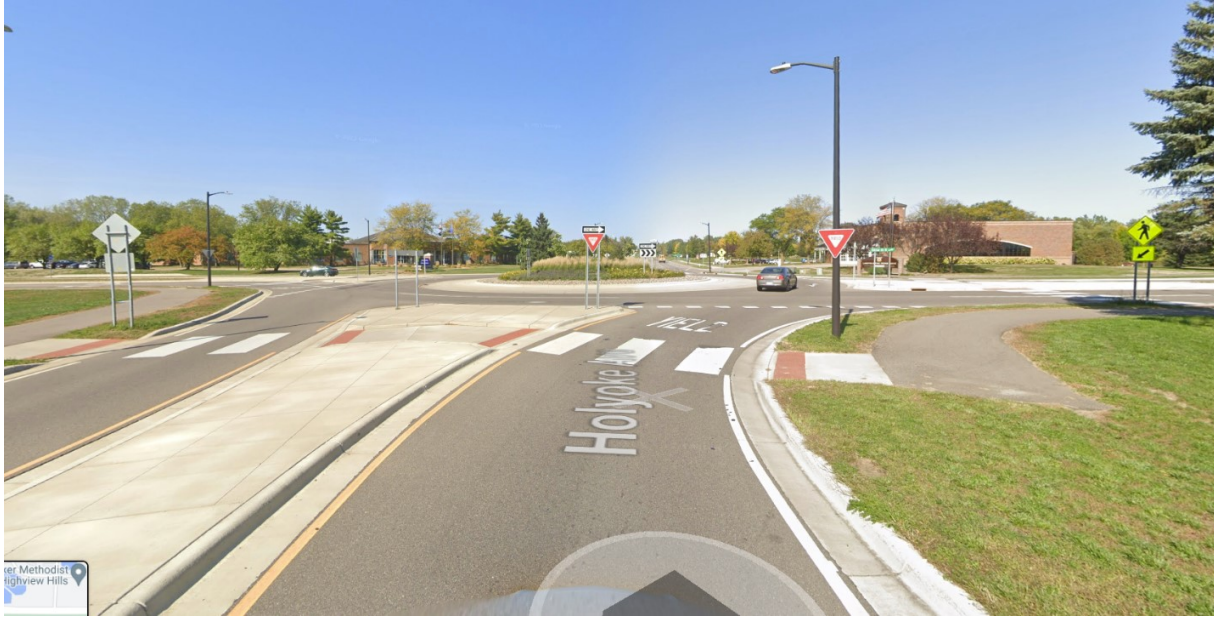
Figure 4.12: View of south leg of the roundabout showing one entry lane and one exit lane

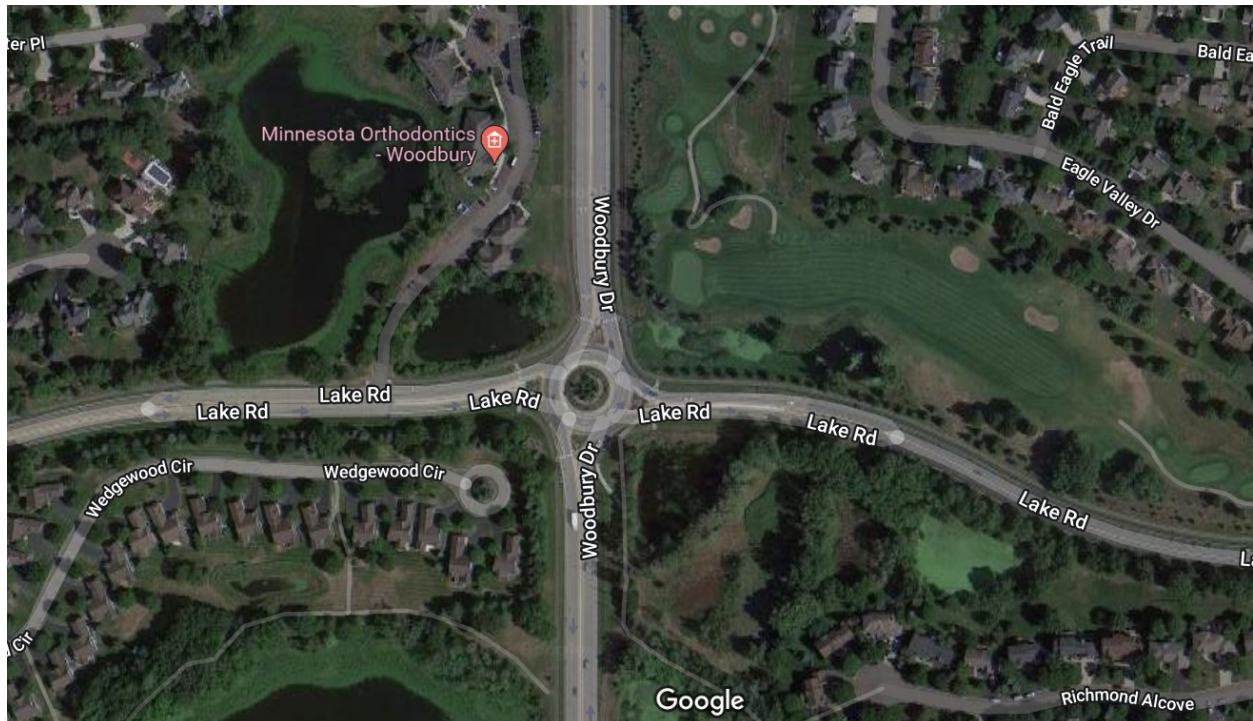
Figure 4.13: Multi-lane roundabout at Lake Rd. and Woodbury Dr., Woodbury, Minnesota

A multi-lane roundabout (Figure 4.13, and Figure 4.14) at Lake Road and Woodbury Drive, Woodbury, Minnesota, was studied for this case study. More specifically, the roundabout can be classified as a 2x1 roundabout; two circulating lanes for the Woodbury Drive and one circulating lane for the Lake Road (Figure 4.14). The roundabout is located in a residential area. Initial survey findings for this location have reported lack of clear gaps for pedestrians to cross the road, vehicle-yielding concerns toward pedestrians, and pedestrians not being clearly visible to drivers, especially for the exiting lanes. All four legs have pedestrian crosswalks. Crosswalks on the Woodbury drive (North and South legs) have in-roadway signs installed (refer Figure 4.15). Crosswalks on the Lake Road (east and west legs) do not have any specialized crossing treatments apart from yield signs placed at the marked crosswalks which are a minimum MUTCD requirement at the roundabout crossings (refer Figure 4.16).

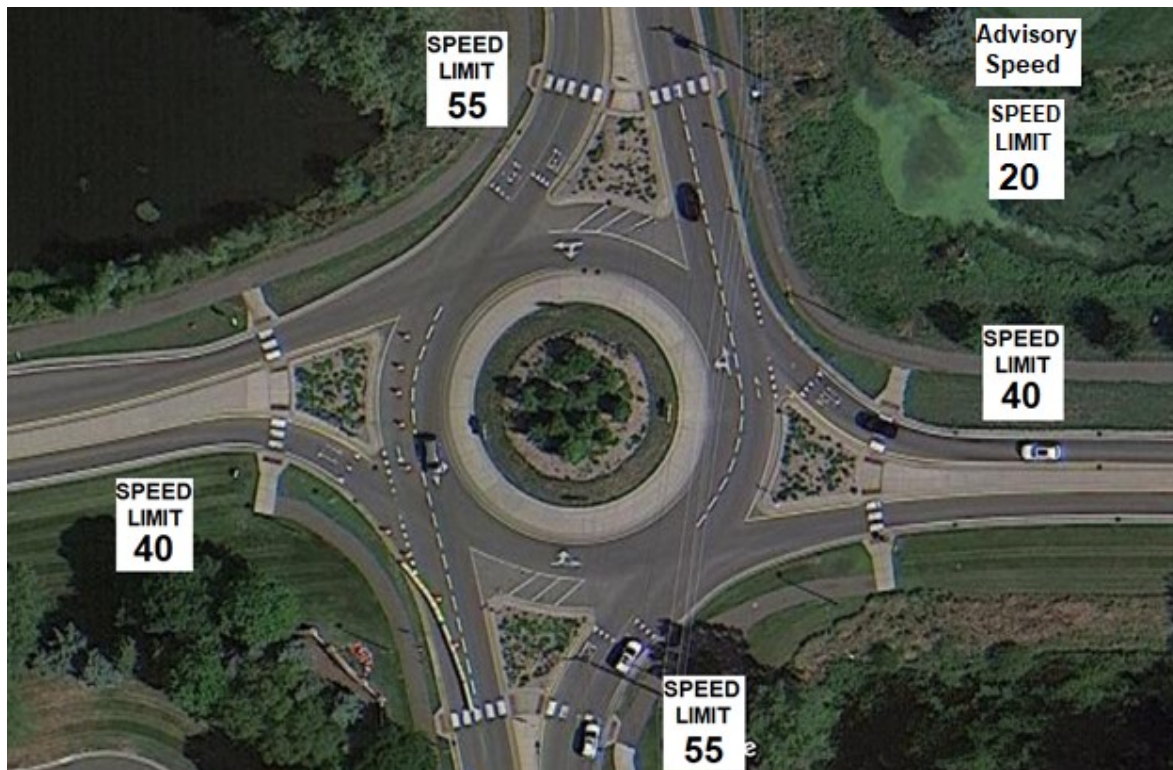
Figure 4.14: Multi-lane roundabout at Lake Rd. and Woodbury Dr., Woodbury, Minnesota – Close-up view along with speed limits marked

The speed limit is 55 mph for the north and south approaches, 40 mph for east and west approaches (Figure 4.10). The advisory speed for the roundabout was posted as 20 mph. North and South legs of the roundabout have two entry lanes and two exit lanes, and east and west legs of the roundabout have one entry lane and one exit lane (Figure 4.14). Four cameras were installed at the roundabout, one at each leg.

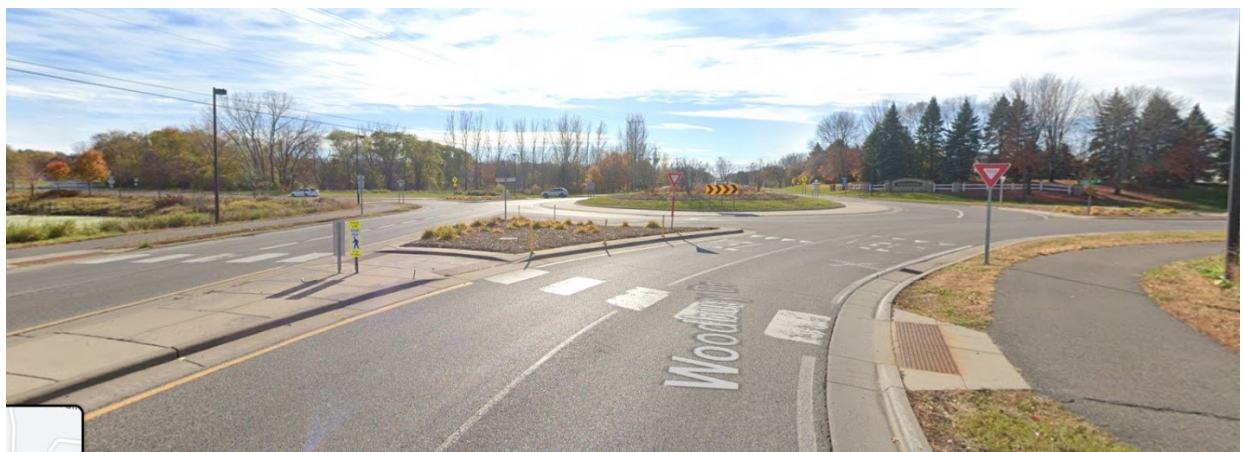
Figure 4.15: View of north leg of the roundabout showing two entry lanes and two exit lanes

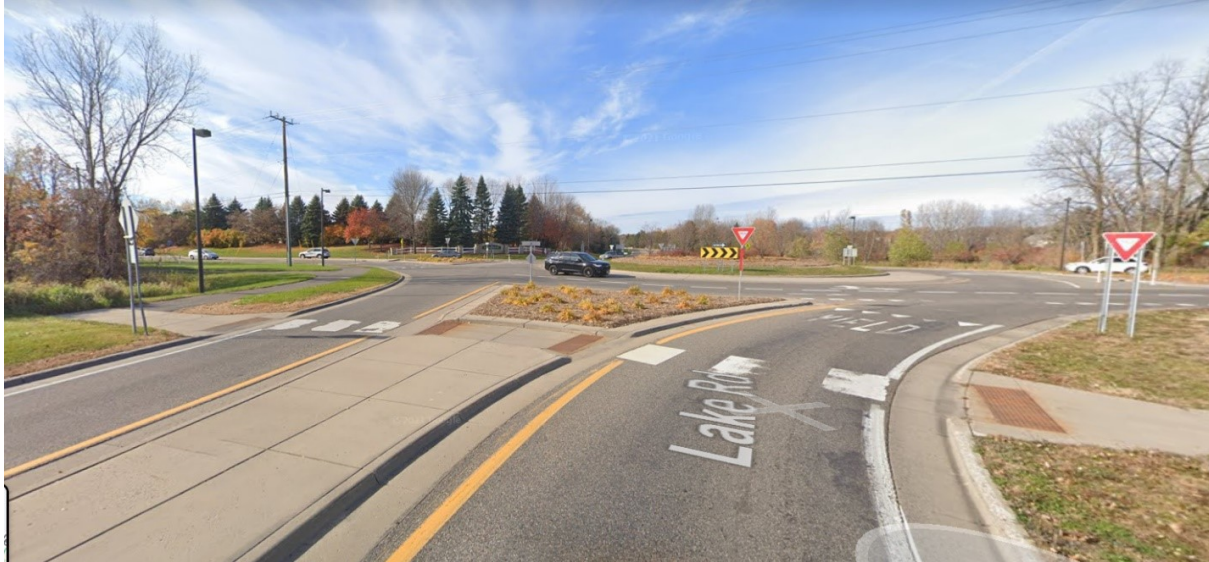
Figure 4.16: View of east leg of the roundabout showing one entry lane and one exit lane

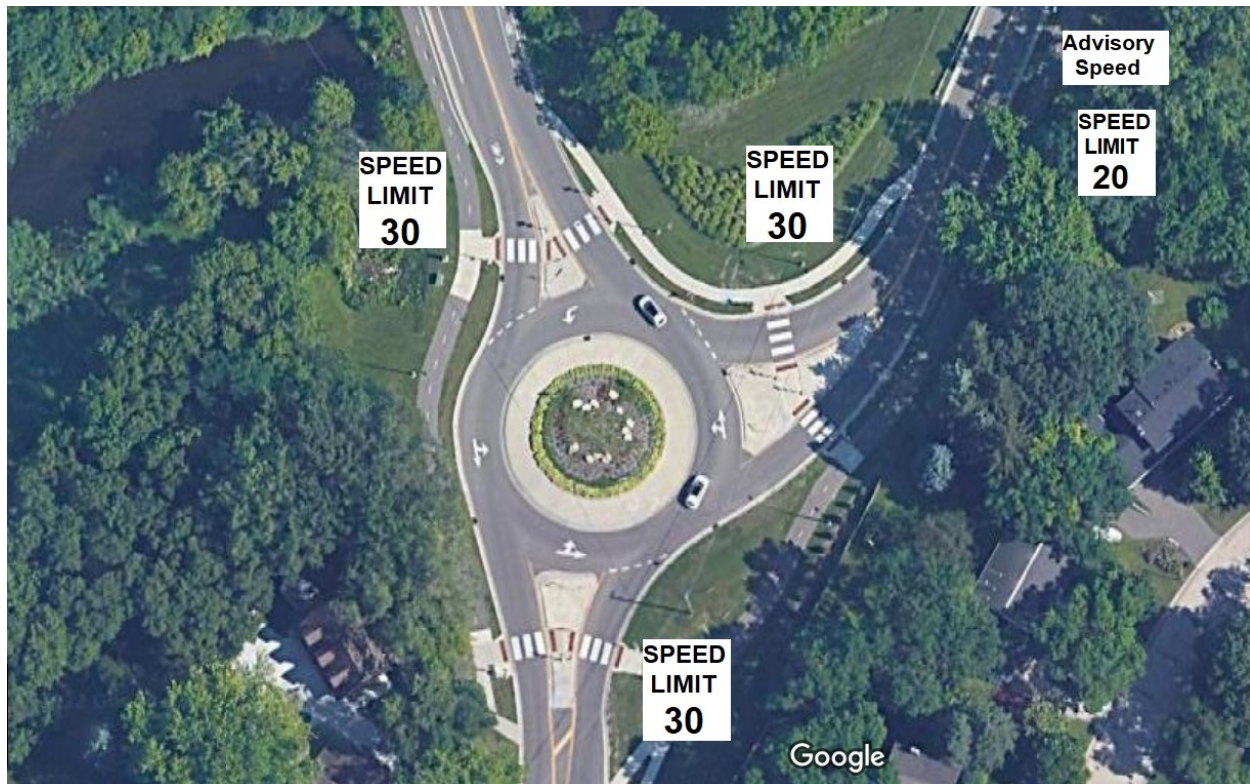
Figure 4.18: Single-lane roundabout at Tracy Ave. and Valley View Ln., Edina, Minnesota – Close-up view along with speed limits marked

The speed limit is 30 mph for all the three approaches (Figure 4.18). The advisory speed for the roundabout was posted as 15 mph. Each leg of the roundabout has one entry lane and one exit lane (Figure 4.18 and Figure 4.19). Three cameras were installed at the roundabout, one at each leg.

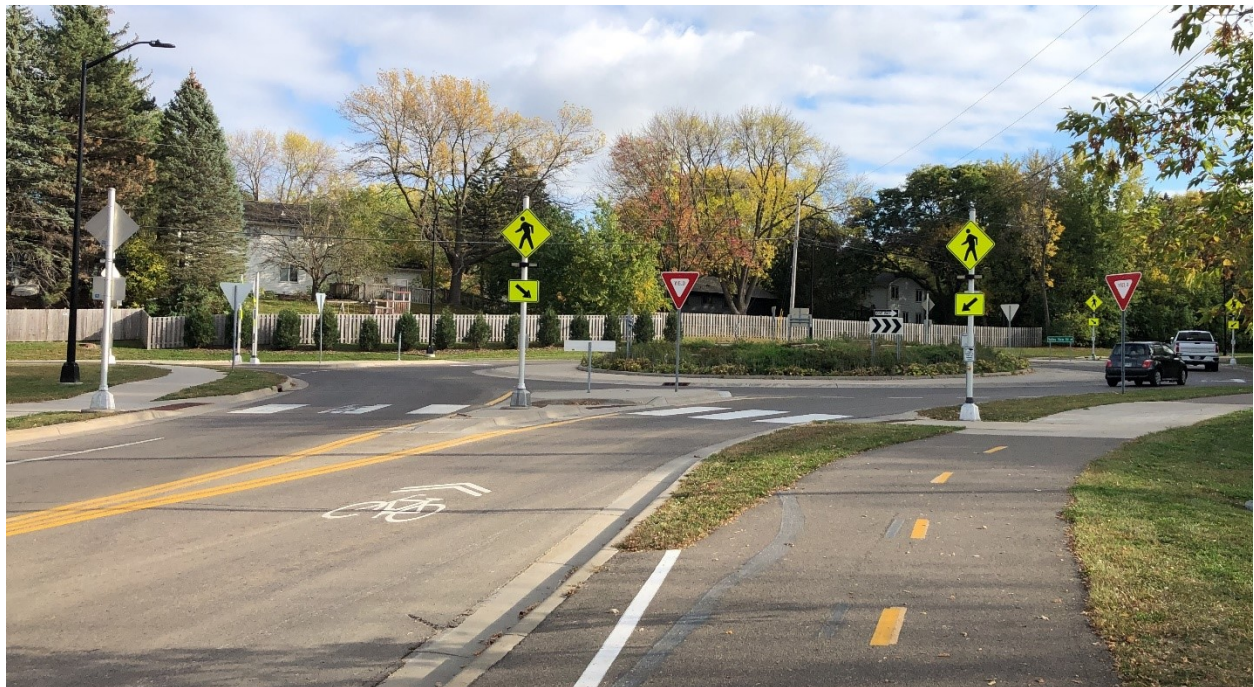
Figure 4.19: View of northeast leg of the roundabout showing one entry lane, one exit lane, and RRFBs installed

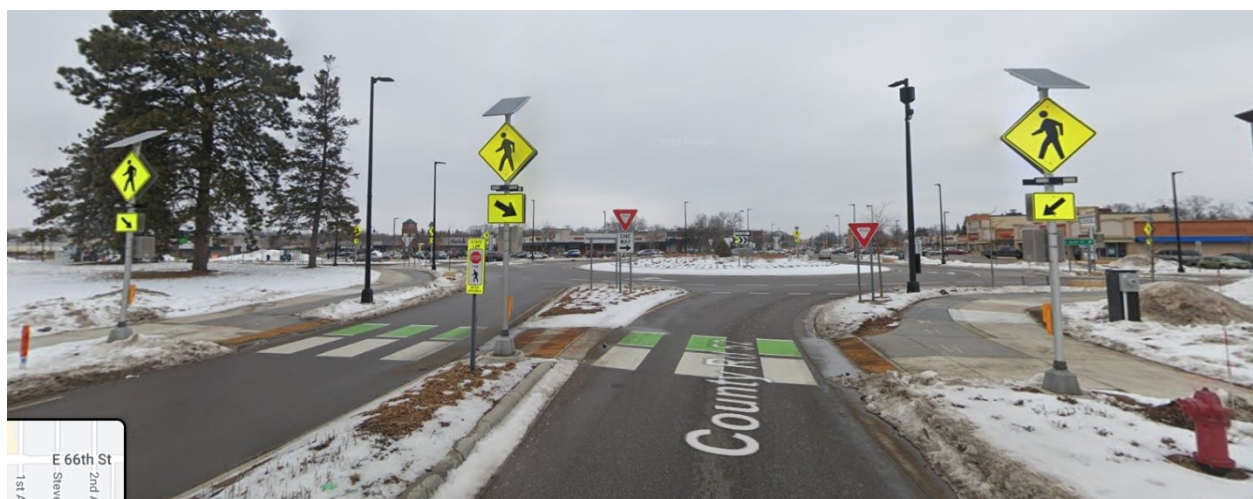
Figure 4.22: View of south leg of the roundabout showing one entry lane, one exit lane, and RRFBs installed

The speed limit is 35 mph for Nicollet Avenue south approach (Figure 4.21). The advisory speed for the roundabout was posted as 15 mph. Nicollet Avenue south leg of the roundabout has one entry lane and one exit lane (Figure 4.21 and Figure 4.22).

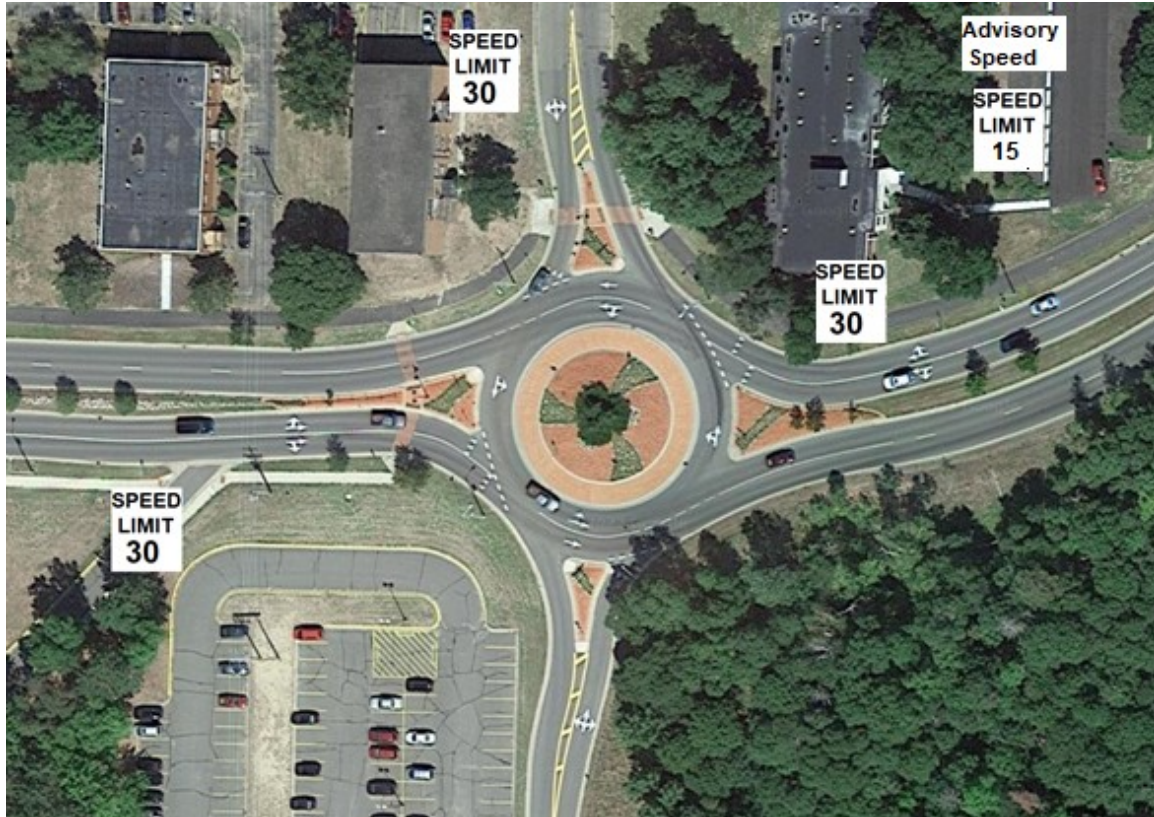
Figure 4.24: Multi-lane roundabout at College Dr. and Mississippi Pkwy., Brainerd, Minnesota– Close-up view along with speed limits marked

The speed limit is 30 mph for the College Drive west approach (Figure 4.24). The advisory speed for the roundabout was posted as 15 mph. The College Drive west-leg of the roundabout has two entry lanes and two exit lanes (Figure 4.24 and Figure 4.25).

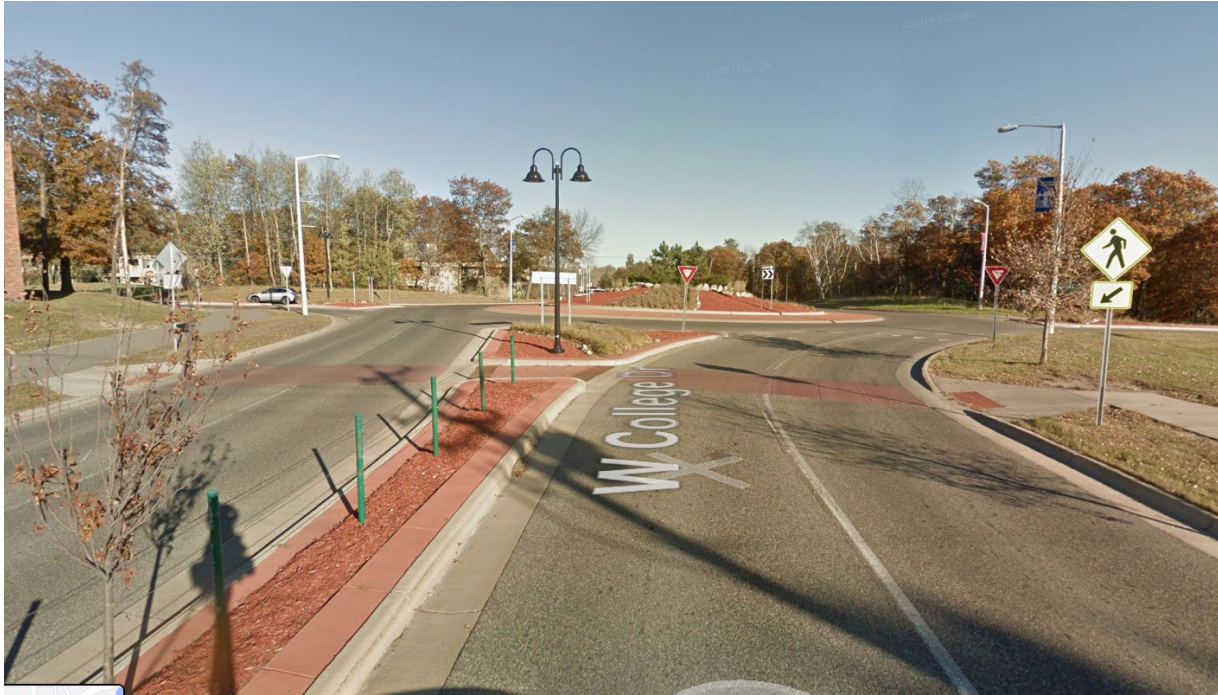
Figure 4.25: View of west-leg of the roundabout showing two entry lanes, two exit lanes, and colored crosswalk installed

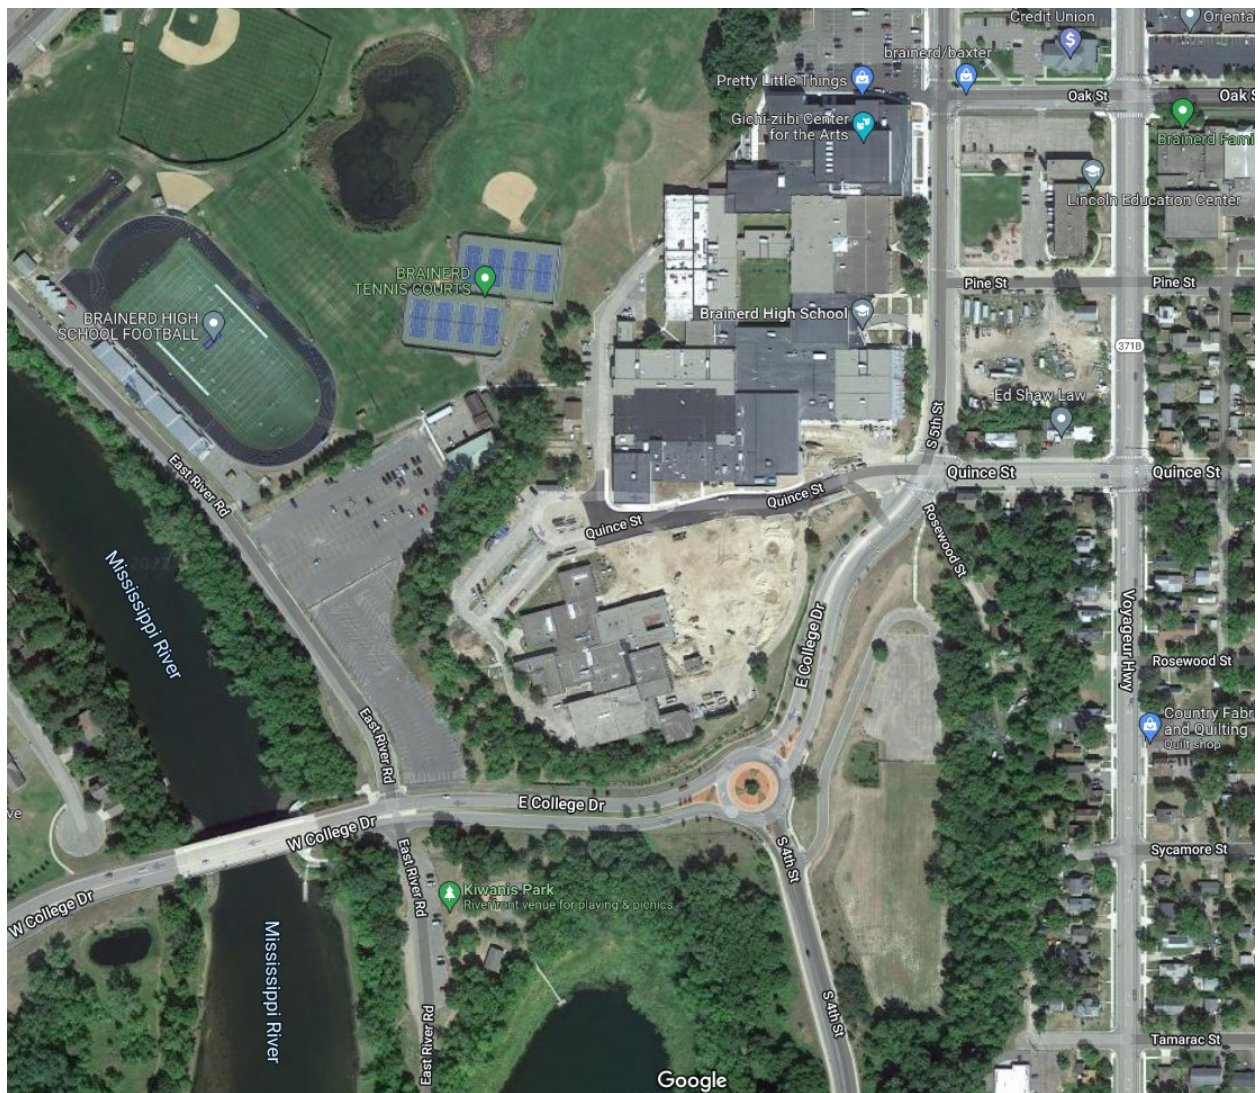
Figure 4.26: Multi-lane roundabout at East College Dr. and S. 4th St., Brainerd, Minnesota

A three-leg multi-lane roundabout (Figure 4.26 and Figure 4.27) at East College Drive and S 4th Street, Brainerd, Minnesota, was studied for this case study. The roundabout is located near a high school. This roundabout location was selected as it has a colored crosswalk installed for pedestrian crosswalks on the northeast and southeast legs of the roundabout. The west-leg of the roundabout does not have a marked crosswalk (refer Figure 4.27). The research team wanted to compare the performance of a roundabout with colored crosswalk with those that has other or no specialized crossing treatments.

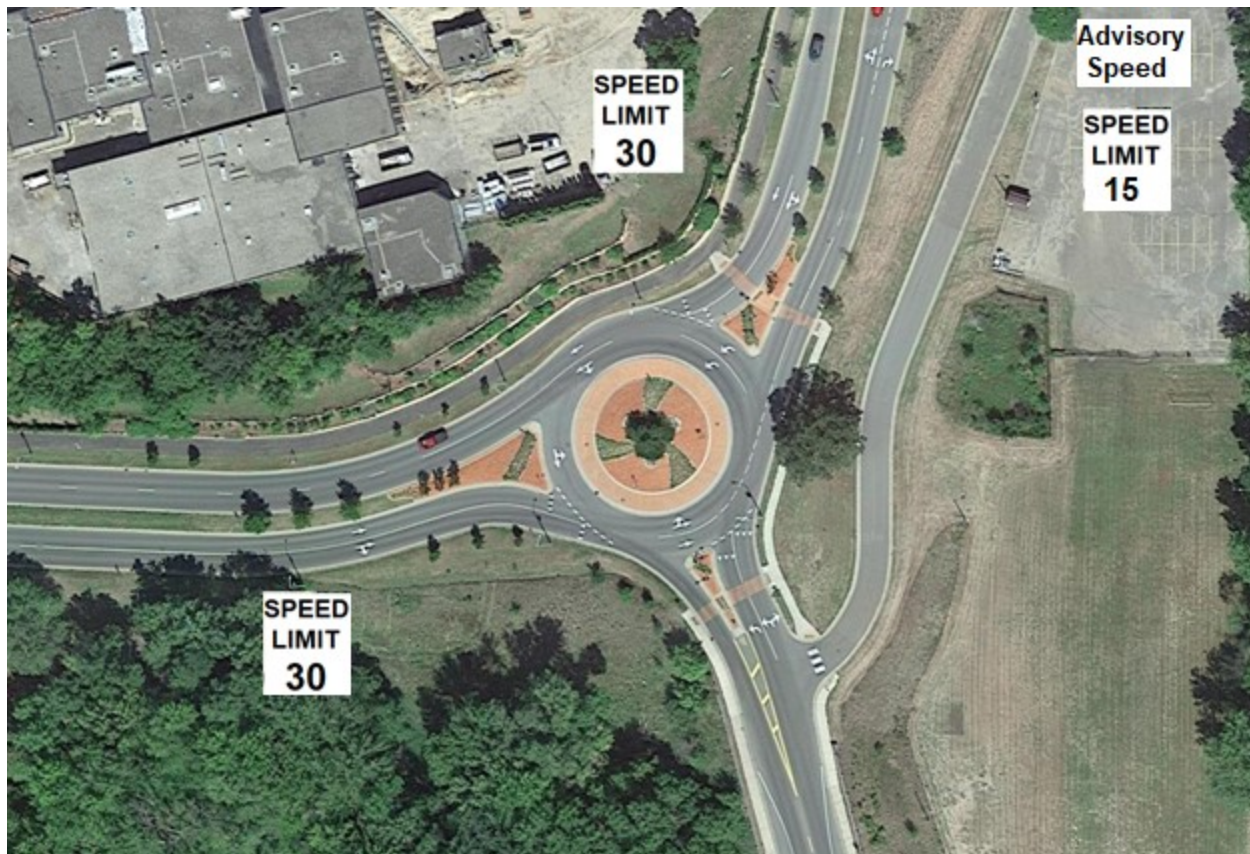
Figure 4.27: Multi-lane roundabout at East College Dr. and S 4th St., Brainerd, Minnesota – Close-up view along with speed limits marked

The speed limit is 30 mph for East College Drive northeast approach (Figure 4.27). The advisory speed for the roundabout was posted as 15 mph. The East College Drive northeast-leg of the roundabout has two entry lanes and two exit lanes (Figure 4.27 and Figure 4.28).

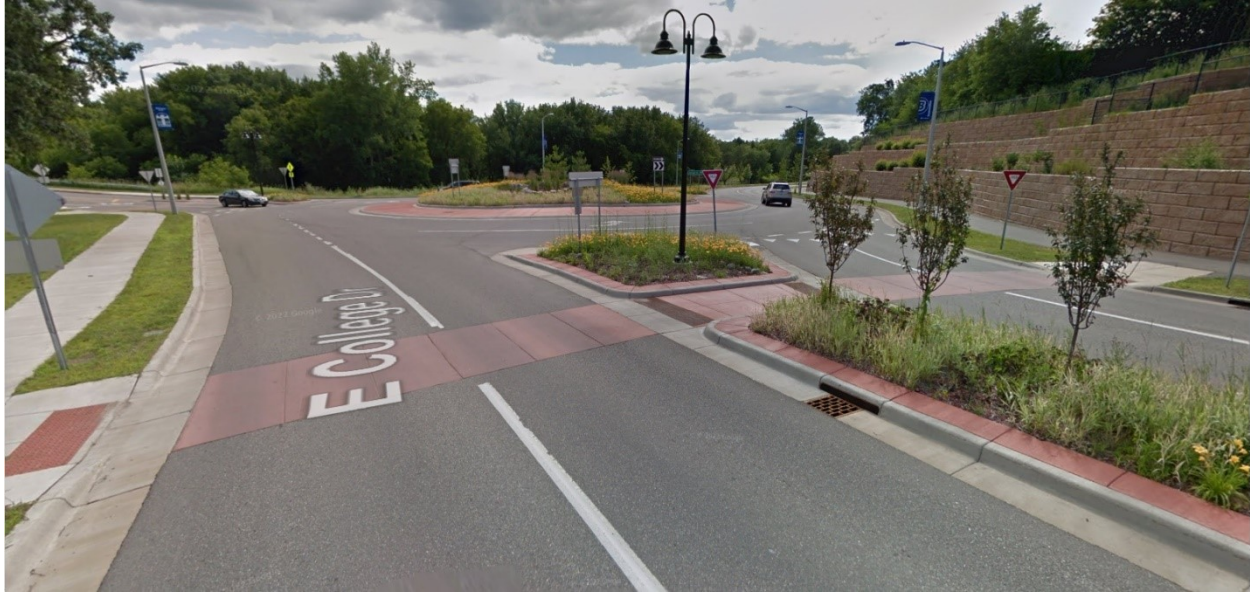
Figure 4.28: View of northeast-leg of the roundabout showing two entry lanes, two exit lanes, and colored crosswalk installed
