# Assessing the Deterioration of Pedestrian Assets

**Inya Nlenanya, Principal Investigator**  
Institute for Transportation  
Iowa State University

**February 2025**

Research Report  
Final Report 2025-19

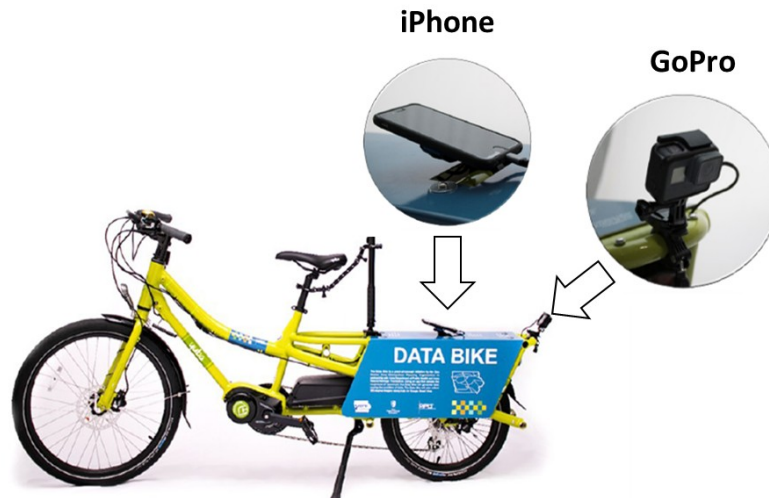
The data bike system is comprised of two major components: an iPhone and a GoPro camera, mounted on the back of the data bike as shown in Figure 6-1. The iPhone is equipped with an accelerometer sensor. The SensorLog app, installed on the iPhone, captures the accelerometer data while the bike is ridden at cycling speed. Additionally, the GoPro camera mounted on the back of the bike is capable of capturing continuous geo-tagged imagery while riding.

Figure 6-1. Iowa data bike system

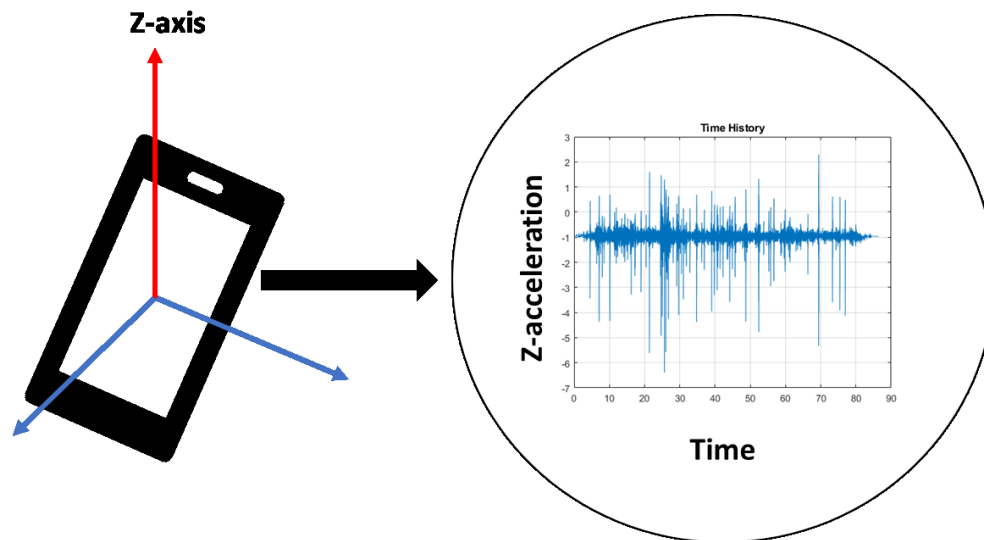
acceleration data from the accelerometer was utilized to characterize sidewalk roughness, aligning with the vertical motion experienced during traversal. These data were synchronized with the corresponding latitude and longitude coordinates obtained from the GPS sensors, facilitating precise spatial mapping of roughness variations along the sidewalk routes. Figure 6-2 shows a simplified illustration of how the accelerometer sensor collects the acceleration data.

Figure 6-2. Acceleration data collected from smartphone accelerometer

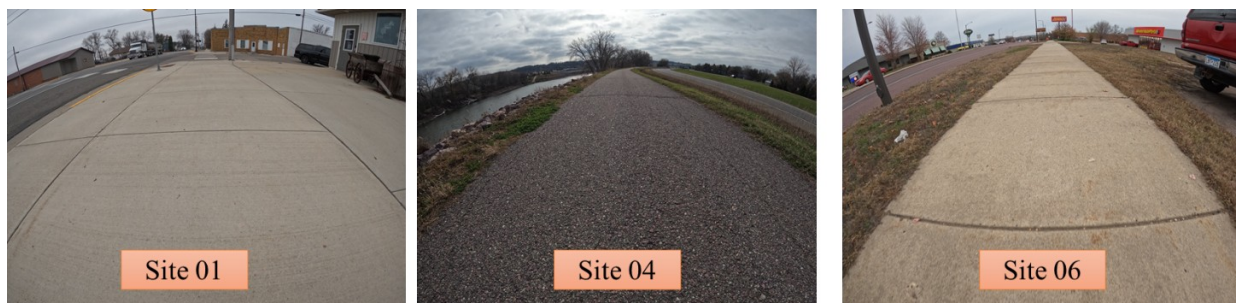
For the purpose of collecting vision data, we employed the GoPro Hero 10 Black, which features a 23 MP camera equipped with a GP2 processor, enabling the collection of continuous georeferenced photos. The GoPro camera was strategically mounted on the back of the data bike, positioned at a downward 45° angle to capture the full width of the sidewalk surface. We set the camera to "wide angle" mode to capture the adjacent features of the sidewalks. The images were captured in time-lapse mode at 1-second intervals. To ensure clarity in the captured images, the bike's speed was maintained between 7 to 8 mph. Figure 6-3 presents some sample photos collected from the test sites.

Figure 6-3. Images captured by GoPro camera

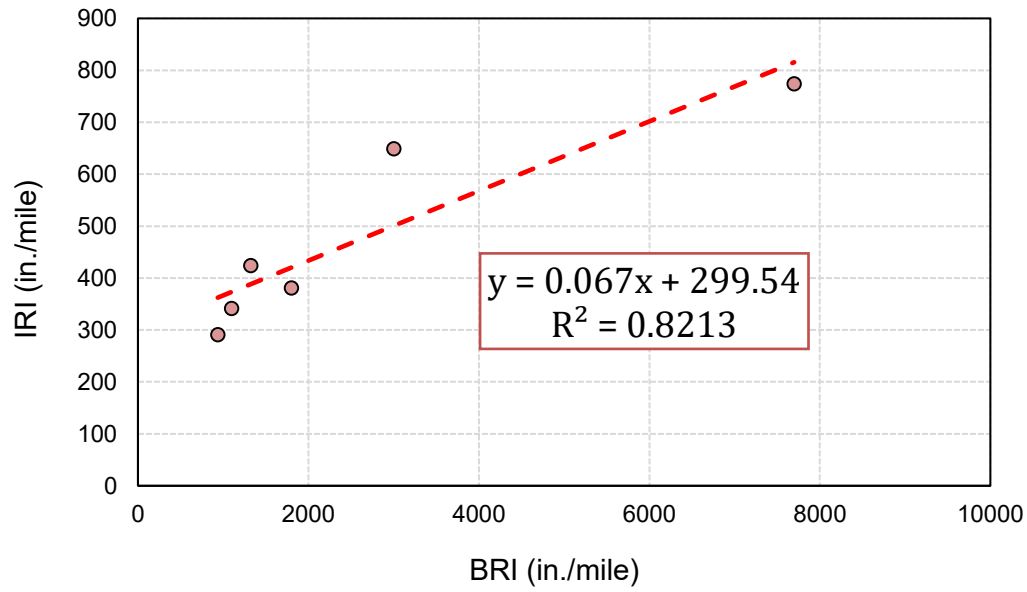
To validate the derived roughness parameter, comparisons were made with established IRI data obtained through a walking profiler. The IRI data, collected through systematic surveys utilizing specialized equipment, served as a reference for sidewalk condition assessment. By correlating the BRI with the established IRI values, the accuracy and reliability of the smartphone-based method were evaluated as shown in Figure 6-8. Figure 6-8 is based on more than 2,000 data points aggregated to the six sites where the walking profiler IRI was collected. The goodness of fit ( $R^2$ ) between IRI and BRI was high, reaching 0.82. This indicates a good correlation between the two methods. Table 6-2 shows information about the data collected from the sections used to calibrate the data bike method. The root mean square (RMS) of the vertical acceleration is another roughness indicator could be used to describe the sidewalk roughness.  $V$  is the average velocity used to collect the data using the data bike, and it is used to determine the cutoff frequency for filtering the acceleration data. These data were utilized to calculate BRI and estimate IRI.

**Figure 6-8. Correlation between BRI and IRI**
