Innovative Materials and Advanced Technologies for a Sustainable Pavement Infrastructure

Department of Civil, Environmental, and Geo- Engineering
University of Minnesota

Research Project
Final Report 2021-18

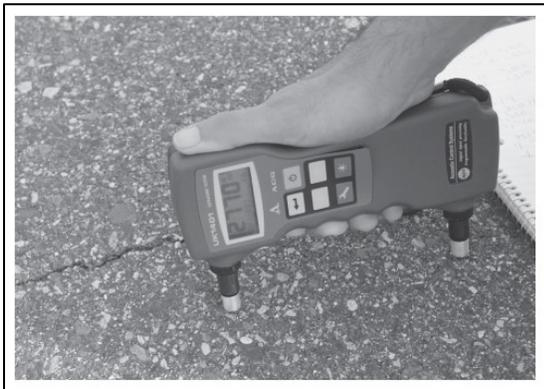
Figure 2.1: Ultrasonic tester UK1401. (Khazanovich *et. al.*, 2005)

An ultrasonic technology that has been used successfully for many years to determine cracking in concrete structures, provided an evaluation of distresses in asphalt concrete pavements through a simple procedure. (Khazanovich *et. al.*, 2005) The ultrasonic tester, a UK1401 (Figure 2.1), is used to obtain crack measurements in two directions: along and across each crack.

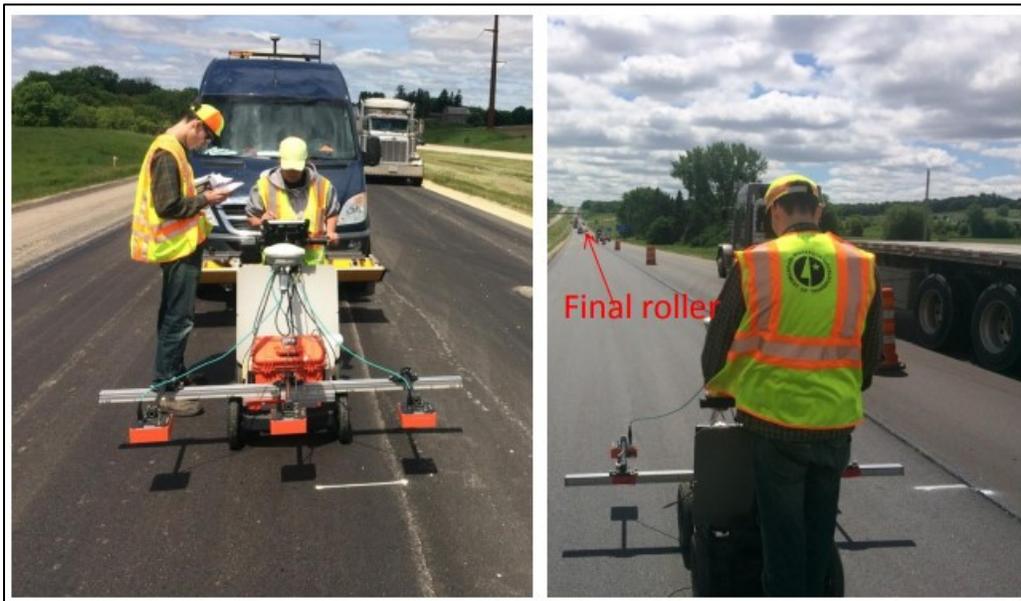
Figure 2.4: Equipment and Data Collection before a 500 ft pass (left), and during data collection moving behind the final roller compactor (right). (Hoegh & Dai, 2017)

The Rolling Density Meter (RDM), which is a Ground-penetrating radar (GPR), provides a non-destructive alternative to evaluate asphalt pavement air voids. The RDM, shown in Figure 2.4, is a commercially available device recently developed under an SHRP2 study that can be used to assess relative compaction levels nondestructively. (Hoegh & Dai, 2017)

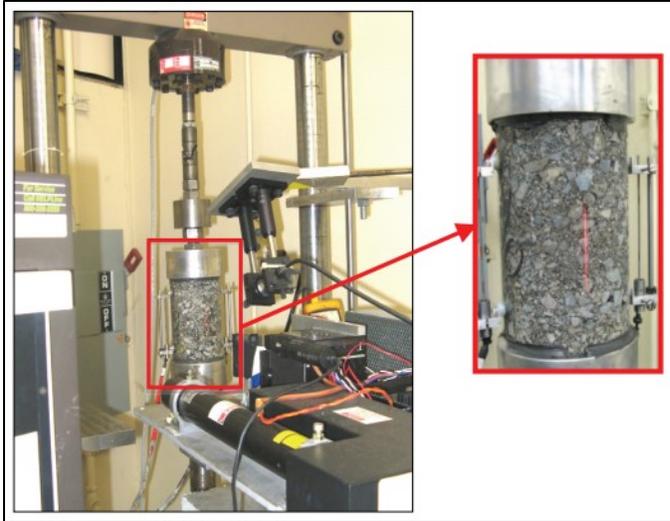
Figure 2.5: Photograph of laser scanning detection setup. (Ajideh *et. al.*, 2012)

Scanning laser detection, also known as SLD, is used to monitor damage and characterize fatigue behavior of asphalt mixtures. As shown in Figure 2.5, a laser beam sweeps the specimen surface at a constant frequency. The data is recorded and analyzed by a computer-controlled measuring system and used to calculate the defect frequency (DF) parameter.

The SLD system can detect small cracks, crack initiation, and microcracks spread in specimen surface; crack initiation is captured at earlier stages when compared to traditional methods. The system also generates fatigue performance results that strongly correlate with change in fatigue behavior and mechanical and viscoelastic properties obtained from traditional dissipated energy approaches. Scanning laser detection does not require image processing, resulting in less processing time and memory requirements. (Ajideh *et. al.*, 2012)

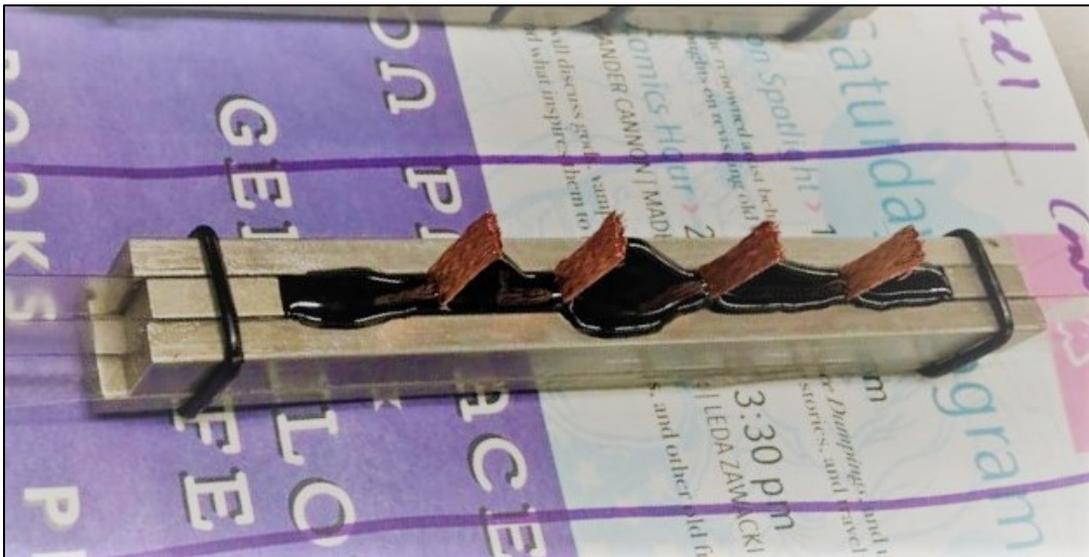
Figure 3.6: Sample with copper electrodes immediately after pouring.

The GNP 4827 and heated binder were mixed by a high-velocity shear mixing device for one hour. Due to particle size, the taconite concentrate was mixed with the heated binder through hand stirring for about 5 minutes. The four samples were poured into the beam molds used for BBR experiments. Four electrodes made of copper were placed in the mold and the heated binder was poured, as shown in Figure 3.6. The beams were kept in the refrigerator for 19 days, after which they were tested. The electrical conductivity tests were performed on the four binder beams using the same method as before: the outer two probes were used to supply electrical current to the specimens, while the inner probes were used to measure the voltage.

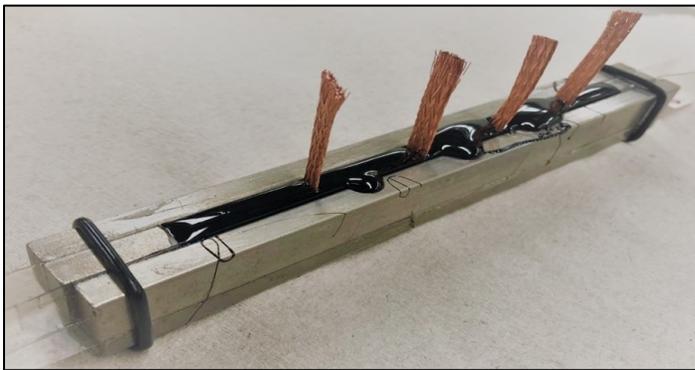
Figure 4.3: Sample preparation: beam molds with four copper electrodes.

Similar to Chapter 3, the electrical conductivity was measured by using a four-probe method. The mix was poured into the beam molds with four copper electrodes, as shown in Figure 4.3.

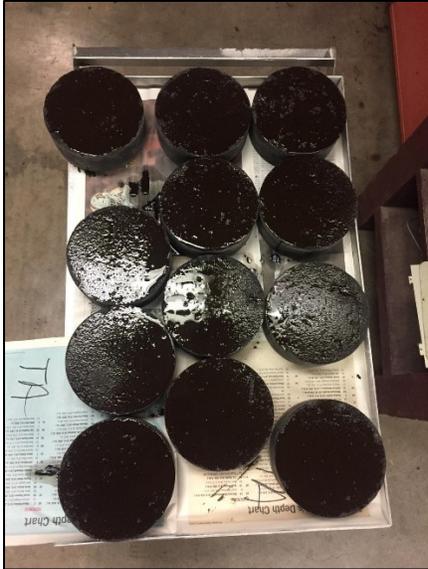
Figure 6.1: Bottom pucks with applied tack coat.

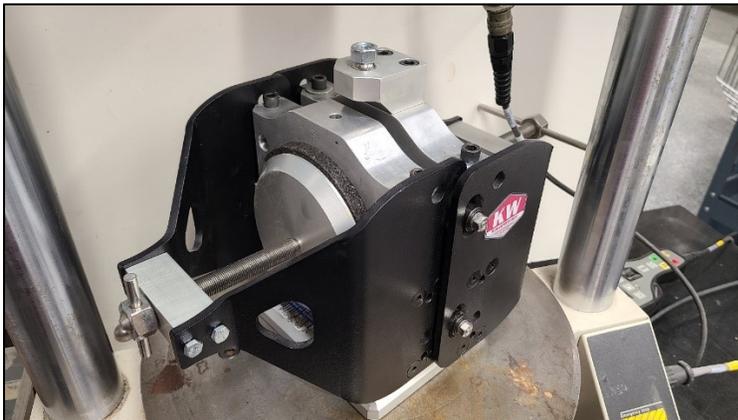
Figure 6.5: MS-43 Asphalt Tack Bond Shear Strength Apparatus

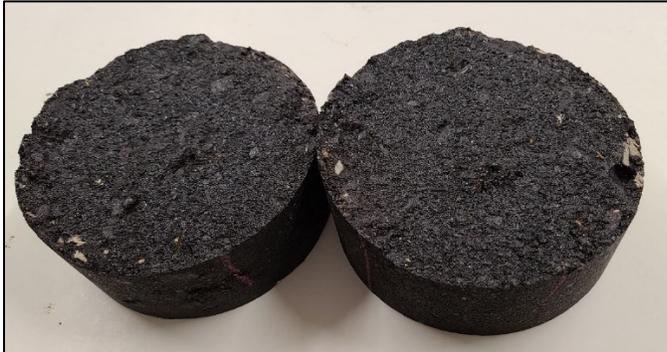
Figure 6.6: A specimen that failed along the tack coat interface.
