# Development of Best Practices for Inspection of PT Bridges in Minnesota

Minnesota  
Department of  
Transportation

**April 2012**

Research Project  
Final Report 2012-09

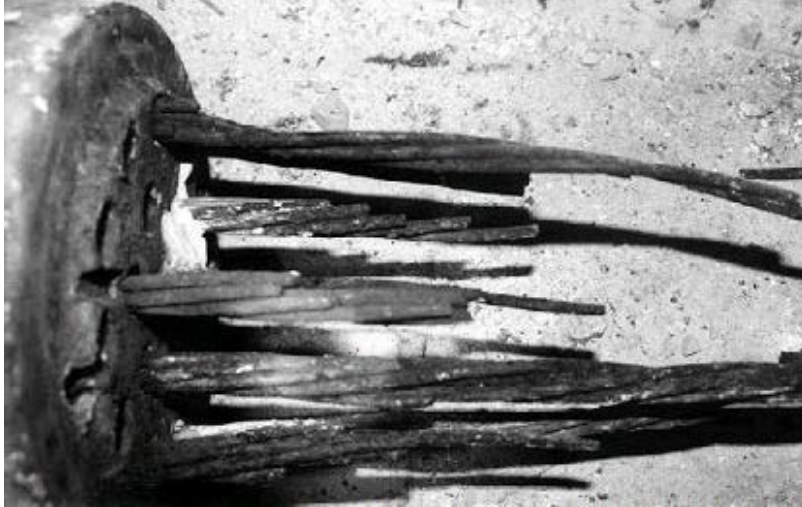
**Figure 2.2. Strands corroded at anchor (Corven Engineering, 2002)**

After full inspection, it was found that one of the six tendons in each span had failed. The boot connecting the steel pipe and the duct was opened for further investigation and active corrosion was found. Investigation of the removed tendon showed voids in the grout around the tendon, and pitting on the prestressing strands at the anchor head as shown in figure 2.2. The failed tendons were removed and replaced.

There was initial concern that this corrosion at the voids was due to corrosive bleed water from the grout, although continued examination concluded that the corrosion was due to saltwater ocean spray. It was believed that the wind carried ocean spray and came into contact with the tendons through a void in the anchor head. Seeping between the segments at the expansion joints the chloride enriched water entered the anchor and provided the conditions for active corrosion to occur. Figure 2.3 shows the staining around the anchor where the tendon corroded. While the bleed water itself did not corrode the strands, the void left by the bleed water provided a void where chlorides, moisture and oxygen could congregate and cause severe corrosion.

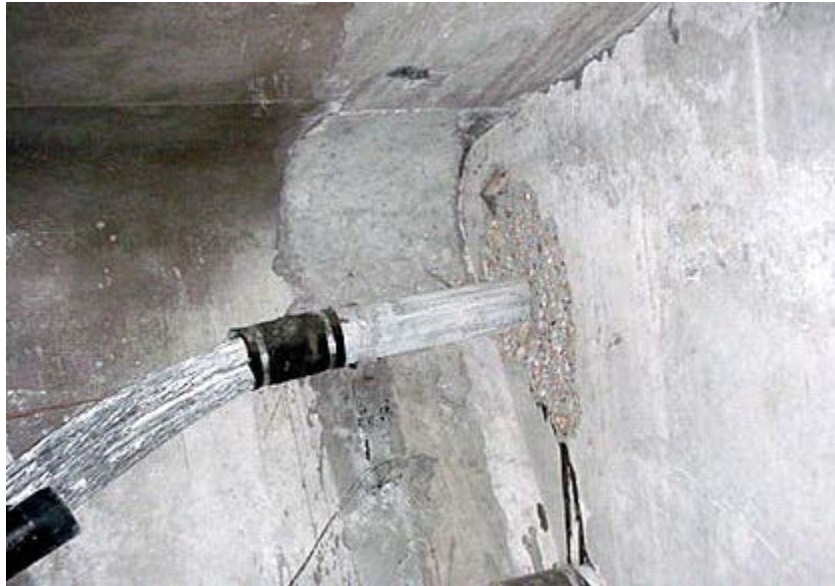
**Figure 2.4. Tendon at expansion joint were failure occurred (Corven Engineering, 2002)**

28, 2000 it was discovered that two tendons had failed. One of the failures was similar to that seen in the Niles Channel Bridge with corrosion concentrated at the anchor head. Figure 2.4 shows the tendon pullout at the expansion joint.

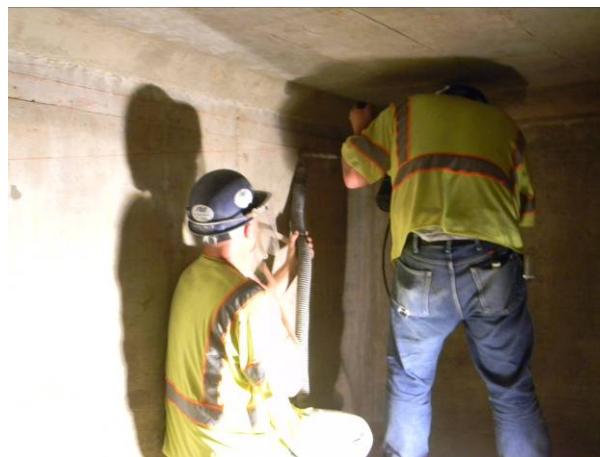
**Figure 3.2. Drilling into post-tensioning duct**

After the mapping was completed, select locations were drilled at varying depths to penetrate the duct. Figure 3.2 shows VStructural personnel drilling into the internal post-tensioning duct in an interior web of the box girder at a tendon high point near a pier. The true high point typically cannot be reached due to the heavy reinforcement congestion as the tendon enters the end block or diaphragm, but inspection of areas near the high point are valuable indicators of potential voids or corrosion.

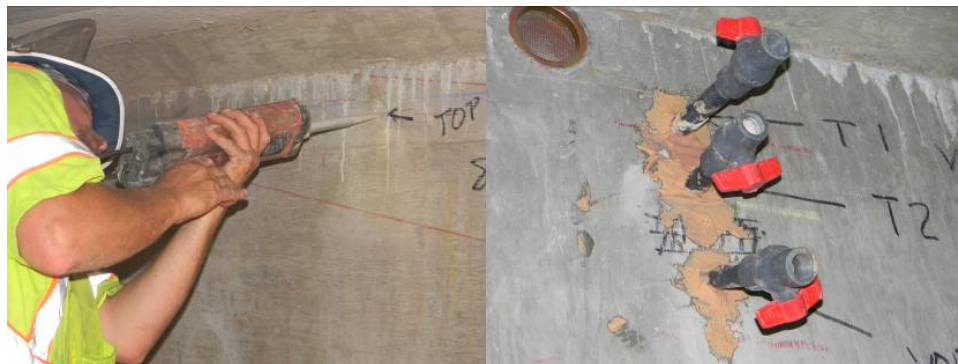
**Figure 3.4. (Left) Re-sealed exposed duct holes**

**Figure 3.5. (Right) Re-sealed exposed duct holes with valve**

Once the duct inspection was completed and samples had been taken, the drilled holes were filled with Hilti HY150 Epoxy to insure the tendons would not experience additional exposure due to the invasive inspection. This Hilti fill material is a fast set, high strength non-shrink epoxy that was designed for anchor embedment. Seen in figure 3.4 is the filing of the hole with the Hilti HY 150 Epoxy. When a void was found in the duct, a valve was sealed into the created hole to allow for the duct to be filled during future repair. The valve is capped and sealed to ensure no additional ingress of moisture or oxygen prior to repair. Figure 3.5 shows the embedded valves placed after inspection.

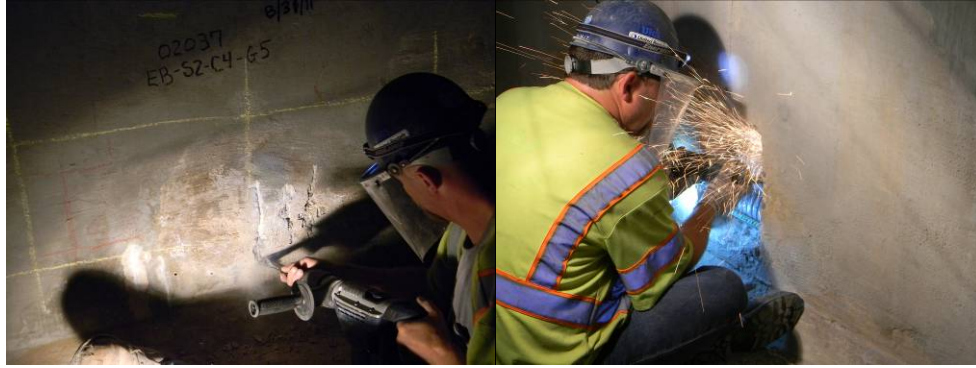
When visual signs pointed to a larger potential problem area (moisture, rust staining, cracking), a section of the web was removed to expose a length of the duct. Removal of the web concrete cover is shown in figure 3.6. This removal reveals a section of duct so that its condition can be evaluated. A window is then cut into the duct (shown in figure 3.7) to allow inspection of the grout and strand condition.

**Figure 3.6. (Left) Exposing post-tensioning duct by cutting web**

**Figure 3.7. (Right) Exposing post-tensioning strand and grout by cutting duct**

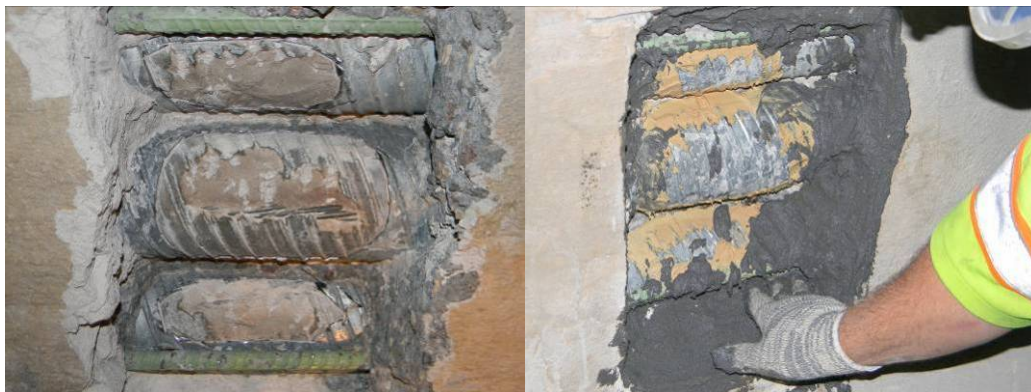
Once the duct has been opened, the surrounding grout is examined and samples are taken. After the duct is opened, all additional excavation is done by hand without power tools so that the strand is not accidentally nicked. The condition of the post-tensioned strands is also inspected at this point. Strand condition was evaluated for degree of corrosion in relation to a ranking from Sason (1992) as published by PCI. After the inspection of the post-tensioning system is completed, the window of the duct that was removed could be re-bonded with the Hilti HY 150 Epoxy, and a Sika 123 repair patch was used to cover the exposed area. Figure 3.8 and figure 3.9 show the exposed strand in the tendon, and the patching procedure on the duct, respectively.

**Figure 3.8. (Left) Exposed post-tensioning strand**

**Figure 3.9. (Right) Patching of examined duct**

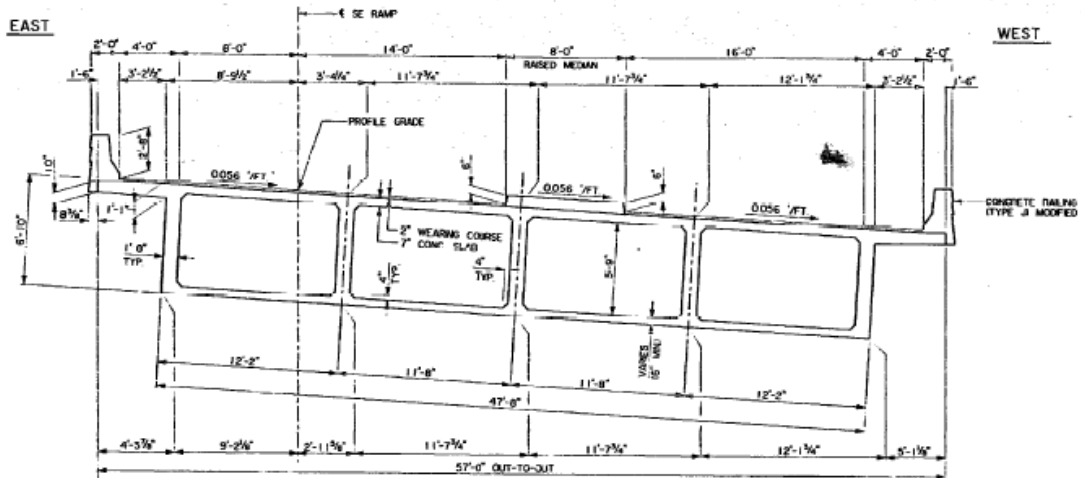
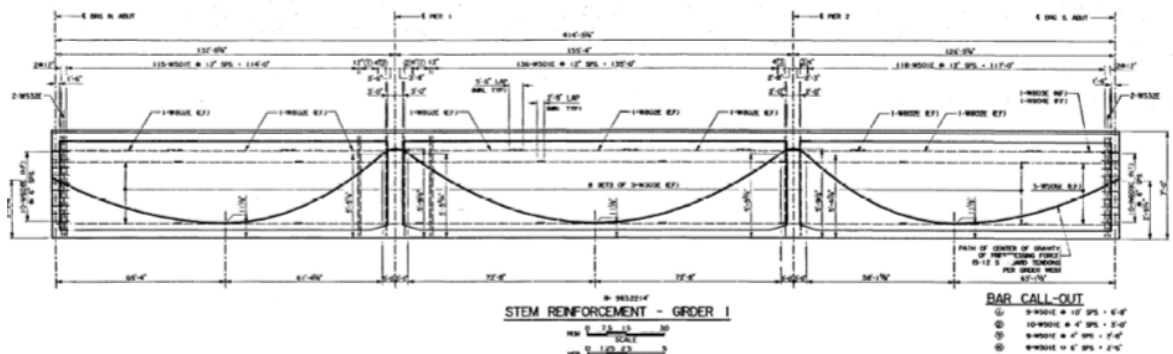
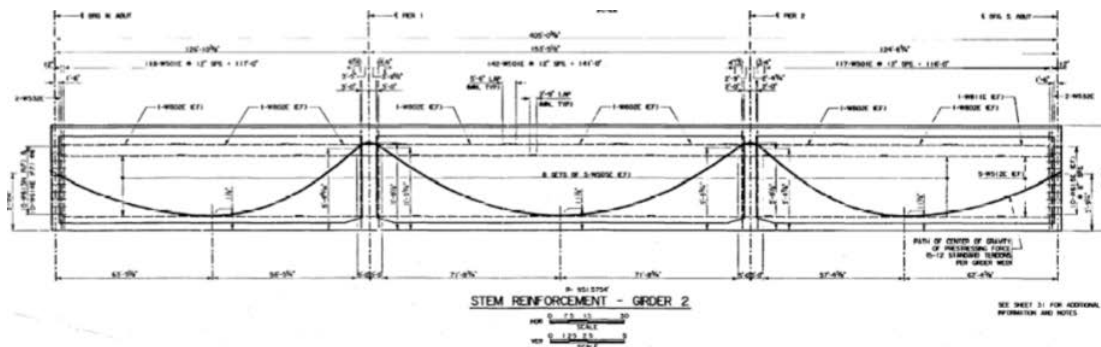
**Figure 4.32. Bridge 02034 tendon profile view B**

- PT pier cap #1 has vertical cracks with leaching
- Deck cracking up to 1/4" width
- Cracking inside boxes

Deck cracking of ¼” is significant. Cracking requiring epoxy fill inside the box is also of interest as a sign of PT related problems or potential for corrosion. A full visual inspection of the box interiors is recommended for this bridge. The 2009 inspection report does not have any information specific to the PT boxes. The parabolic drape profile does not have a tall vertical rise, but this layout may be susceptible to bleed problems near intermediate high points and end anchors.

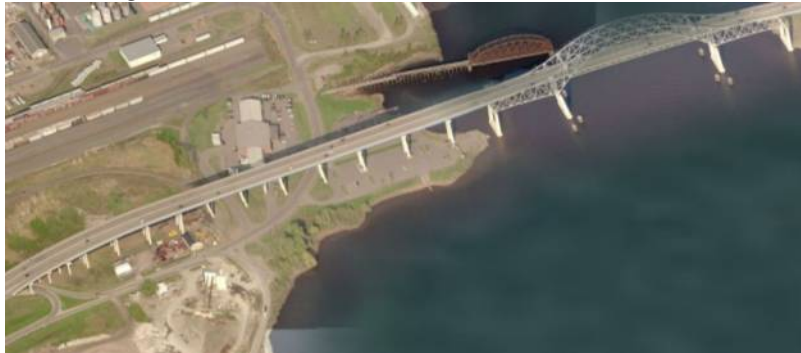
**Figure 4.33. Bridge 9030 aerial view (Bing, 2011)**

- PT pier caps had shrinkage cracking that was repaired shortly after construction; nearly identical cracks visible on each pier cap

The PT components in this bridge are the PT pier caps. The inspection notes do not indicate any problem areas related to the PT other than the recorded cracking. End anchorage protection should be visually inspected during routine inspections. The end protection for the anchorages as shown in the plans indicate good defense. Plastic end caps are recommended for current construction, but were not typically used at the time of this construction. Metallic caps (that were typically removed) were often used. Indications of cracking, efflorescence and/or rust staining would be indicators of the need for a more detailed inspection. The overall recommendation for inspection of this bridge related to PT is low, however it has been given an

“8” based on the reported cracking in the piers. The inspection notes indicate a need for further inspection specific to the PT pier caps.

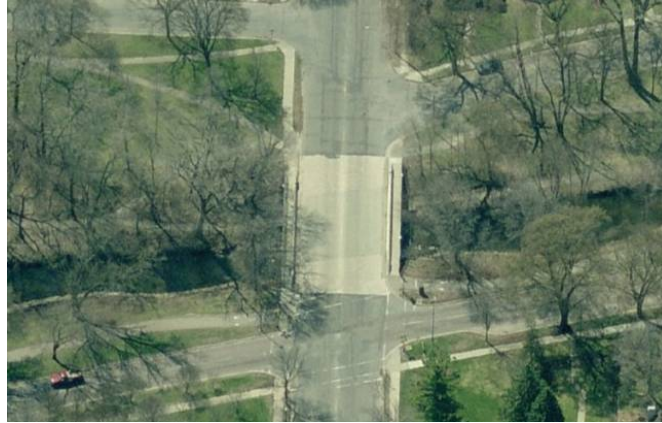
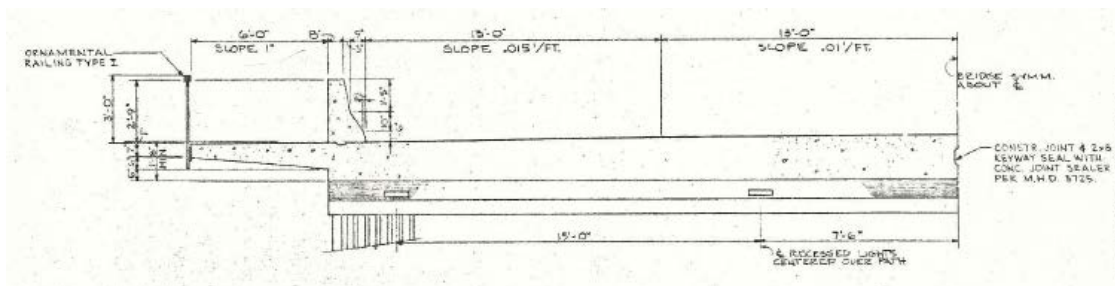
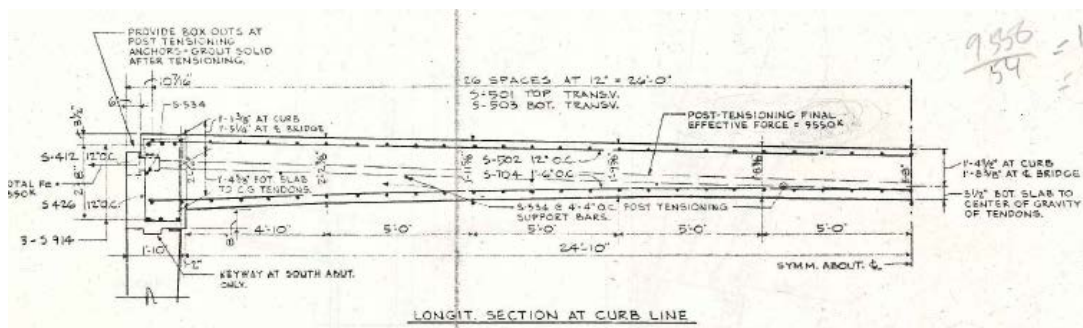
Figure 4.40. Bridge 27547 aerial view (Bing, 2011)

- Deck surface has minor uniform scaled, 3 sealed longitudinal full depth cracks, and some small spalls at the longitudinal joint line
- Underside of deck has a fine longitudinal cracks with efflorescence
- Underside has some spall at the outside edges with rebar exposed

This PT slab bridge has cracking as would be expected in a bridge of this age. The tendon profile has little vertical rise, so bleed problems should be minimal. The end anchorage details should be visually inspected for signs of corrosion. This is the oldest PT bridge listed in the MnDOT inventory, so is of interest for brief visual inspection under this contract from that perspective.

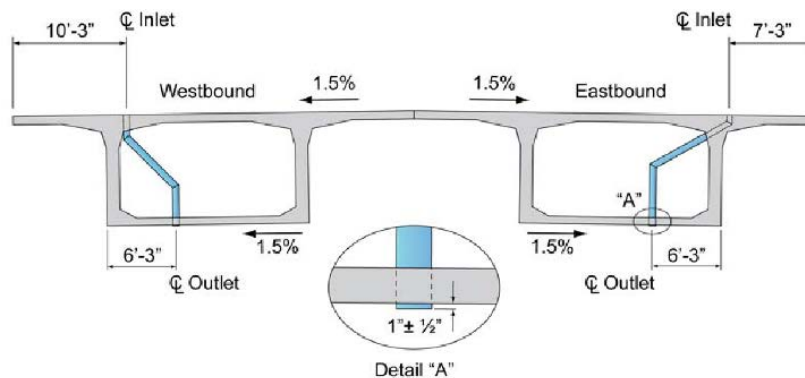
**Figure 6.3. Drainage system representation (Corven Engineering, 2010)**

Also seen in figure 6.2 (above) is a drainage outlet that was tested during the inspection. The drainage system collects water from an inlet at the top slab where it flows through pipes that are running through the interior of the box girders. Figure 6.3 shows a graphical representation of the drainage system of the bridge. To test the drainage system, the south half of the bridge was flooded (over the eastbound box girder). This flooding resulted in water being present within the interior of the box girder above some of the damaged areas of the exterior of the bottom slab. This is a clear indication of leaks in the drainage system. During a closer investigation, attempted repair seals could be seen at various locations in the drainage system, although not all leaks were sealed.

Water from the drains was also present on the underside of the bottom slabs. As seen in figure 6.3, the drainage outlet has minimal extension beyond the bottom slab. When the volume of discharge diminished, the water would flow along the bottom of the slab following the 1.5 percent pitch in the longitudinal direction towards the exterior of the box girder. Corrosion

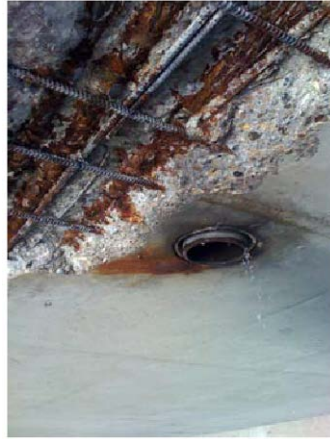
**Figure 6.4. Bottom slab drainage outlet (Corven Engineering, 2010)**

appeared around these areas of the water flow, and with removal of cracked concrete, corrosion of the spiral wound galvanized metal duct and the prestressing strand was present. Figure 6.4 shows the rust staining around the outlet duct and the corrosion on the steel reinforcement, galvanized ducts and prestressing strands.

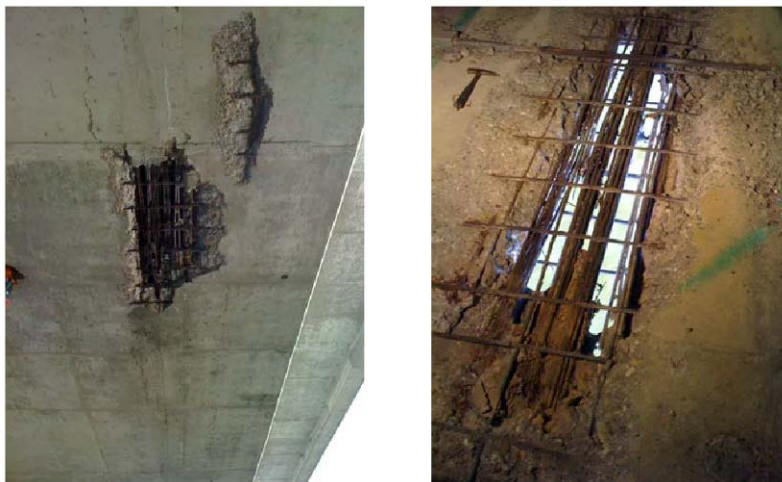
A jackhammer was used to remove a limited portion of damaged concrete in the bottom slab of the main span (span 3) at mid-span. Five of the ten tendons in the exposed area are visible. One of these tendons has corroded completely through, and the other four exposed tendons have broken strands as well as cross section loss to the prestressed strand (of varying degrees). The other unexposed tendons produced a hollow sound when struck with a hammer. Figure 6.5 shows the exterior (bottom) of the exposed post-tensioning and in figure 6.6 is the interior of the same segment.

**Figure 6.5. (Left) Exposed post-tensioned tendons view exterior (Corven Engineering, 2010)**

**Figure 6.6. (Right) Exposed post-tensioned tendons view from interior of box girder (Corven Engineering, 2010)**

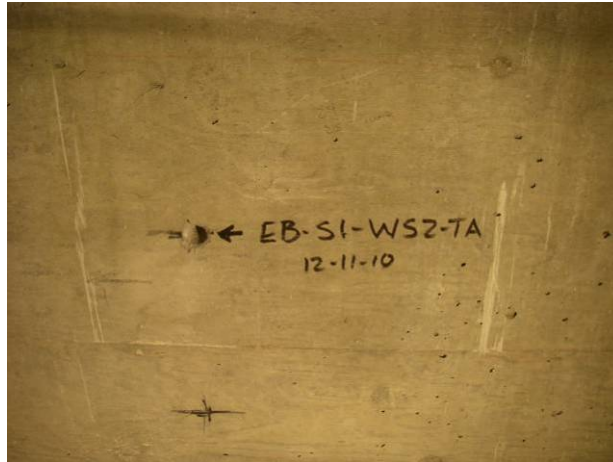
**Figure 6.9. Overview photo of drilled hole into span 1 web S2 tendon A**

All web duct inspections done in span 1 were found to have clean and dry ducts with no voids detected, and no moisture seen. The grout in all the ducts appeared to be solid and of good color. Figure 6.9 shows an overview photo of the drilled hole into tendon A, in web S2 that is located 10.17 feet (3.1 meters) from abutment A (a representation of a typical drilled hole in span 1).

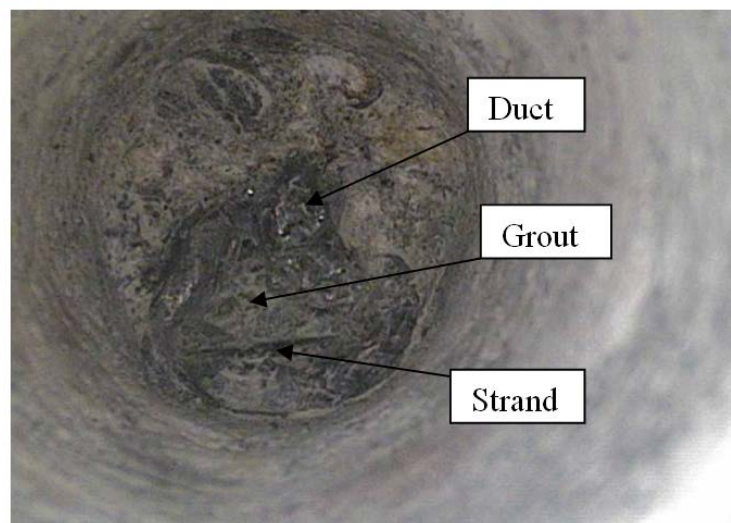
**Figure 6.10. Boreoscope picture of drilled hole in web S2 of span 1**

Figure 6.10 shows a picture taken with the borescope inside of the drilled hole in web S2 of Span 1 as seen above. The metal duct is visible in the picture with no signs of corrosion. One wire of one of the cables can also be seen, and no signs of corrosion are visible. The grout within the duct also is solid and of good color.

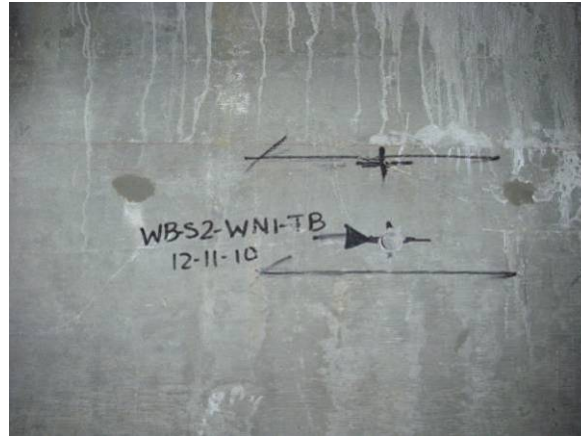
**Figure 6.14. Overview photo of drilled hole into span 2 web S2 tendon B**

All web duct inspections done in span 2 were found to have clean and dry ducts with no voids detected, and no moisture seen. The grout in all the drill holes appeared to be solid and of good color. Figure 6.14 is an overview photo of the drilled hole into tendon B in web N1 that is located 24.83 feet (7.57 meters) from pier 2 (representation of all inspection holes drilled in span 2).

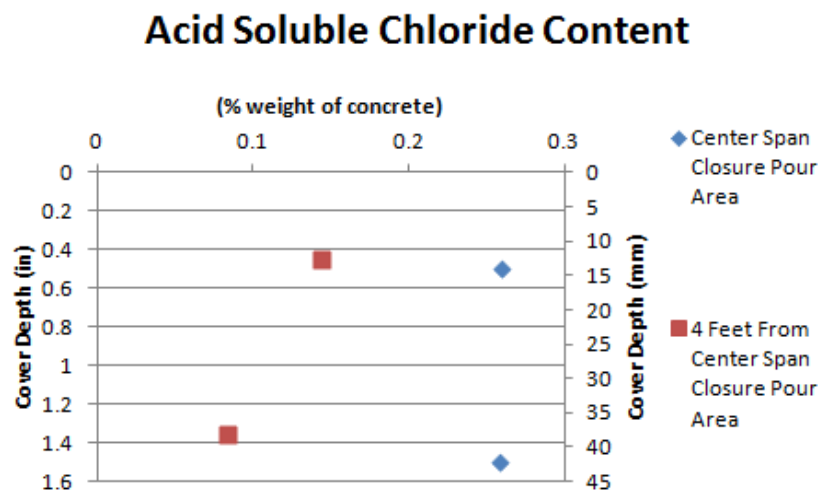
**Figure 6.17. Acid soluble chloride content eastbound span 3**

Samples of the concrete were taken at 0 to 1 inch deep (0 to 2.5 cm) and 1 to 2 inches deep (2.5 to 5 cm) at the center span closure pour area, as well as at 4 feet (1.22 m) from center span towards pier 3. These samples were evaluated for acid soluble chloride content at the University of Minnesota Duluth (UMD). Figure 6.17 shows the results of the acid soluble chloride test conducted.

The literature varies widely on the threshold value of chloride levels for corrosion depending on access to moisture and oxygen and also dependent on the concrete mixture. The closure pour samples show levels of chloride that are significant enough to cause corrosion at the reinforcement depth and the investigation revealed active corrosion in this area. The chloride content is high in both sample depths in the closure pour. This may be somewhat related to data spread, but also leans toward direct ingress through cracks and/or very poor quality concrete.

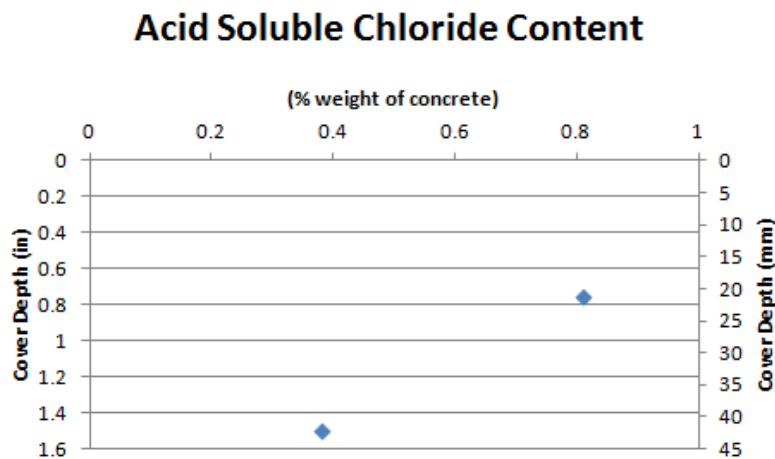
**Figure 6.22. Acid soluble chloride results westbound span 3**

Samples of concrete were taken at several depths at this location to test for chloride content. Figure 6.22 shows the results of the acid soluble chloride test for these samples. Chloride content in this area was very high as would be expected given the extent of the corrosion of the reinforcement.

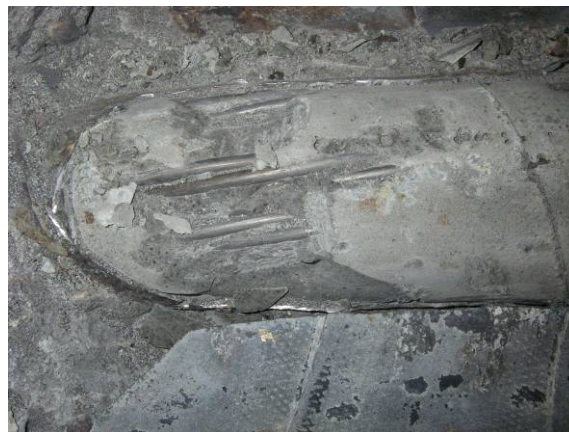
**Figure 6.26. Tendon B15 with removed window exposing multiple strands**

Ducts B15 and B14 were also opened to check their condition. The exterior of the duct was found to be corroded so windows in the ducts were cut out. Tendons B15 and B14 were found to be full of good colored and solid grout. The strands were noted to be in good condition at class 1-2. Figure 6.26 shows tendon B15 with 3 exposed strands, and no visible corrosion.

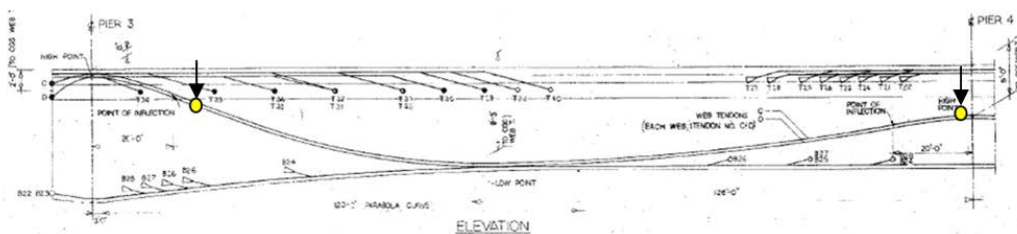
**Figure 6.33. Web S1 eastbound structure span 4 drill locations**

Two locations were drilled along Web S2 to inspect the tendons within the webs. Figure 6.33 shows an elevation view of web S1 (interior web of eastbound box girder). Highlighted on the figure are the approximate locations that were drilled into during inspection. When the web was tapped in these locations, a clean and dry duct was found with solid grout of good color filling the duct. In the drilled hole near pier 3 one wire of strand was exposed and had no visible corrosion.

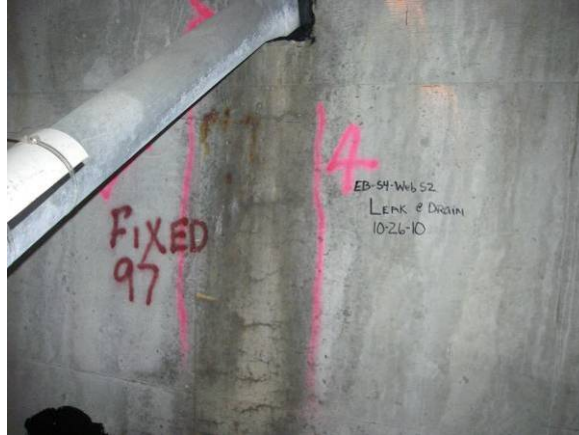
A leaking drain was noted with a moderate amount of cracking on web S2 (exterior web of box girder). Figure 6.34 shows the drainage duct with visible moisture staining.

**Figure 6.34. Drainage duct with moisture staining**

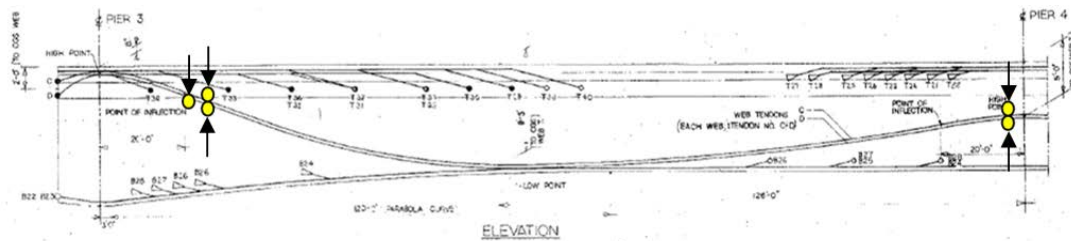
**Figure 6.35. Web S2 eastbound structure span 4 drill locations**

To inspect the tendons in web S2, five drill holes were made. Despite the observation made of moisture staining and cracking in the web, no moisture or corrosion was present on the ducts, and the grout appeared to be solid and of good color. Figure 6.35 shows an elevation view of web S2 (exterior web of eastbound box girder) with the approximate locations highlighted.

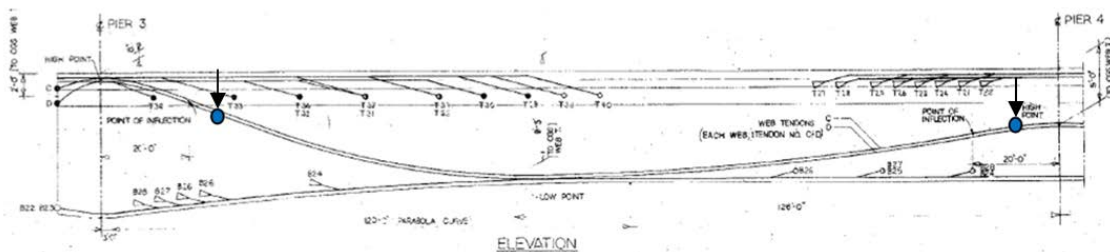
**Figure 6.37. Web N1 westbound structure span 4 drill locations**

Figure 6.37 shows the two drill locations highlighted in blue in web N1 (interior web of box girder). Drilled inspection holes into web N1 were found to have clean and dry ducts without moisture or voids. The grout in all the drill holes appeared to be solid and of good color.

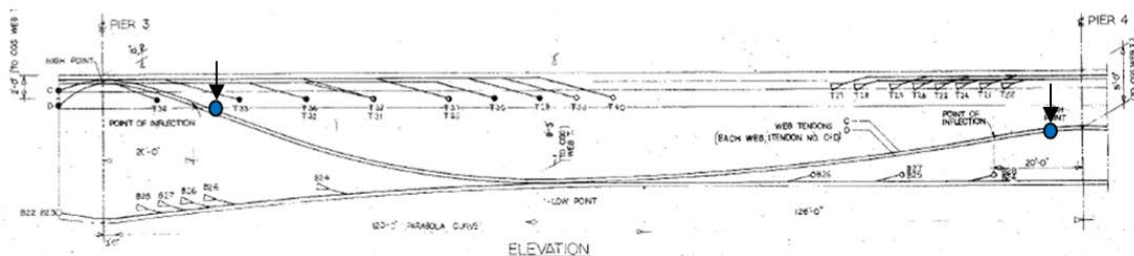
**Figure 6.38. Web N2 westbound structure span 4 drill locations**

Figure 6.38 shows the drill location highlighted in blue in web N2 (exterior web of box girder). Again grout appeared solid and of good color and no voids were detected.

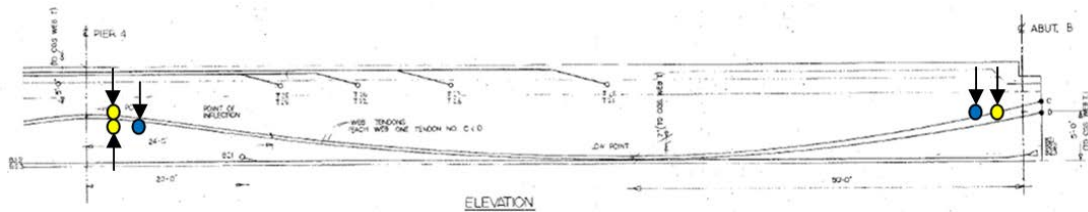
**Figure 6.39. Span 5 web S1 and web N1 elevation view**

Inspection of span 5 composed of drilling inspection holes into several locations along the post-tensioned tendons within the webs of the box girders. Figure 6.39 shows an elevation view of

web S1 (interior web of eastbound box girder) and web N1 (exterior web of westbound box girder) of span 5.

All drilled inspection holes in span 5 were found to have clean and dry ducts with no voids detected, and no moisture seen. The grout in all the drill holes appeared to be solid and of good color.

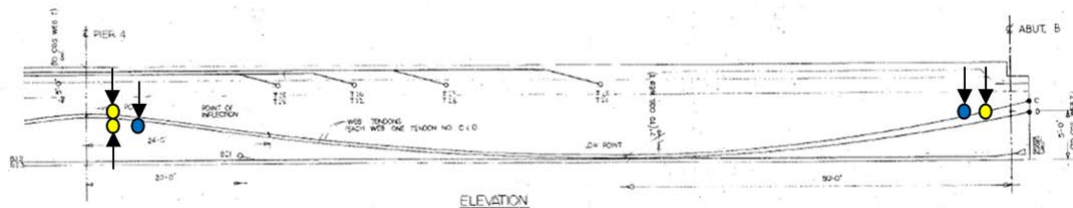
**Figure 6.40. Span 5 web S2 and web N2 elevation view**

Figure 6.40 shows the elevation view of web S2 (the exterior web of the eastbound box girder) and web N2 (exterior web of westbound box girder).

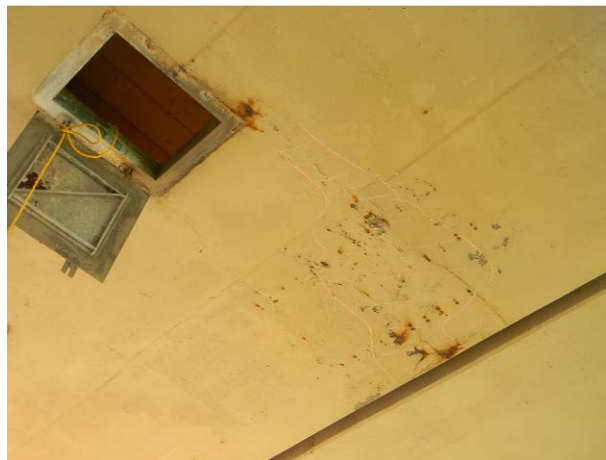
**Figure 7.9. Access hatch for structural unit 6N**

From the exterior of the bridge, rust staining was observed around the access hatches, as well as on the bottom slab. Figure 7.9 shows the rust staining observed near the access hatch of structural unit 6N. Also in this figure is a region (outlined in pink chalk) that has indications of honeycombing, as well as rust staining emitting. The area outlined produces a hollow sound during hammer sounding, indicating delamination in this section.

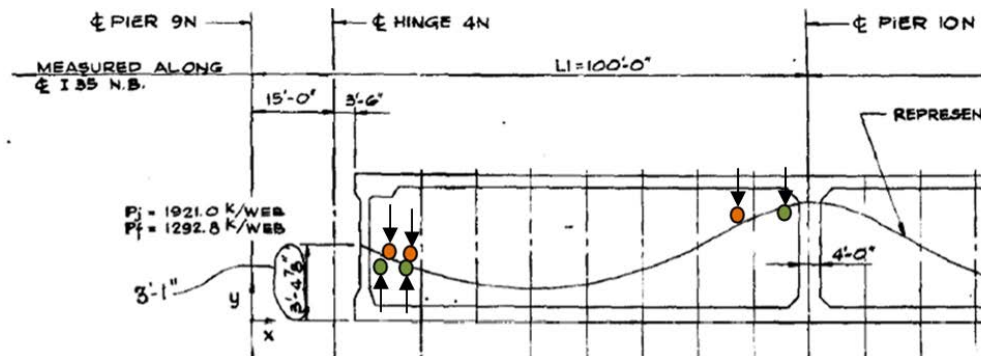
**Figure 7.13. Span 1 web 3 structural unit 6N tendon profile view**

Figure 7.13 shows the locations that were drilled into web 3. The tendon profile seen represents the center of gravity of the two contributing tendons (tendon 1 is the above the center of gravity, tendon 2 is below). Highlighted are the approximate locations that VSL drilled into to inspect post-tensioning system (orange represents inspections on tendon 1, green represents inspections on tendon 2).

Conditions of the tendons in web 3 were similar to that seen in tendon 2. Full ducts with good colored, solid grout were found in all inspection locations.

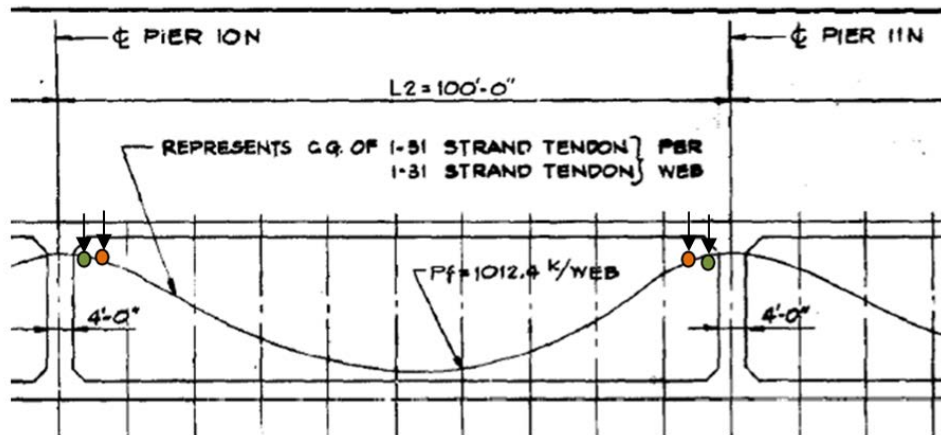
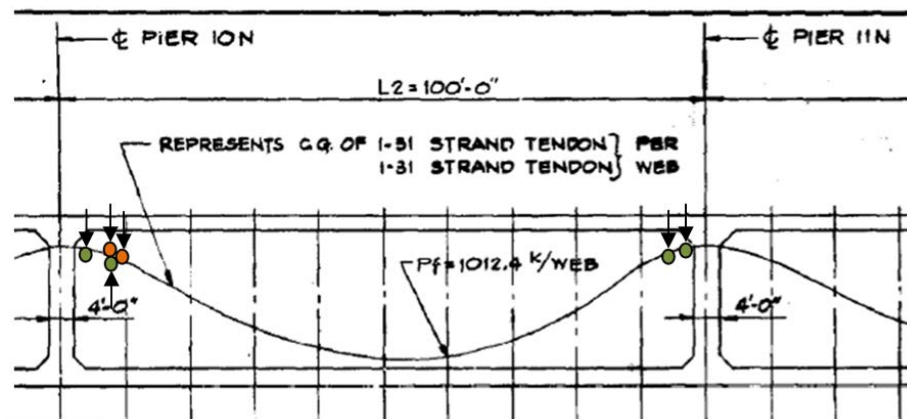
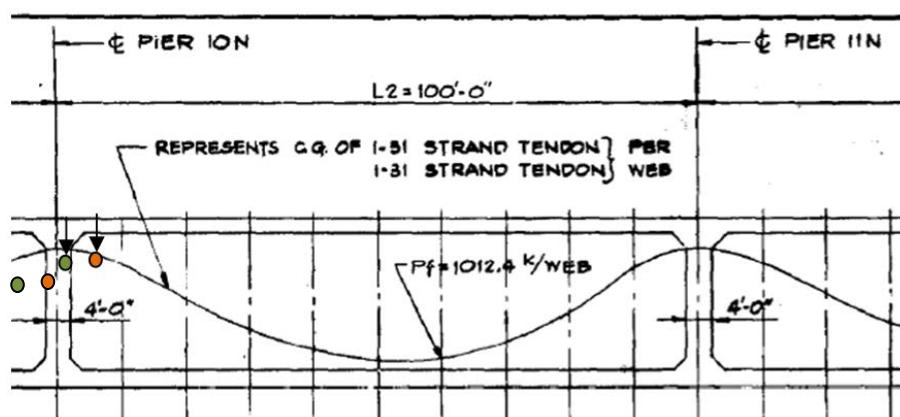
To continue inspection of a suspected trouble area, span 2 of structural unit 6N was investigated. Drilling locations were in webs 2, 3, 4, and 5. Figure 7.14 shows the tendon profile view of span 2. The locations that were drilled into were highpoints in the tendon profile. Figures 7.14 through 7.17 show the drill locations. Approximate locations that the post-tensioning system was inspected are highlighted (orange represents inspections on tendon 1, green represents inspections on tendon 2).

Grout was found covering a large area on the bottom slab of cell 4 near at mid span. This was a possible indication of a grout leakage that may have left of void. Upon inspection of the ducts in web 4 and web 5, no voids were found.

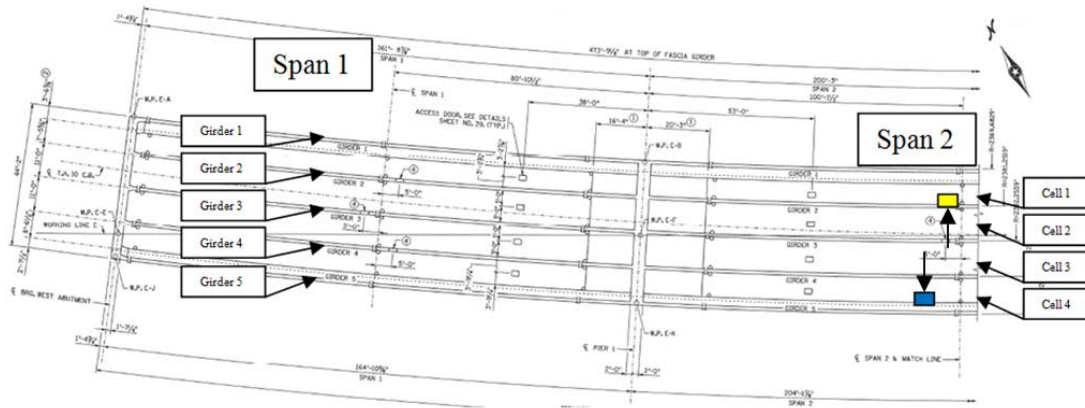
**Figure 8.1. Plan view of span 1 and 2**

The first location of interest was 90.5 feet (27.4 meters) from pier 1, in cell 1, within girder 2. Highlighted in figure 8.1 is the location of this inspection location (yellow highlight box). The location was a spot where the repair patchwork had effluence emitting, and cracking as shown in figure 8.2.

The second location was located in cell 4 on girder 5 a distance of 78 feet (23.8 meters) from pier 1. This location is highlighted in figure 8.1 with a blue highlight box. Again the area was a location where a patch had effluence emitting from cracks. Figure 8.5 shows the location of interest during chipping of the patch material. Small tools were used once the duct was reached so that no damage was done to the tendon.

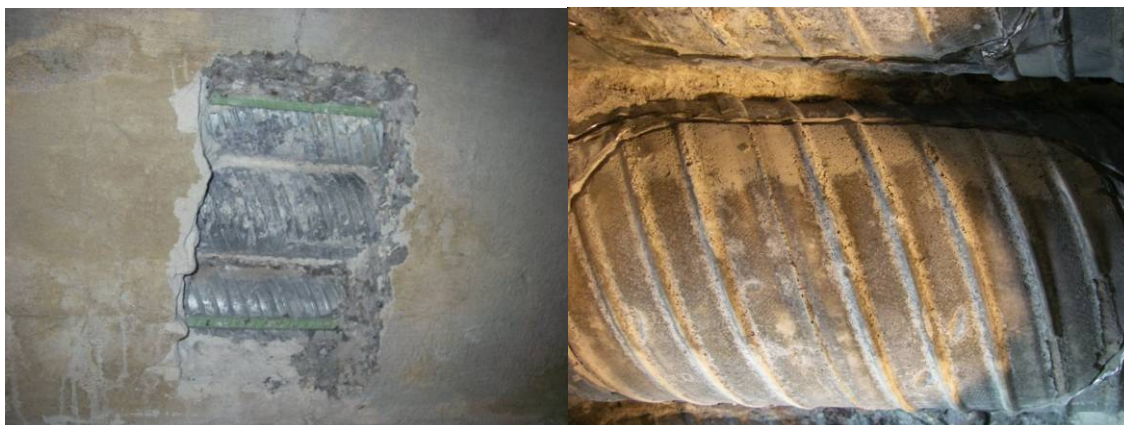
The removal of the concrete cover revealed the ducts to be in good condition. Figure 8.3 shows the chipped out area with the duct exposed. The inspection hole made was approximately 8 by 15 inch area (20.3 by 38.1 centimeter area). Figure 8.4 shows the opening of the middle tendon (tendon 2). Seen in this figure is good colored, solid grout that completely filled the tendon.

**Figure 8.3. (Left) Cut out area exposing ducts**

**Figure 8.4. (Right) Opened tendon 2**

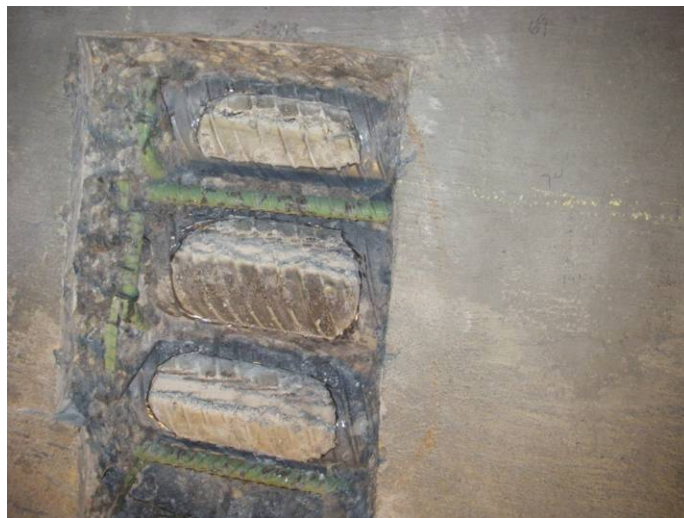
**Figure 8.6. Exposed ducts in girder 5 of span 2**

The inspection hole was approximately a 9.75 by 19.75 in (24.8 by 50.2 cm) area as shown in figure 8.6. The figure shows that the ducts were in good condition with no visible corrosion (the windows have already been cut out exposing the interior of the duct).

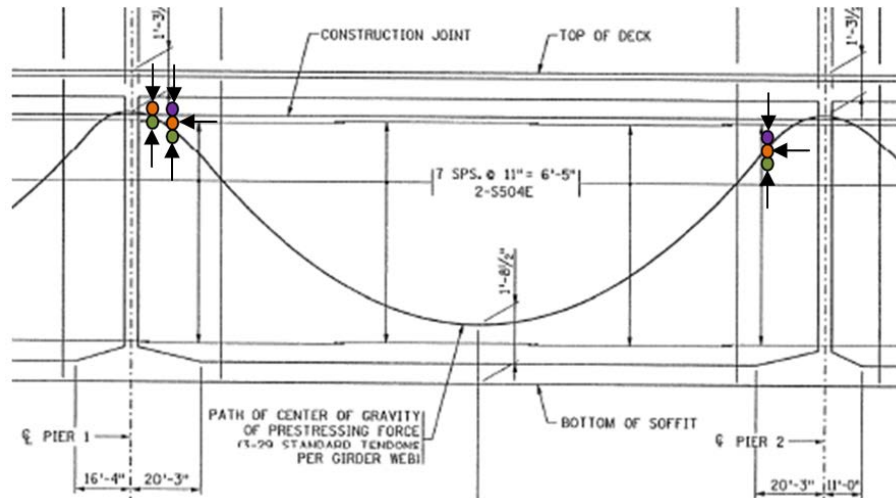
**Figure 8.8. Span 2 tendon profile of girder 5**

During the inspection of 02037 E, eight duct locations within girder 5 were inspected. Each of the three tendons had their highpoints examined near pier 1 and pier 2. Figure 8.8 shows the elevation view of the tendon profile (the tendon line represents the path of the center of gravity of the three contributing tendons) with a highlight on the inspection locations (indicated by purple for tendon 1, green for tendon 2, and orange for tendon 3).

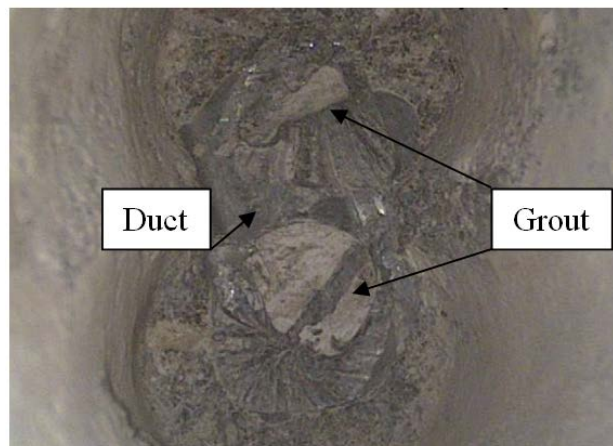
**Figure 8.9. Borescope picture of drilled hole in girder 5 of span 2**

The inspection locations near pier 1 have similar results for each of the three tendons (one inspection point for tendon 1 and two inspection points for tendons 2 and 3). Each of these spot checks had a duct full of grout that was white in color and very chalky in consistency at the drill location. Figure 8.9 shows a photo taken with the borescope in the inspection hole of tendon 3, 101 in (256.5 cm) from pier 1. This inspection is a representation of the findings from all inspection holes near pier 1.

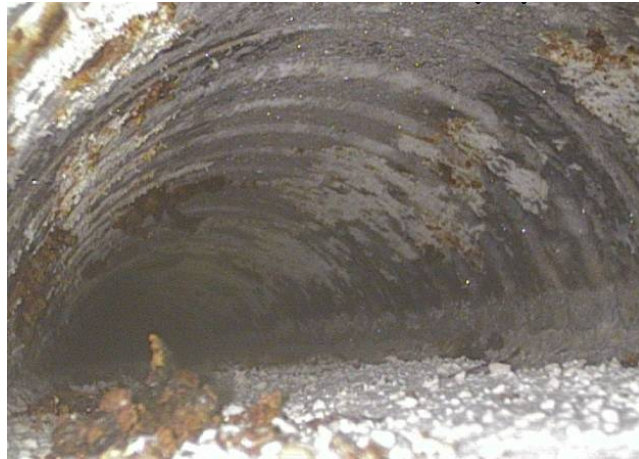
**Figure 8.10. Borescope picture looking toward highpoint in tendon 1**

Inspection holes of the three tendons towards pier 2 in span 2 had significant voids and some corrosion. Each of the duct inspections revealed large voids present, despite being 205.5 inches (522 centimeters) from the high point of the tendon at the pier. Tendon 1 had corrosion on top of the grout and duct with bubbles of corrosion product seen on the grout surface. The grout is a white and chalky indicating a poor quality material (high in water content and segregated). Despite the large void, there are no cables visible on top of the grout level in this tendon. Figure 8.10 shows a photo taken with the borescope within the duct (accessed through the inspection

holes) taken toward the high point (towards pier 2). The grout fills the duct only to approximately half capacity. Figure 8.11 shows the same location with the direction of the borescope to be pointed towards the low point (mid span).

Structure 02027 E has indications of significant voids toward the high points in the structure. Some evidence of corrosion was also found. All repairs were sealed up with accommodations made for future access for investigation and repair. A full investigation of this structure continuing in a similar manner of accessing ducts at high points is recommended to determine areas with corrosion and voids. Remediation may include vacuum grouting the voided areas to establish a protective environment for the strand.

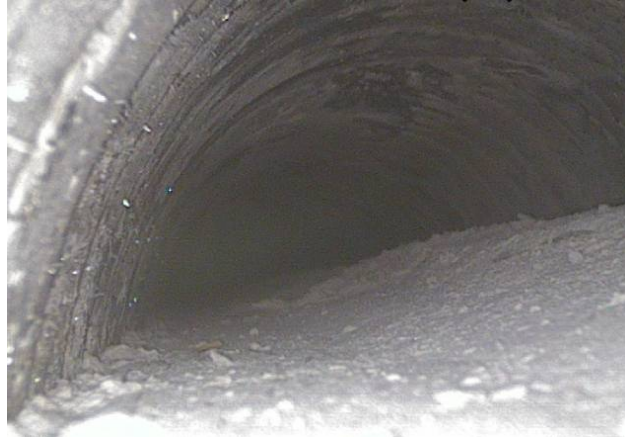
**Figure 8.12. Borescope picture looking toward highpoint in tendon 2**

The inspection into tendon 2 showed similar results. Again the void within the duct occupies half of the total area, and the grout that is present is a white and chalky in consistency. It is likely that closer to the highpoint there is a much larger void that exposes strands. Figure 8.12 shows a photo taken with the borescope within the duct (accessed through the inspection holes) taken toward the high point (towards pier 2). Figure 8.13 shows the same location with the direction of the borescope to be pointed towards the low point (mid span).

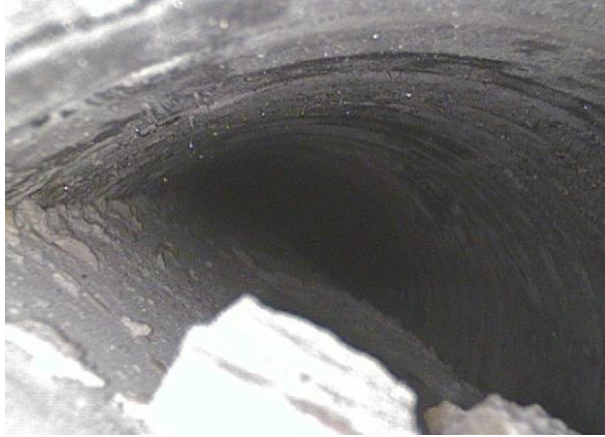
**Figure 8.14. Borescope picture looking toward highpoint in tendon 3**

The inspection of tendon 3 showed similar results to that seen in the previous two tendons. Voids within the duct occupied a third to half of the total area, and the grout that is present is a white and chalky. Figure 8.14 shows a photo taken with the borescope within the duct (accessed through the inspection holes) taken toward the high point (towards pier 2). Figure 8.15 shows the same location with the direction pointed towards the low point (mid span).

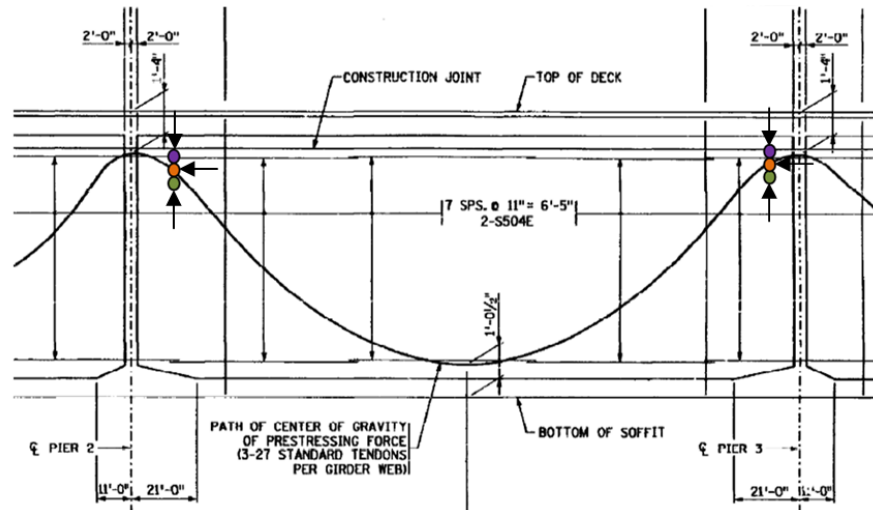
**Figure 8.16. Span 3 tendon profile of girder 5**

Inspection of span 3 focused on girder 5 from cell 4, at six different locations (high points along the tendon profile). Figure 8.16 shows the elevation view in of the tendon profile in span 3 (the tendon line represents the path of the center of gravity of the three contributing tendons). The inspection locations are highlighted in the figure (indicated by purple for tendon 1, green for tendon 2, and orange for tendon 3).

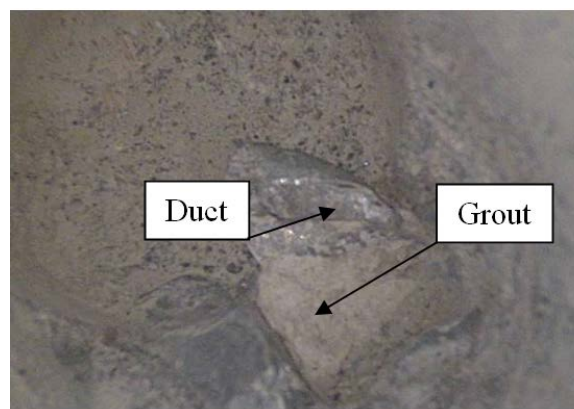
**Figure 8.17. Borescope picture of drilled hole in girder 5 of span 3**

All of the inspection locations within span 3 have similar results for each of the three tendons. Each of these spot checks had a full duct of grout that was white in color and very chalky. Figure 8.17 shows a photo taken with the borescope into the inspection hole of tendon 1, 110 inches (279.4 centimeters) from pier 2. This inspection is a representation of the findings from all inspection holes in span 3.

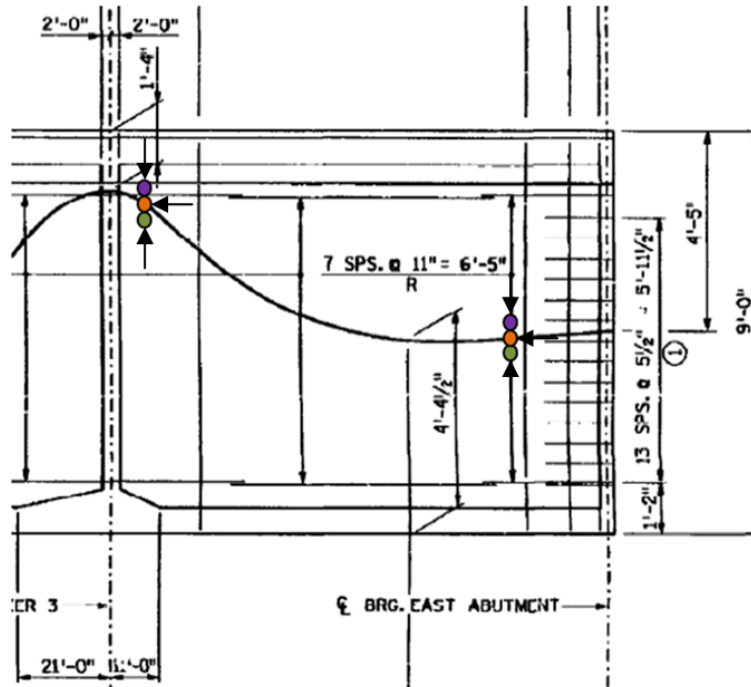
**Figure 8.18. Span 4 tendon profile of girder 4**

Each of the three tendon highpoints were examined near pier 3 and by the east abutment. Figure 8.18 shows the elevation view of the tendon profile (the tendon line represents the path of the center of gravity of the three contributing tendons) with a highlight on the inspection locations into girder 4 (indicated by purple for tendon 1, green for tendon 2, and orange for tendon 3).

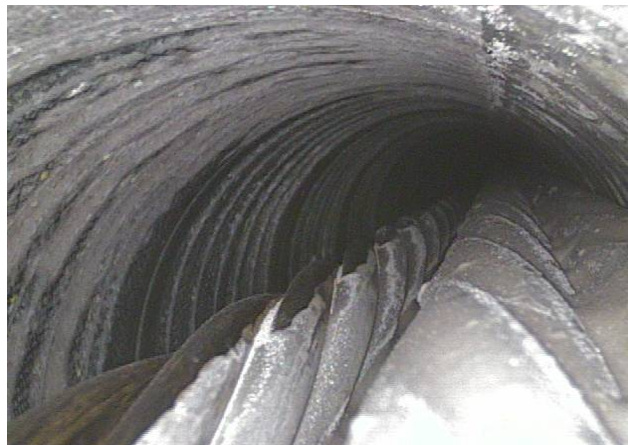
**Figure 8.20. Borescope picture looking toward highpoint in tendon 3, 6 inches (15.2 centimeters) inside of the inspection hole**

The inspection holes located towards pier 3 for tendons 1 and 2 had similar results to those seen near the east abutment. A full duct of grout that was white in color and chalky was observed. When a screwdriver was pushed into the grout, it easily sank into the chalky grout. The inspection hole into tendon 3 revealed a large void in the duct. The duct was found to be approximately half to two thirds empty. The cables in the duct are exposed with what was classified as class 2 corrosion (Sason, 1995). Some of the cables are seen to have a slight film of grout covering them, others are completely unprotected. Figure 8.20 shows a picture from the borescope looking towards the highpoint (towards pier 3). This photo was taken 6 inches (15.2 centimeters) inside of the inspection hole.
