# Development of Best Practices for Inspection of PT Bridges in Minnesota

Minnesota  
Department of  
Transportation

**April 2012**

Research Project  
Final Report 2012-09

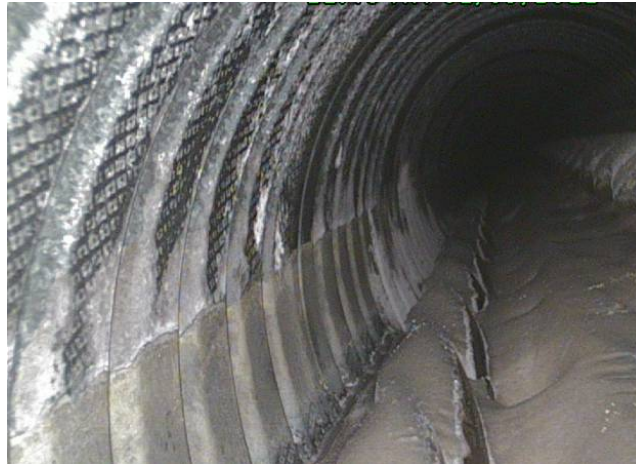
**Figure 8.21. Borescope picture looking toward highpoint in tendon 3, 24 inches (61 centimeters) inside of the inspection hole**

To look further towards the highpoint of the duct the borescope proceeded to approximately 2 feet (60 centimeters) into the duct. At this point the duct is seen to be two thirds empty. Two cables have visible corrosion. Figure 8.21 shows a picture from the borescope looking towards the highpoint (towards pier 3). This photo was taken 24 inches (60 centimeters) inside of the

inspection hole. In this case, the grout level appears to have dropped after initially filling to a higher level. This indicates the potential for a leak or poor shutoff procedure of at a vent or inlet/outlet.

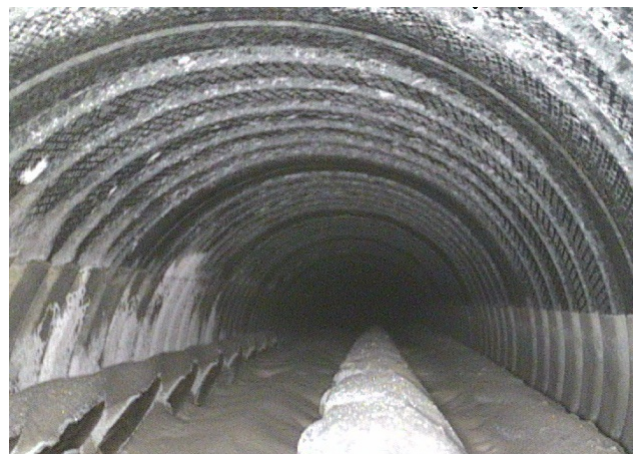
**Figure 8.22. Borescope picture looking toward highpoint in tendon 3, 3.5 feet (1.07 meters) inside of the inspection hole**

To investigate as close to the highpoint as possible, the borescope was threaded 3.5 feet (1.07 meters) into the duct. Figure 8.22 shows a picture from the borescope looking towards the highpoint (towards pier 3). This photo was taken 3.5 feet (1.07 meters) inside of the inspection hole. The void at this point is getting larger and the grout fill line is evident. The top half of the duct shows no signs of ever having had grout in it. There are two cables exposed that appear to have corrosion product on them.

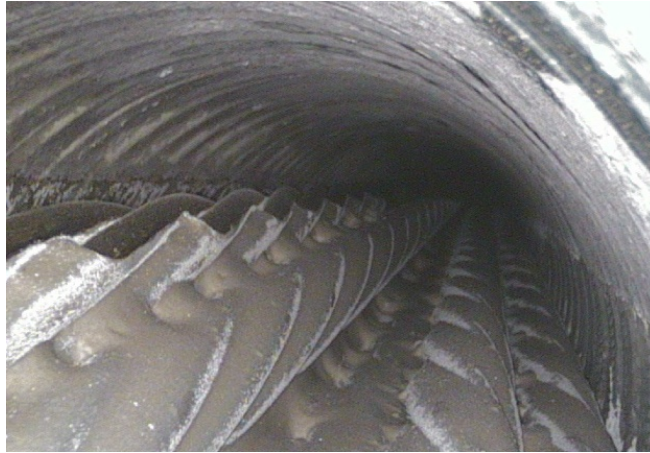
**Figure 8.23. Borescope picture looking toward low point in tendon 3, 6 inches (15.2 centimeters) inside of the inspection hole**

Looking towards the low point (mid span) revealed similar results (although a somewhat higher grout level). The cables are covered in a light film of grout. Figure 8.23 shows a picture from

the borescope looking towards the low point (towards mid span). This photo was taken 6 inches (15.2 centimeters) inside of the inspection hole.

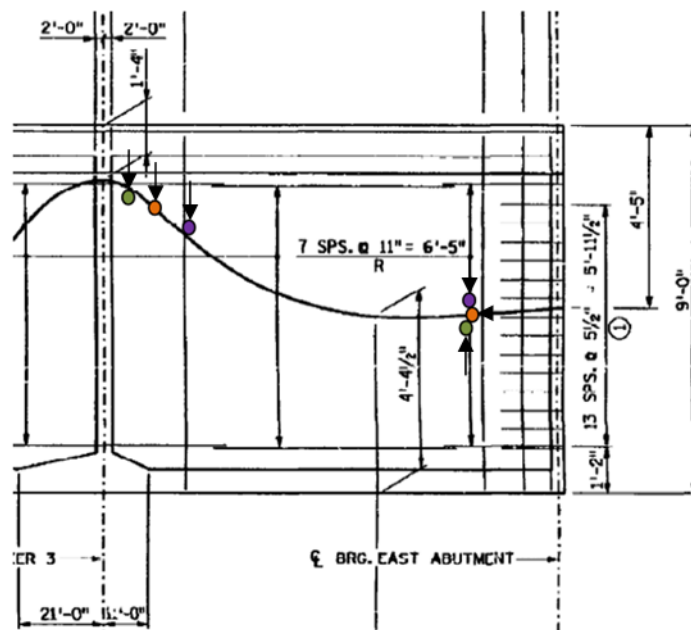
**Figure 8.24. Span 4 tendon profile of girder 5**

Each of the three tendons in girder 5 had their highpoints examined near pier 3 and by the east abutment. Figure 8.24 shows the elevation view of the tendon profile (the tendon line represents the path of the center of gravity of the three contributing tendons) with a highlight on the inspection locations into girder 4 (indicated by purple for tendon 1, green for tendon 2, and orange for tendon 3).

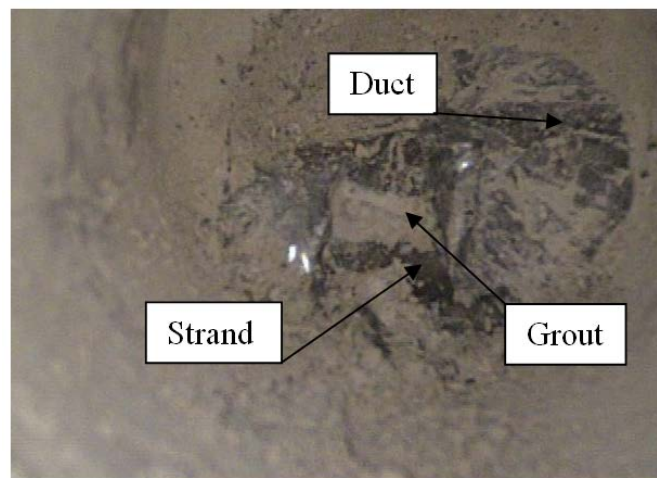
**Figure 8.25. Borescope picture of drilled hole in girder 5 of span 4**

The inspection locations near the east abutment gave similar results for each of the three tendons. Found in each of these spot checks was a duct full (all strands have cover) of grout that was white in color and very chalky. One strand was exposed in the inspection hole in tendon 3 and no visible corrosion was seen on the strand. Figure 8.25 shows a photo taken with the borescope into the inspection hole of tendon 3, 17 inches (43.2 centimeters) from the east abutment. This inspection is a representation of the findings from all inspection holes near the east abutment in girder 5 of span 4.

Significant voiding is present in structure 02037 W along with duct and strand corrosion. Evidence of leakage or back flow is present along with poor quality grout. As with structure 02027, a thorough invasive inspection is recommended to locate voids and corrosion so that repairs can be made. The presence of duct corrosion indicates an adequate presence of moisture and oxygen in the duct that may lead to additional strand corrosion if not remediated.

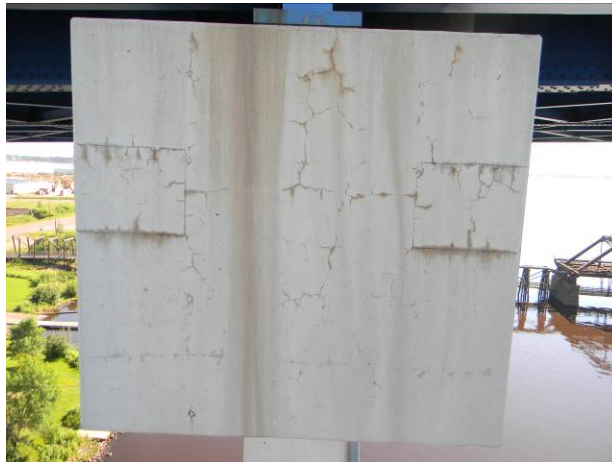
**Figure 9.1. PT cap on Blatnick Bridge pier**

University of Minnesota Duluth team performed an inspection in conjunction with a MnDOT critical fracture inspection team that was already on site to further investigate the cracking on the PT caps on July 26<sup>th</sup>, 2011. Using a snooper truck, several of the PT caps were closely inspected and bursting cracking around anchorages was observed. Although it was noted that the cracking occurred during construction, the cracks continued through the patching. Seen below in figure 9.1 is an end view of the pier cap with cracks seen around the anchorage system. Moisture is present in the cracks, particularly those around the anchorage area.

The cracks seen in figures 9.1, 9.2, and 9.3 are typical of each of the piers in the structure. Figure 9.4 shows a longitudinal view of the pier with numerous cracks running vertically on the pier (a yellow highlight has been added to make the cracks more visible in the photo).

The pier caps should be inspected thoroughly including an invasive inspection at one of the anchorage ends. It is important to determine if the moisture present at the cracks is just surface moisture remaining in the cracked areas under humid conditions or if the moisture is trapped near the anchorage (or in a worst case scenario, the moisture is coming from the anchorage).

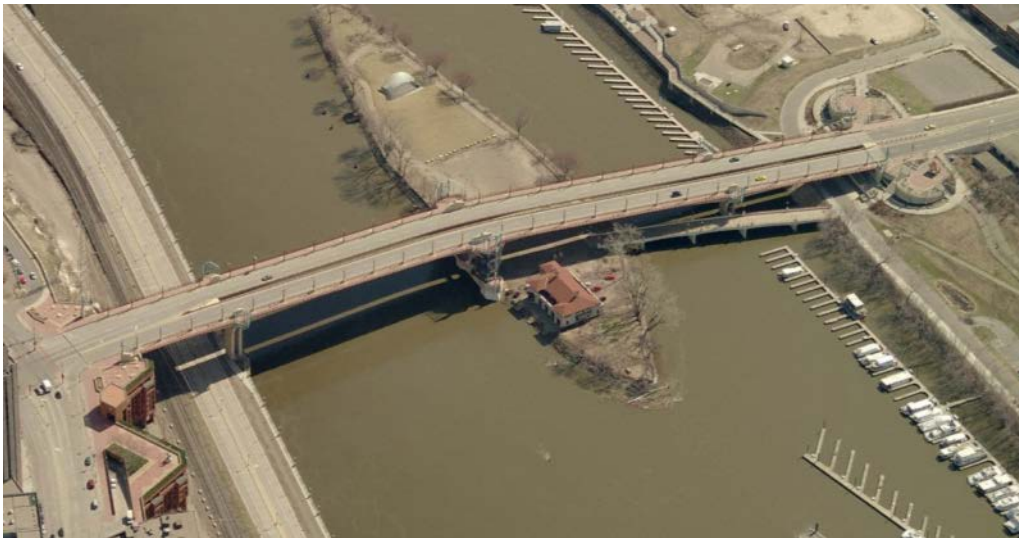
- Spalling at grout tube location on deck
- PT girders show some efflorescence in transverse joints along bottom; paint peeling in these locations
- Longitudinal cracks in top of box near south abutment cross walk
- Interior inspection of box girders in 2005 (team included Tom DeHaven of Figg)
- Anchor block joint is open 1/4"

The spalled area at the grout port to the deck should be revisited. This type of detail can allow direct ingress of moisture and chlorides to a tendon. The anchor block joint should also be visually inspected for signs of corrosion from moisture/chloride ingress. No major problems were indicated in the 2005 inspection. This bridge has a specific inspection manual from the designers (Figg Bridge) and has been inspected with one of the Figg team who has extensive segmental bridge experience on site. For this reason, the inspection recommendation under this project is lower than for other bridges of this type.

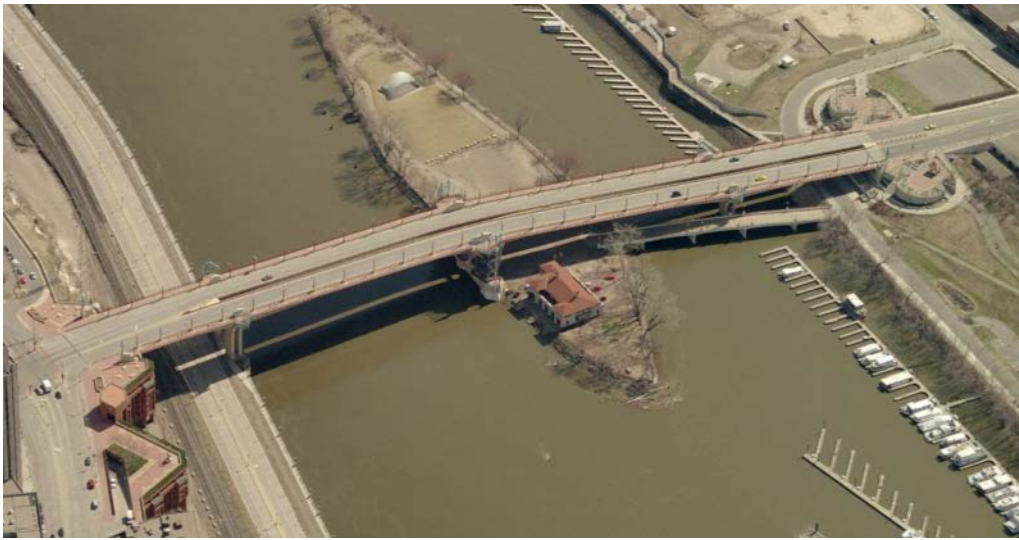
- Transverse deck cracking at numerous locations on the inside southbound lane
- Slight efflorescence along bottom of PT girders at transverse joints
- Thermal cracks at 3 construction joints

This structure is the sister bridge to 62555A and in general, has similar inspection notes with respect to transverse joints. Thermal cracking at the construction joints is also noted. These areas of cracking should be inspected visually from inside of the box.

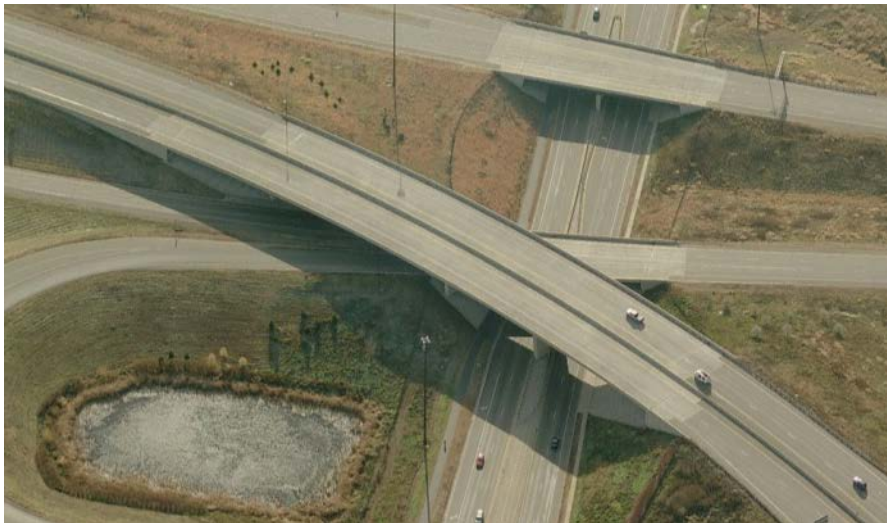
- Deck has 3 sq ft of delamination near east end block
- Deck cracking (2400 linear feet)
- Leaching cracks at coping under deck

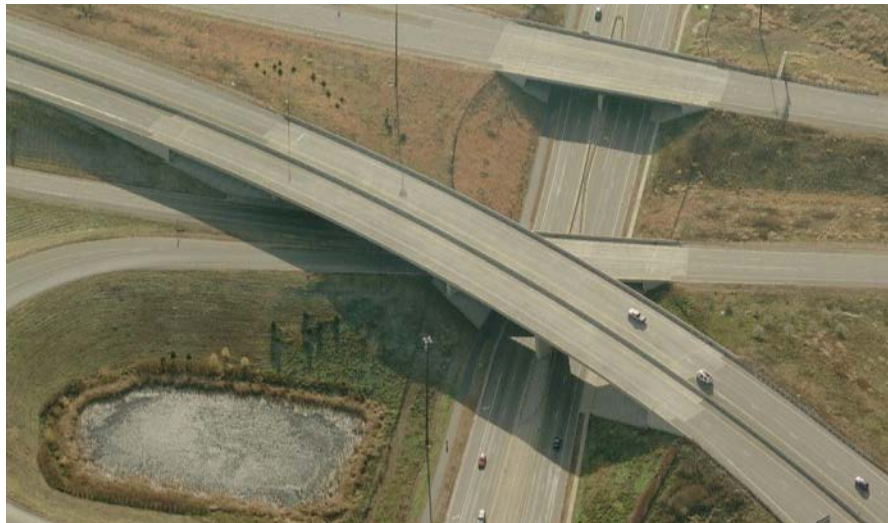
- Deck has 4 sq ft of delamination (2 sq ft spalling) at west end block; 1 sq ft spalling at east end block

This is the sister structure to 02037E. Similar concerns exist at tendon high points. No information is given in the 2009 inspection report about the PT boxes. This structure is potentially more of a concern than the eastbound structure due to grouting procedures observed on site by Mn/DOT personnel.

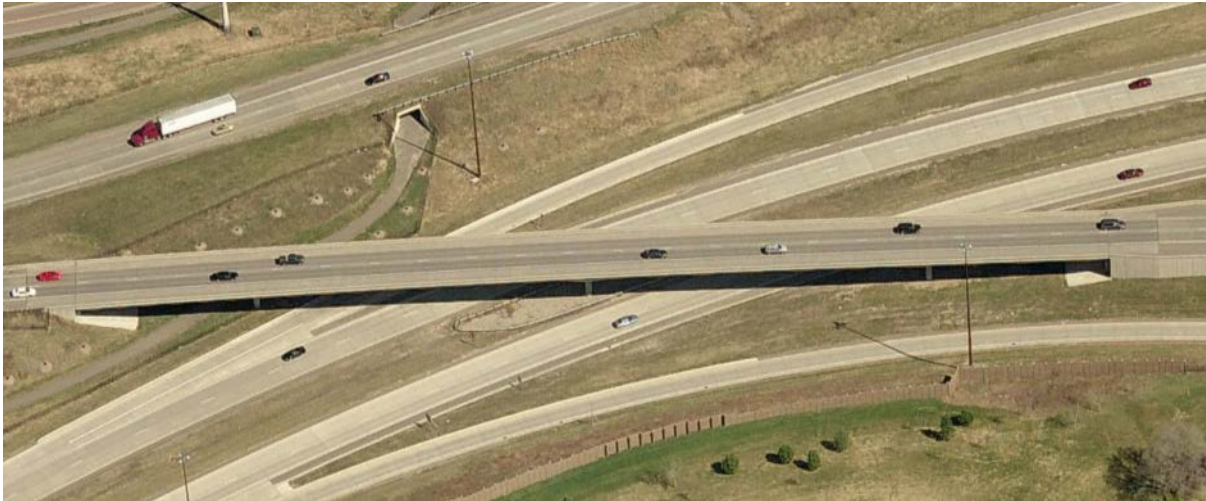
- Deck surface delamination at end block
- Deck joint seal failures
- PT box girder has location with 2 sq ft of cracking and delamination, exposed rebar
- Transverse cracking at pier 1

The bridge has a parabolic tendon profile with relatively tall vertical rise, so high points are susceptible to bleed. The tendon size is not available on the provided plans, but larger tendons will have a higher tendency to accentuate bleeding due to the wicking effect of the 7-wire strand. High points and areas near the joint seal failures should be the focus of inspection. The spalled area with exposed rebar should also be inspected for the effect on tendons in that area.

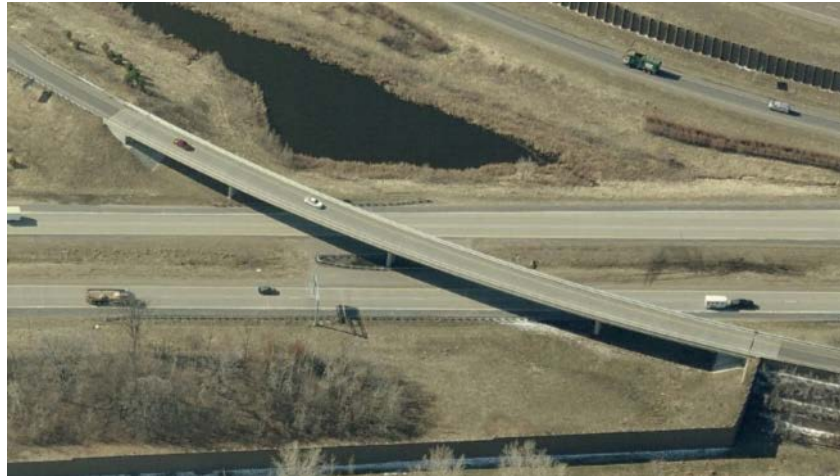
- Deck overlay has 2 sq ft spall at west end block
- Deck has longitudinal and map cracking

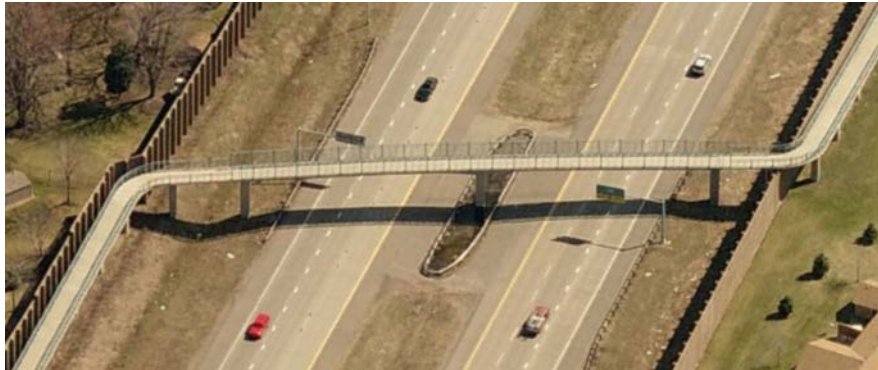
- Transverse and longitudinal deck cracking
- Cracks with leaching on the deck underside at copying (both ramps)

This pedestrian bridge has cracking detailed in the 2009 inspection. These locations should be visually monitored for potential corrosion and/or ingress of moisture/chlorides to tendons (particularly in anchor areas). The parabolic profile is susceptible to high point bleeding, but the tendon rise is only moderate for this type of profile.

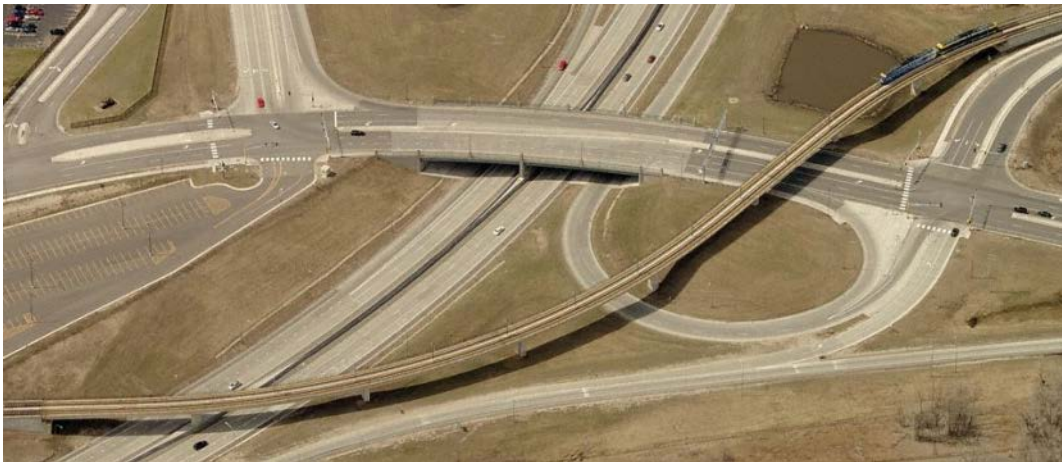
- Void in east girder north of pier #14 (9" deep) with large amount of grout on top of bottom slab that has emanated from the void
- 11" void in span 11 with grout on bottom slab in numerous locations in this area
- Minor cracking with efflorescence in soffit slab
- 4 ft long horizontal cracks around the center web access openings
- Horizontal cracking in W fascia web of the N intermediate diaphragm in span 14

possibility of blowouts/leaks during construction and the likelihood that the structure is not fully grouted. These areas should be more thoroughly inspected beyond visual inspection.

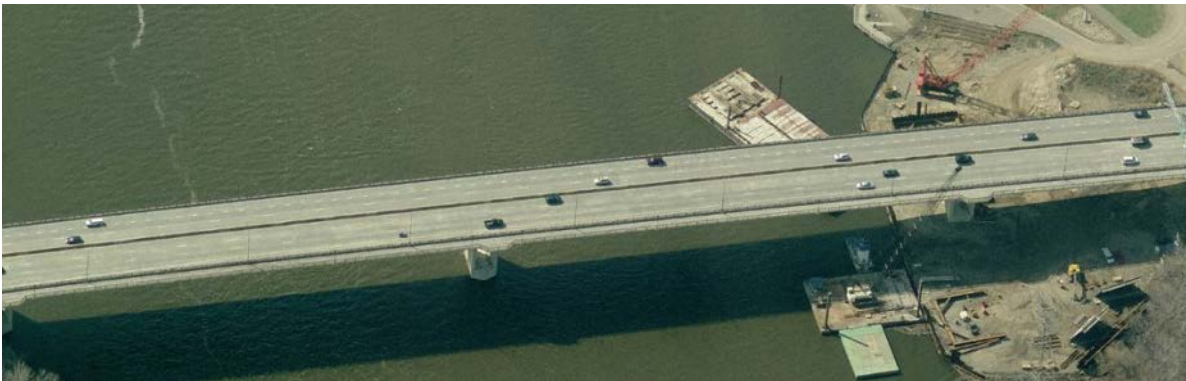
- Random cracks in all box girder members
- Deck cracking

This bridge (sister structure to 82855) has been open to traffic since 2006. Inspection notes from 2009 indicate cracks in all box girder members. These cracks should be visually inspected with specific focus on their potential cause and then the effect they may have on the durability of the post-tensioning. For this reason, this bridge has been given a higher recommended inspection rating than the sister structure. The visual inspection should include the interior of the boxes and may need to be followed up with more invasive inspection if warranted by the visual inspection.

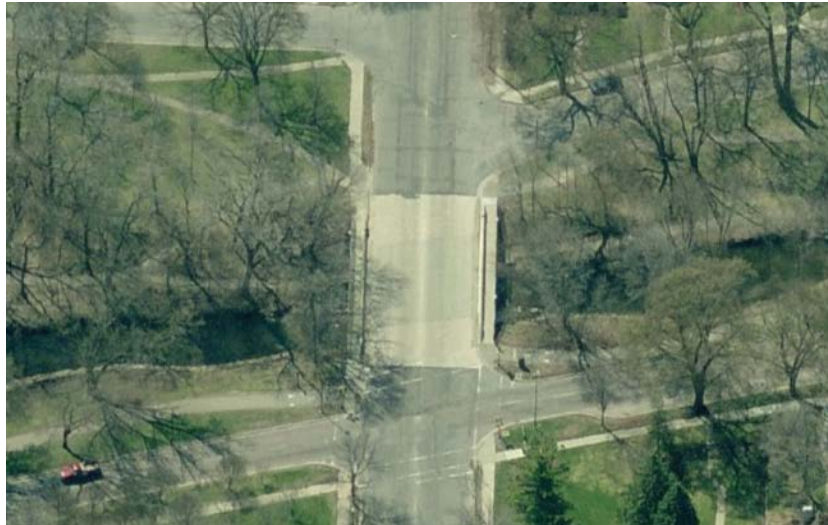
- Deck surface has minor uniform scaled, 3 sealed longitudinal full depth cracks, and some small spalls at the longitudinal joint line
- Underside of deck has a fine longitudinal cracks with efflorescence
- Underside has some spall at the outside edges with rebar exposed

This PT slab bridge has cracking as would be expected in a bridge of this age. The tendon profile has little vertical rise, so bleed problems should be minimal. The end anchorage details should be visually inspected for signs of corrosion. This is the oldest PT bridge listed in the Mn/DOT inventory, so is of interest for brief visual inspection under this contract from that perspective.

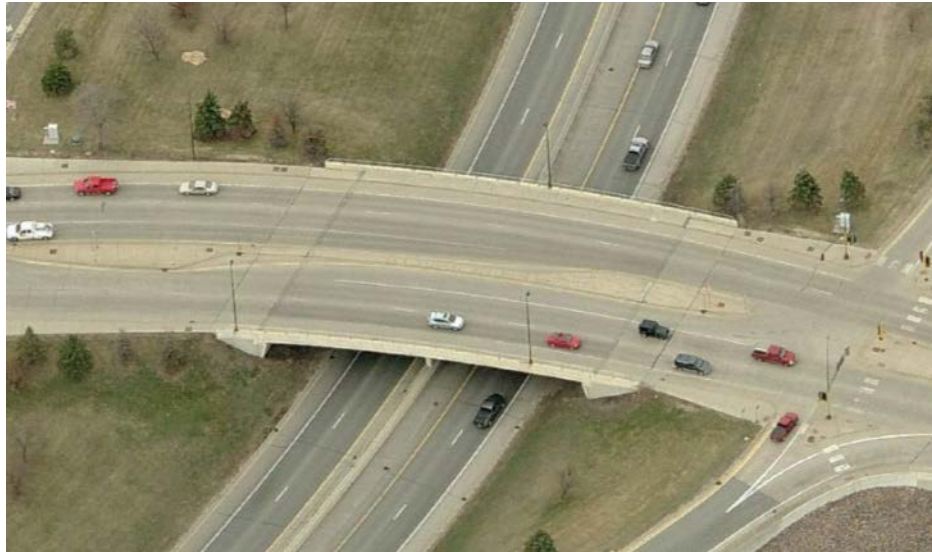
- Deck cracking and experimental patch cracking/failing
- Poured deck joints have failed in some locations; cracking and spalling

This PT slab bridge has some relatively large tendons, but does not have a vertical rise that would indicate the likelihood of large grouting voids in the tendons. The bridge has additional PT tendons at the intermediate pier location that runs in a sharper radius completely through the superstructure (with anchorage below the deck). The amount cracking and spalling indicated in the inspection reports, particularly at joints may be cause for concern due to potential ingress of moisture and chlorides to the tendons. A visual inspection concentrating on these areas as they relate to the tendon profile is recommended, with particular focus on anchorage areas and on the intermediate pier tendon.

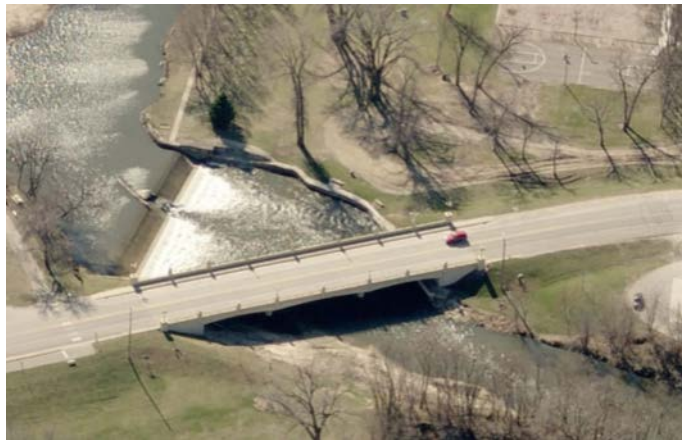
- 2 longitudinal cracks on underside of concrete deck extending out from both abutments near centerline

As detailed in the inspection notes, this PT slab bridge appears to be in good condition. Visual inspection near cracking locations as related to PT is recommended along with visual inspection of anchorage areas where possible.

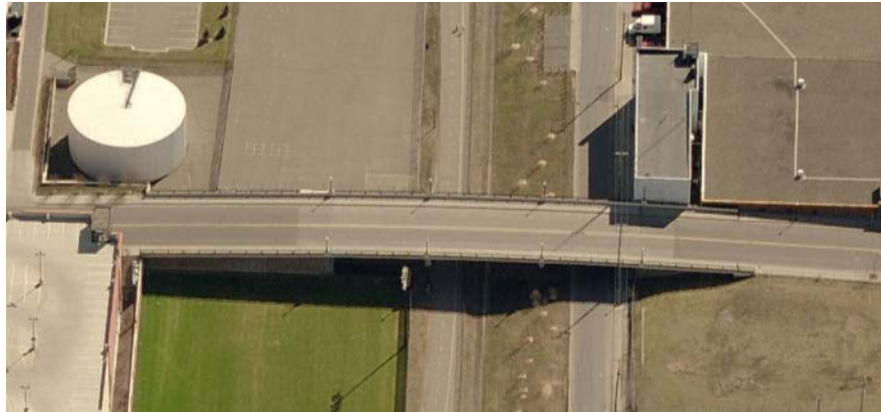
- Fine transverse and longitudinal cracking in overlay; 2445 linear feet of deck cracking (year 2000)

This PT slab bridge appears to be in good condition from the inspection notes. Plans were not available, but this type of bridge is less susceptible to grouting problems and bleed, so there is less concern related to the PT components of this structure than of other structure types.

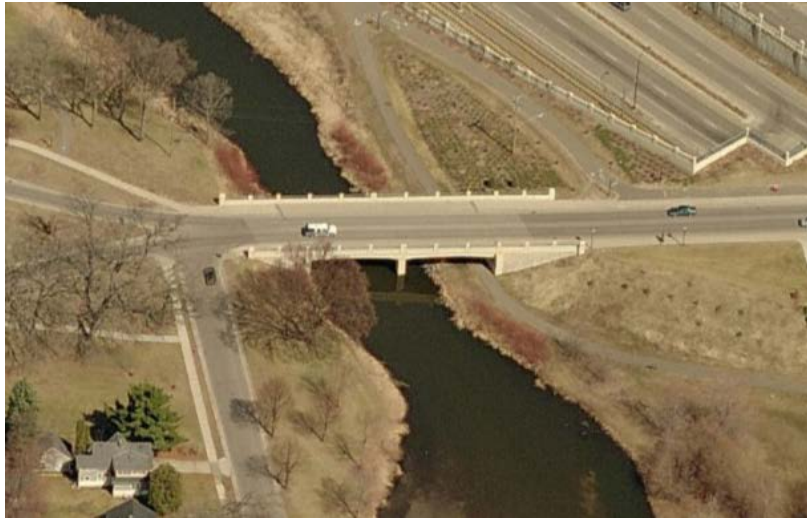
- Fine sized map cracking in deck

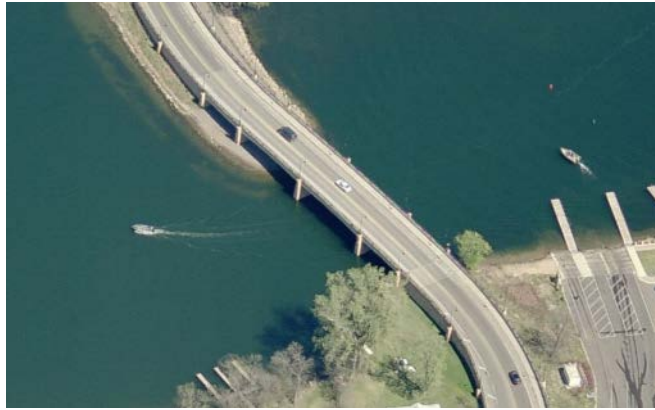
- Some fine transverse and longitudinal cracks in overlay
- Fine longitudinal cracks in underside of slab at centerline in all spans
- Minor areas of honeycombing in the underside of the N span

This PT slab span has some cracking and honeycombing on the underside that should be visually inspected in relation to the location of PT tendons and PT anchorage.

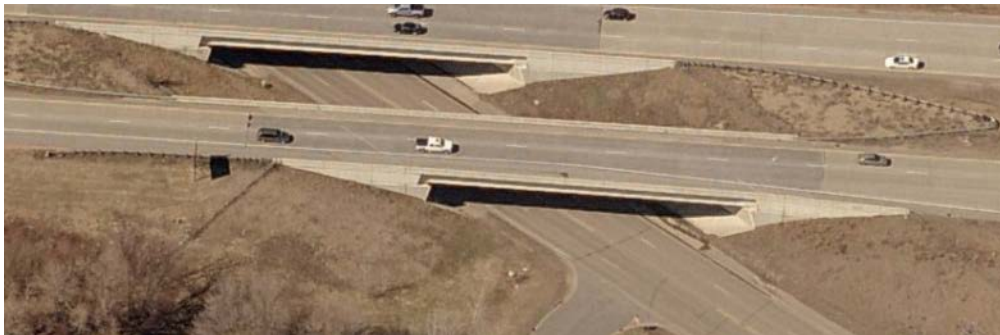
- Overlay delamination and scaling near end block (not likely to be related to PT for this type of system)
- Joint failures

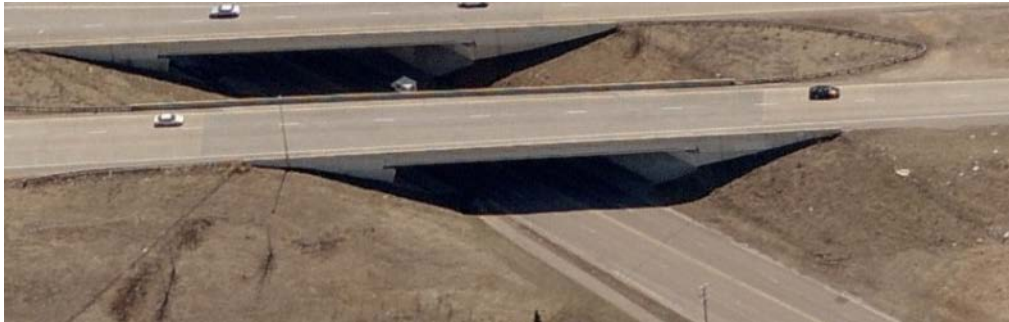
- Overlay delamination and scaling near end block (not likely to be related to PT for this type of system)
- Joint failures

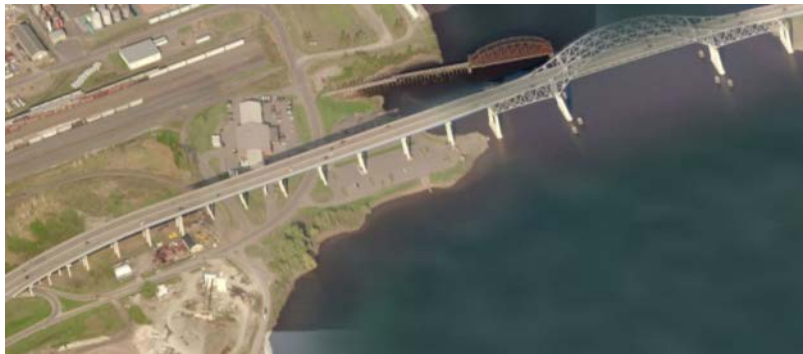
- PT pier caps had shrinkage cracking that was repaired shortly after construction; nearly identical cracks visible on each pier cap

The PT components in this bridge are the PT pier caps. The inspection notes do not indicate any problem areas related to the PT other than the recorded cracking. End anchorage protection should be visually inspection during routine inspections. The end protection for the anchorages as shown in the plans indicate good protection. Plastic end caps are recommended for current construction, but were not typically used at the time of this construction. Metallic caps (that were typically removed) were often used. Indications of cracking, efflorescence and/or rust staining would be indicators of the need for a more detailed inspection. The overall recommendation for inspection of this bridge related to PT is low, however it has been given an “8” based on the reported cracking in the piers. A visual inspection should be done on this bridge under this project contract specific to the PT pier caps.

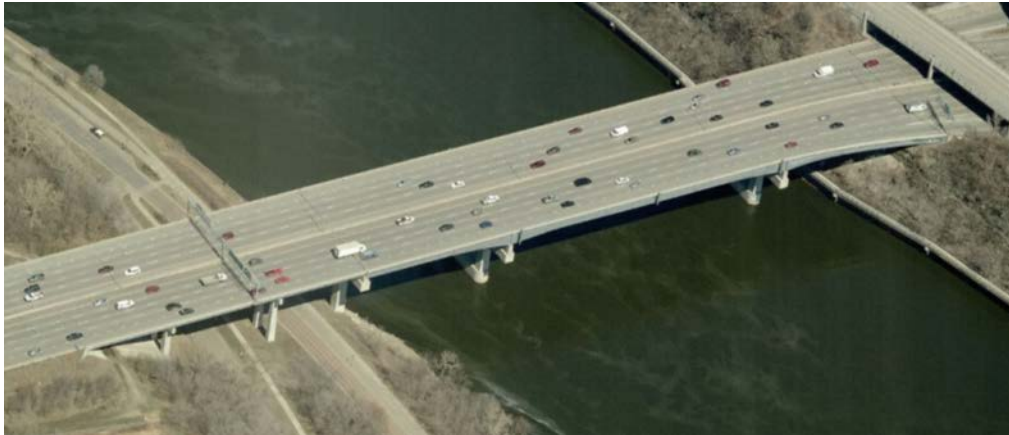
- PT caps added in 1995 (river piers #3, 4, 5); cracks and leaching in #5
