# **Maintenance Painting for Steel Bridges: Evaluation of Coating Systems Over Minimally Prepared Surfaces to Delay Rehabilitation**

**Daniel J. Zienty, Principal Investigator**  
Short Elliott Hendrickson Inc.

**August 2019**

Research Project  
Final Report 2019-37

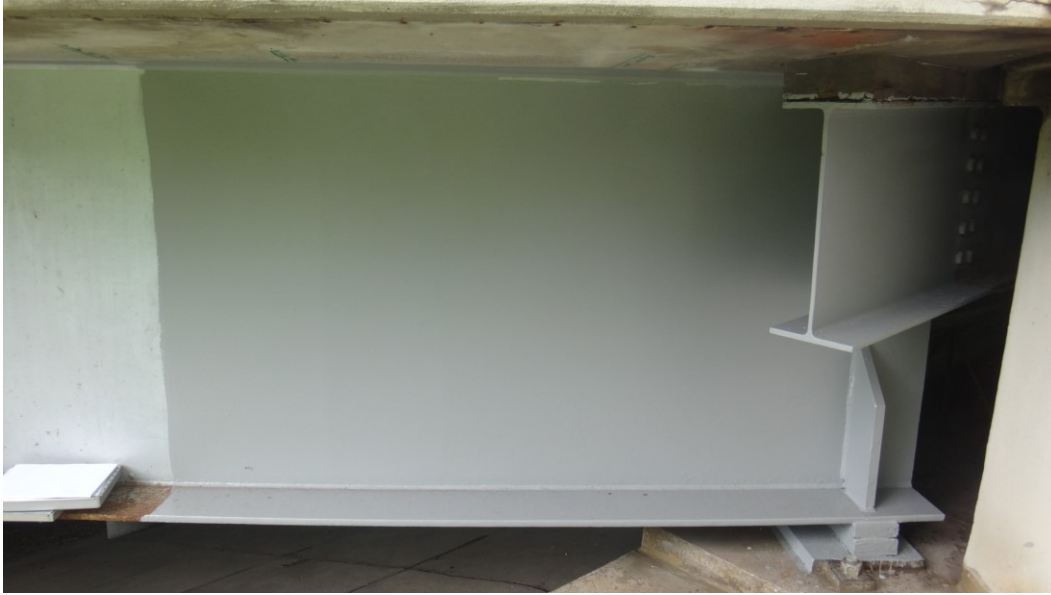
**Figure 4.15 Test Location 1 Finish Coat**

was applied followed by back rolling the entire test surface where finish coat was applied. The average total coating system thickness was 17.0 mils DFT resulting in a finish coat average thickness of 5.5 mils DFT, which was just outside the specified coating thickness range of 3-5 mils DFT. This minimal change in finish coat thickness will not affect the performance or life cycle of the coating system and may be attributed to the locations selected during thickness measurements. Use of a respirator was required for this product application.

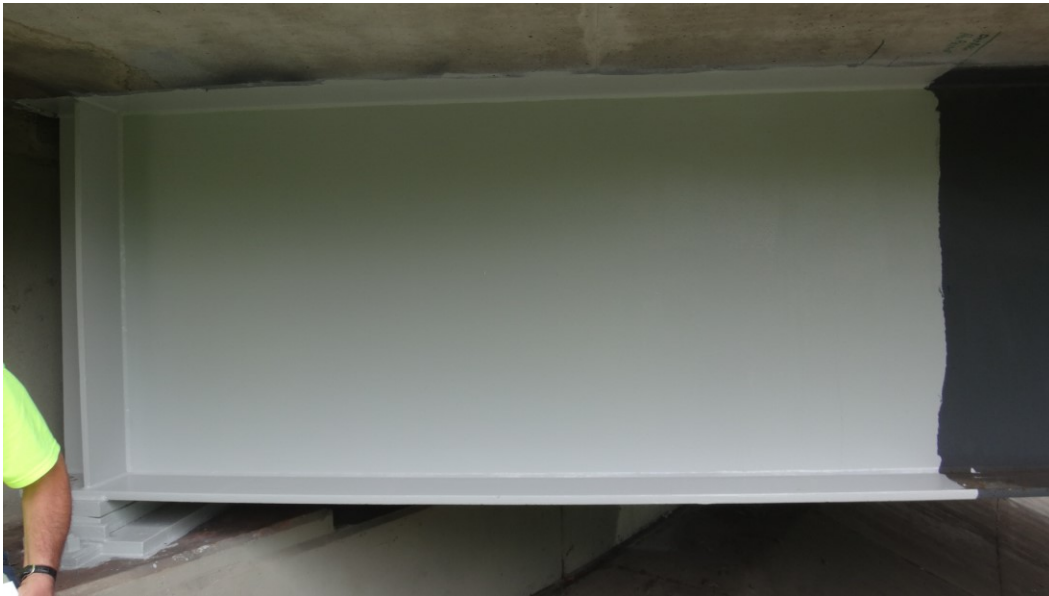
Figure 4.18 Test Location 4 Finish Coat

Test Location 4 received a Polyaspartic Urethane (similar to Test Location 3) applied over the Moisture Cure Urethane with Micaceous Iron Oxide prime coat. This finish coat product required a 2:1 mix ratio. The coating was applied achieving an average coating thickness of 5.3 mils DFT, which was just under the specified coating thickness range of 6-9 mils DFT. This minimal change in finish coat thickness will not affect the performance or life cycle of the coating system and may be attributed to the locations selected during thickness measurements. The total coating system thickness was 8.1 mils DFT. Use of a respirator was required for this product application.

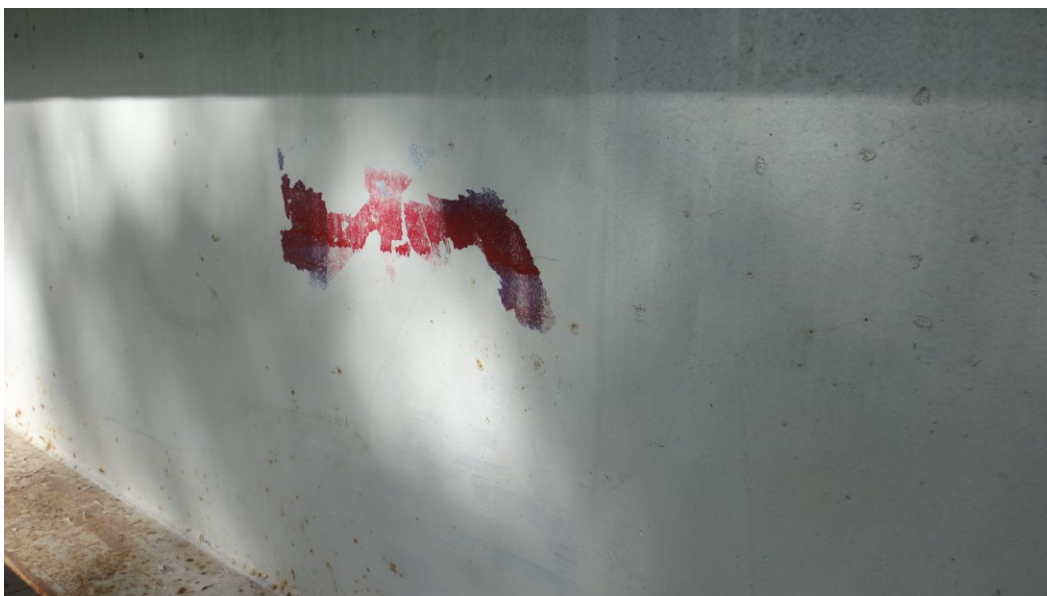
**Figure 8.2 Additional Test Patch Locations - Pre-Existing Conditions**

Pre-existing conditions were documented prior to surface preparation and application to provide a baseline for the additional test patch locations. However because the additional test patch locations were applied on a single beam on the same bridge, variables such as orientation, traffic conditions, differing film thicknesses, pre-existing conditions, degree of rust, and chloride exposure were minimized.

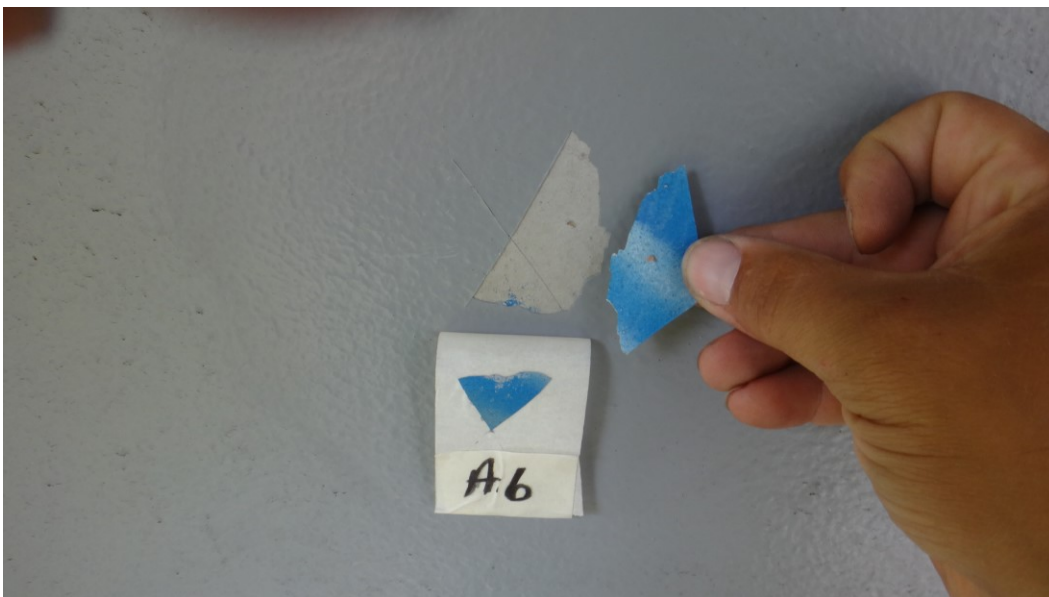
**Figure 11.2 Test Location 1 Adhesion Test A6 - Web**

Adhesion Testing on the web and top of the bottom flange was also performed in accordance with ASTM D 3359 – Standard Test Methods for Measuring Adhesion by Test Tape. The initial adhesion test on the web indicated a 0A (Removal beyond the area of the X) result due presumably to graffiti that was previously coated over, and prior to application at this maintenance test location in 2015. This is identified by a blue delamination layer beneath the coating system. A subsequent adhesion test on the web, and an additional test on the flange, indicated a 4A (Trace peeling or removal along incisions) result respective of each location.

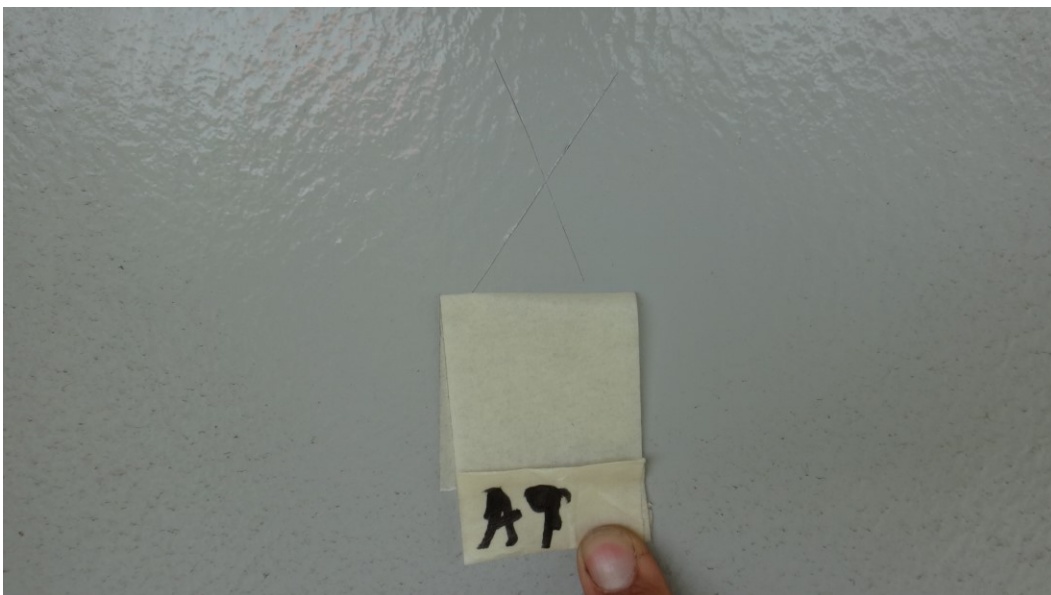
**Figure 11.5 Test Location 2 Adhesion Test A9 -Web**

Adhesion testing was performed in conformance with ASTM D 3359 – Standard Test Methods for Measuring Adhesion by Test Tape at the fascia of the web and the top of the bottom flange. The adhesion test on the web resulted in a 4A (Trace peeling or removal along incisions) result indicating excellent adhesion to the existing substrate. The bottom flange adhesion test also resulted in a 4A reading (Trace peeling or removal along incisions).

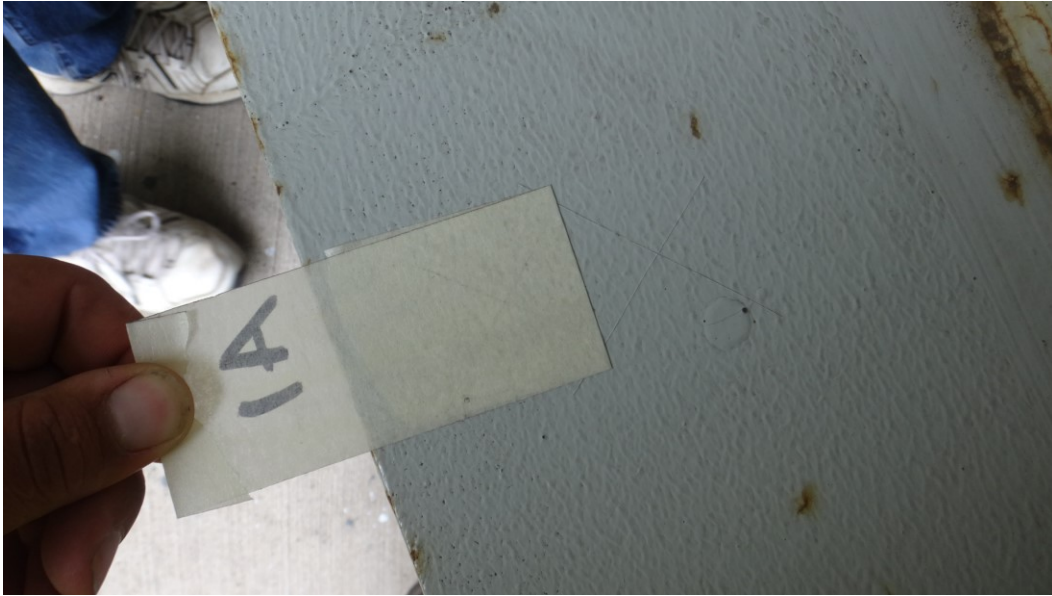
Figure 11.10 Test Location 4 - Adhesion Test 1A - Flange

Adhesion testing was performed in conformance with ASTM D 3359 – Standard Test Methods for Measuring Adhesion by Test Tape on the top of the bottom flange and the web. The adhesion test on the flange and web both resulted in a 4A (Trace peeling or removal along incisions) result.

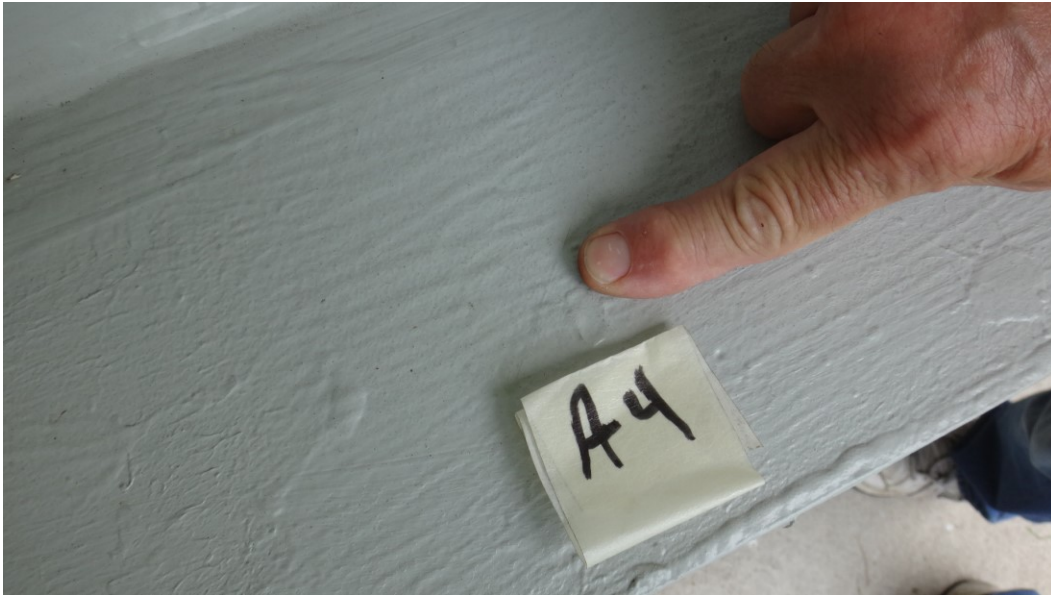
**Figure 11.13 Test Location 5 - Adhesion Test A4 - Flange**

Adhesion Testing was performed in conformance with ASTM D 3359 – Standard Test Methods for Measuring Adhesion by Test Tape, at the fascia of the web and the top of the bottom flange. The adhesion test on the web resulted in a 4A (Trace peeling or removal along incisions) reading, which is

indicative of excellent adhesion to the existing substrate. The bottom flange adhesion test also provided results of 4A (Trace peeling or removal along incisions).

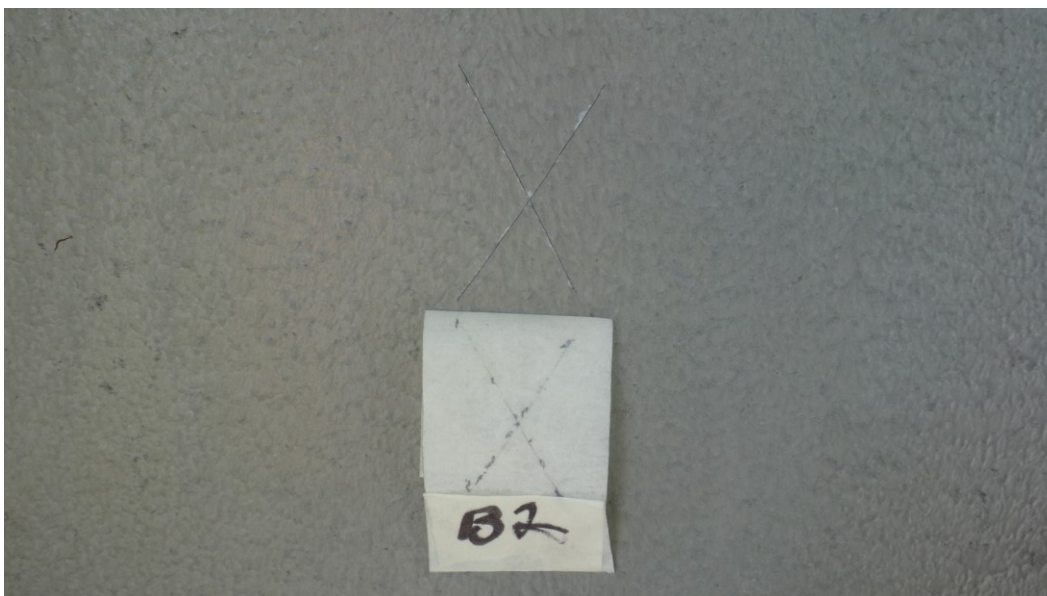
Figure 12.2 Additional Test Patch Location A - Adhesion Test Web

Final testing consisted of Adhesion Testing in conformance with ASTM D 3359 – Standard Test Methods for Measuring Adhesion by Test Tape at the fascia of the web and the top of the bottom flange. The adhesion test on the web indicated a 3A (Jagged removal along incisions up to 1.6 mm (1/16 in.) on either side) result which indicates good adhesion to the existing substrate. The bottom flange adhesion test resulted in a 4A reading (Trace peeling or removal along incisions) representative of excellent adhesion to the existing substrate.

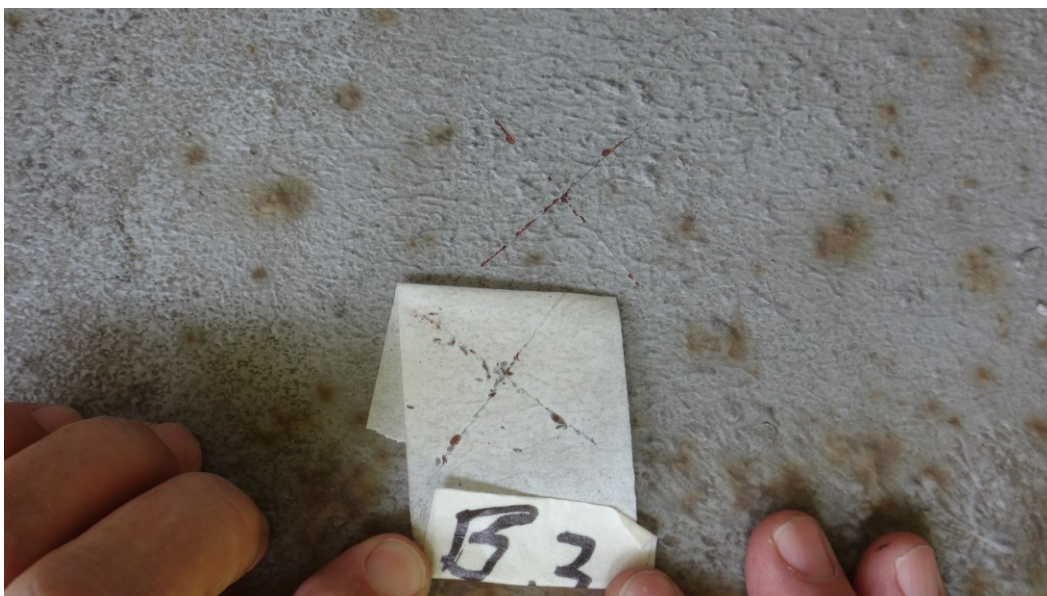
Figure 12.5 Additional Test Patch Location B - Adhesion Testing Flange

Adhesion testing was completed on the fascia of the web and the top of the bottom flange. The adhesion test on the flange resulted in a 3A (Jagged removal along incisions up to 1.6 mm (1/16 in.) on either side) reading indicates good adhesion to the existing substrate. The web adhesion test resulted in a 1A (Removal from most of the area of the X under the tape) reading which represents poor adhesion to the existing substrate. Similar to the adhesion testing completed at Test Location 1, this result is likely due to graffiti that was previously covered over prior to the original application of the test patch coating system in 2016, as identified by a blue delamination layer beneath the coating system.

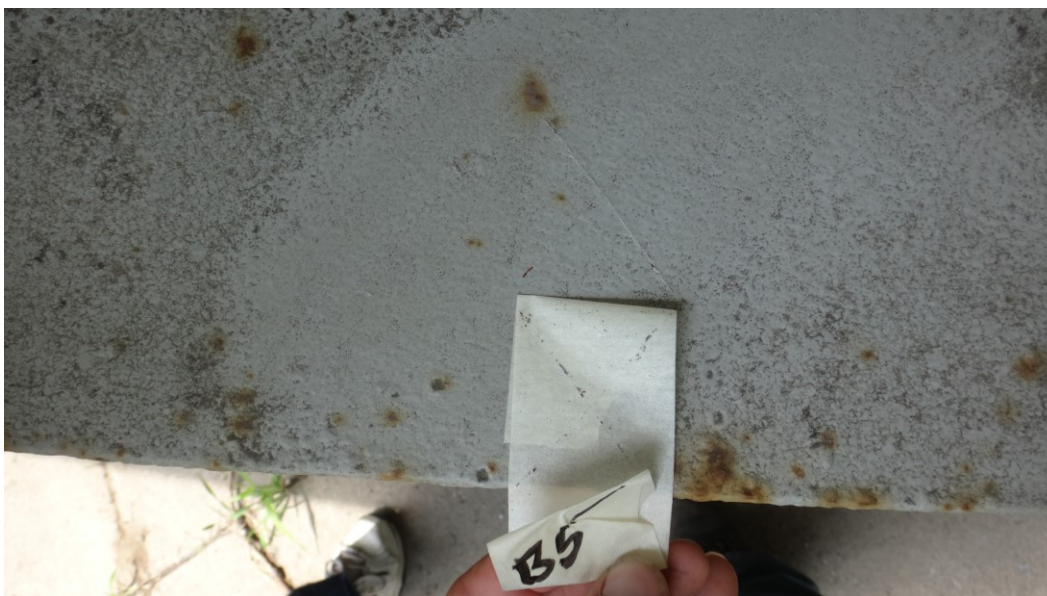
**Figure 12.8 Additional Test Patch Location C - Adhesion Testing Flange**

Adhesion testing was completed on the fascia of the web and the top of the bottom flange. The adhesion test on the flange resulted in a 4A (Trace peeling or removal along incisions or at their intersection) reading which indicates good adhesion to the existing substrate. The web adhesion test resulted in a reading of 3A (Jagged removal along incisions up to 1.6 mm (1/16 in.) on either side), demonstrating fair adhesion to the existing substrate.

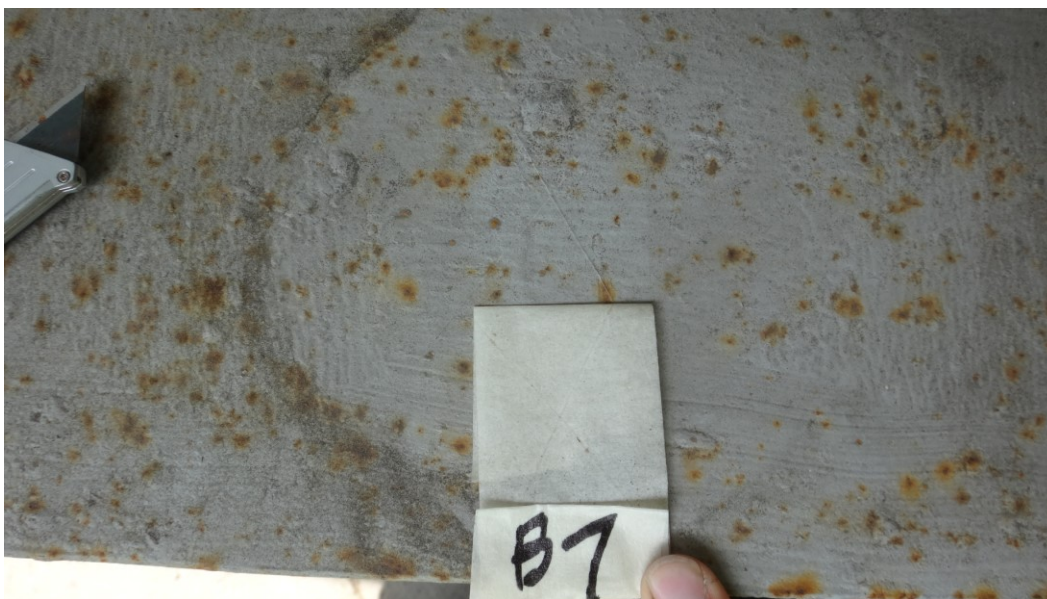
**Figure 12.11 Additional Test Patch Location D - Adhesion Testing Flange**

Adhesion testing completed at this location resulted in 4A adhesion on the flange (Trace peeling or removal along incisions or at their intersection) an indication of a very good adhesion, and 4A adhesion (Trace peeling or removal along incisions or at their intersection) on the web resulting in excellent adhesion to the substrate.

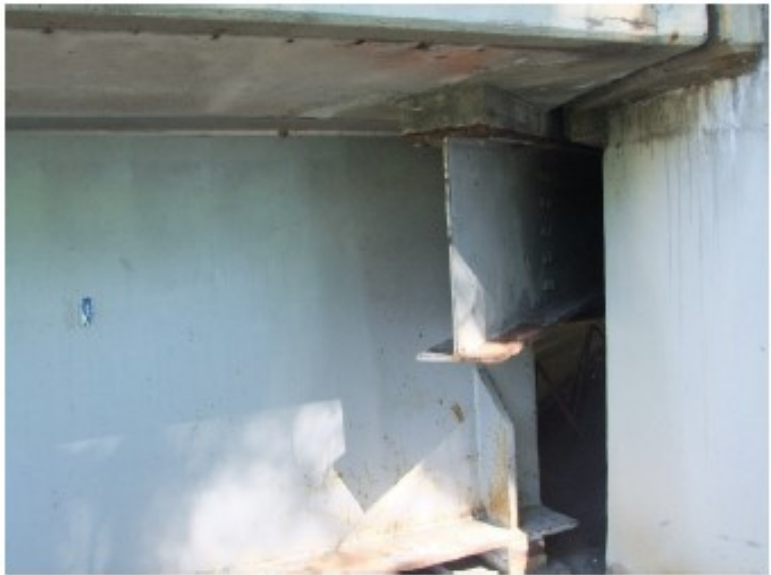
Pre-Existing Conditions

Test Location Number:	1
Existing Conditions:	Poor to Severe rusting present, mild to no pitting present, average dry film thickness of 11.5 mils DFT
Surface Preparation:	SP1/SP2/SP3
Coating System:	Prime Coat: Epoxy Mastic Finish Coat: Aliphatic Acrylic-Polyester Polyurethane

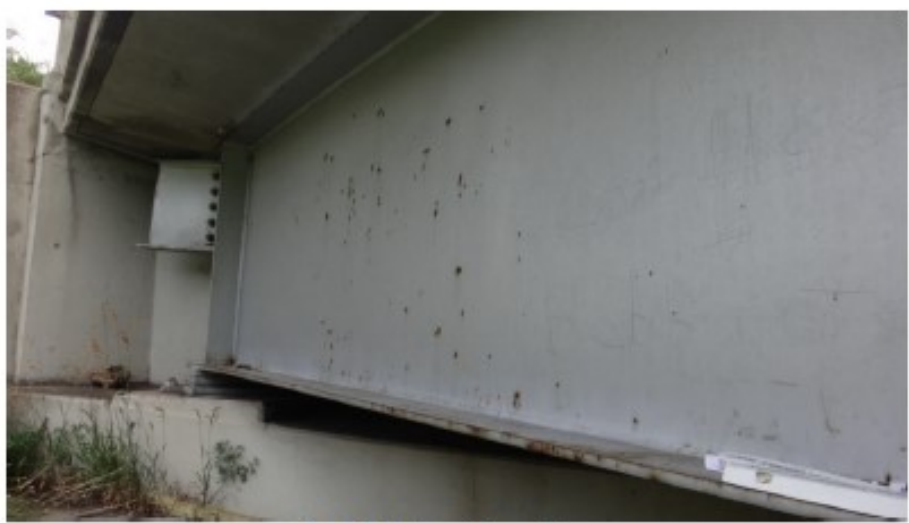
Pre-Existing Conditions

Test Location Number:	2
Existing Conditions:	Poor to Severe rusting in localized areas, mild to no pitting present, average dry film thickness of 7.4 mils DFT
Surface Preparation:	SP1/SP2/SP3
Generic Coating System:	Prime Coat: Polyamide Epoxy Finish Coat: Acrylic Aliphatic Polyurethane

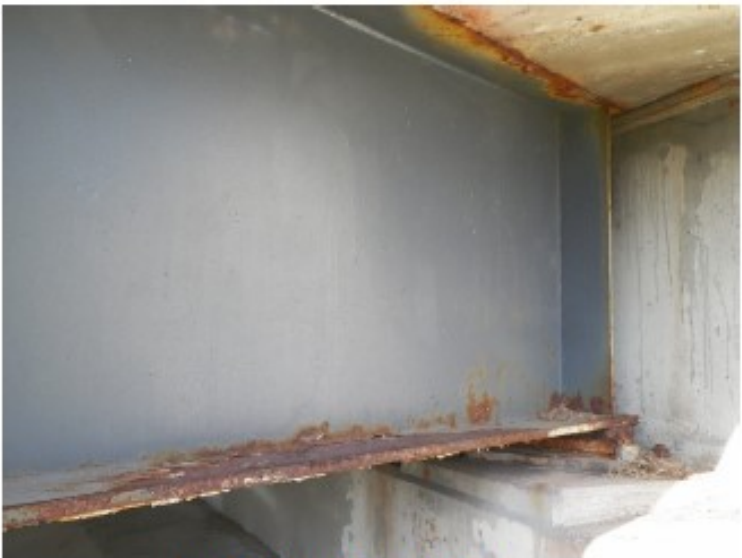
Pre-Existing Conditions

Test Location Number:	3
Existing Conditions:	Poor to Severe rusting present, mild to no pitting present, average dry film thickness of 5.2 mils DFT, Anti-Graffiti coating present
Surface Preparation:	SP1/SP3
Generic Coating System:	Prime Coat: Aluminum Filled Polyamine Epoxy Finish Coat: Polyaspartic Urethane

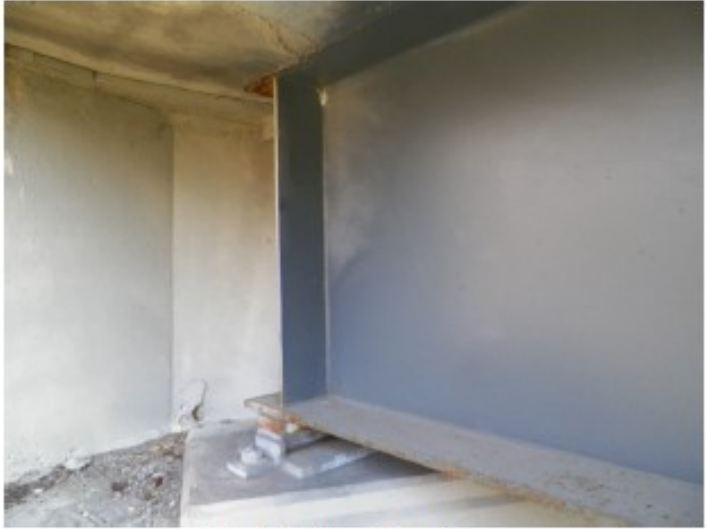
Pre-Existing Conditions

Test Location Number:	4
Existing Conditions:	Poor to Severe rusting present, mild to no pitting present, average dry film thickness of 2.8 mils DFT, Anti-Graffiti coating present
Surface Preparation:	SP1/SP3
Generic Coating System:	Prime Coat: Aluminum and Micaceous Iron Oxide Filled Urethane Finish Coat: Polyaspartic Urethane

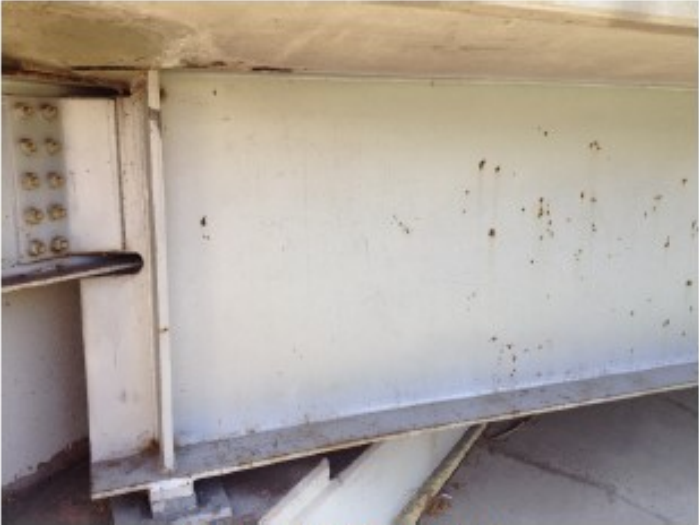
Pre-Existing Conditions

Test Location Number:	5
Existing Conditions:	Fair to Severe rusting in localized areas, mild to no pitting present, average dry film thickness of 10.8 mils DFT
Surface Preparation:	SP1/SP2/SP3
Generic Coating System:	Prime Coat: Mastic Waterborne Acrylic Finish Coat: HDP Acrylic Polymer

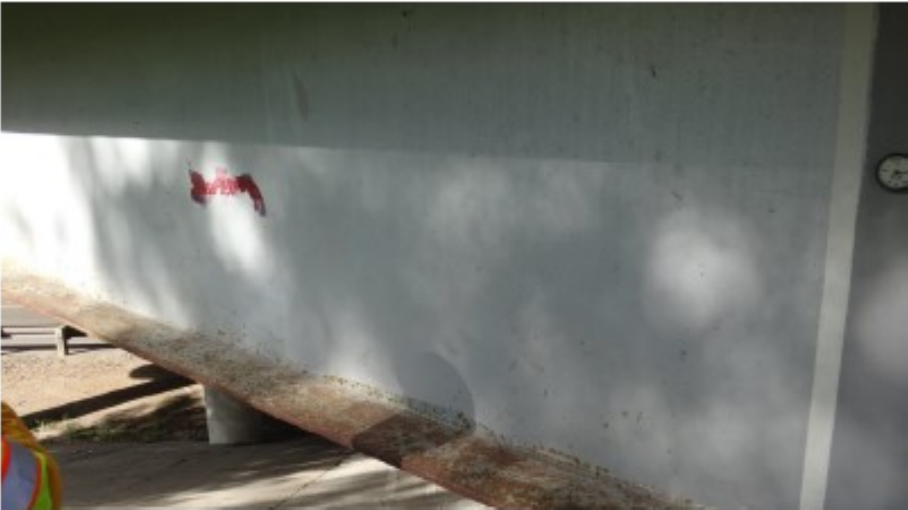
Pre-Existing Conditions

<b>Test Location Number:</b>	Additional Test Patches A, B, C, D
<b>Existing Conditions:</b>	Slight to severe rusting in localized areas, mild to no pitting present, average dry film thickness of 11.5 mils DFT
<b>Surface Preparation:</b>	SP1/Spot SP2
<b>Generic Coating System:</b>	A: Epoxy Mastic B: Aluminum Filled Polyamine Epoxy C: Polyamide Epoxy D: Mastic Waterborne Acrylic
