Infrared Thermography and the Delamtect: A Comparison of Methods for Locating and Measuring Delaminations

Office of Research and Development Minnesota Department of Transportation

In-Depth Report

BRIDGE # 9340 (SQUIRT BRIDGE)

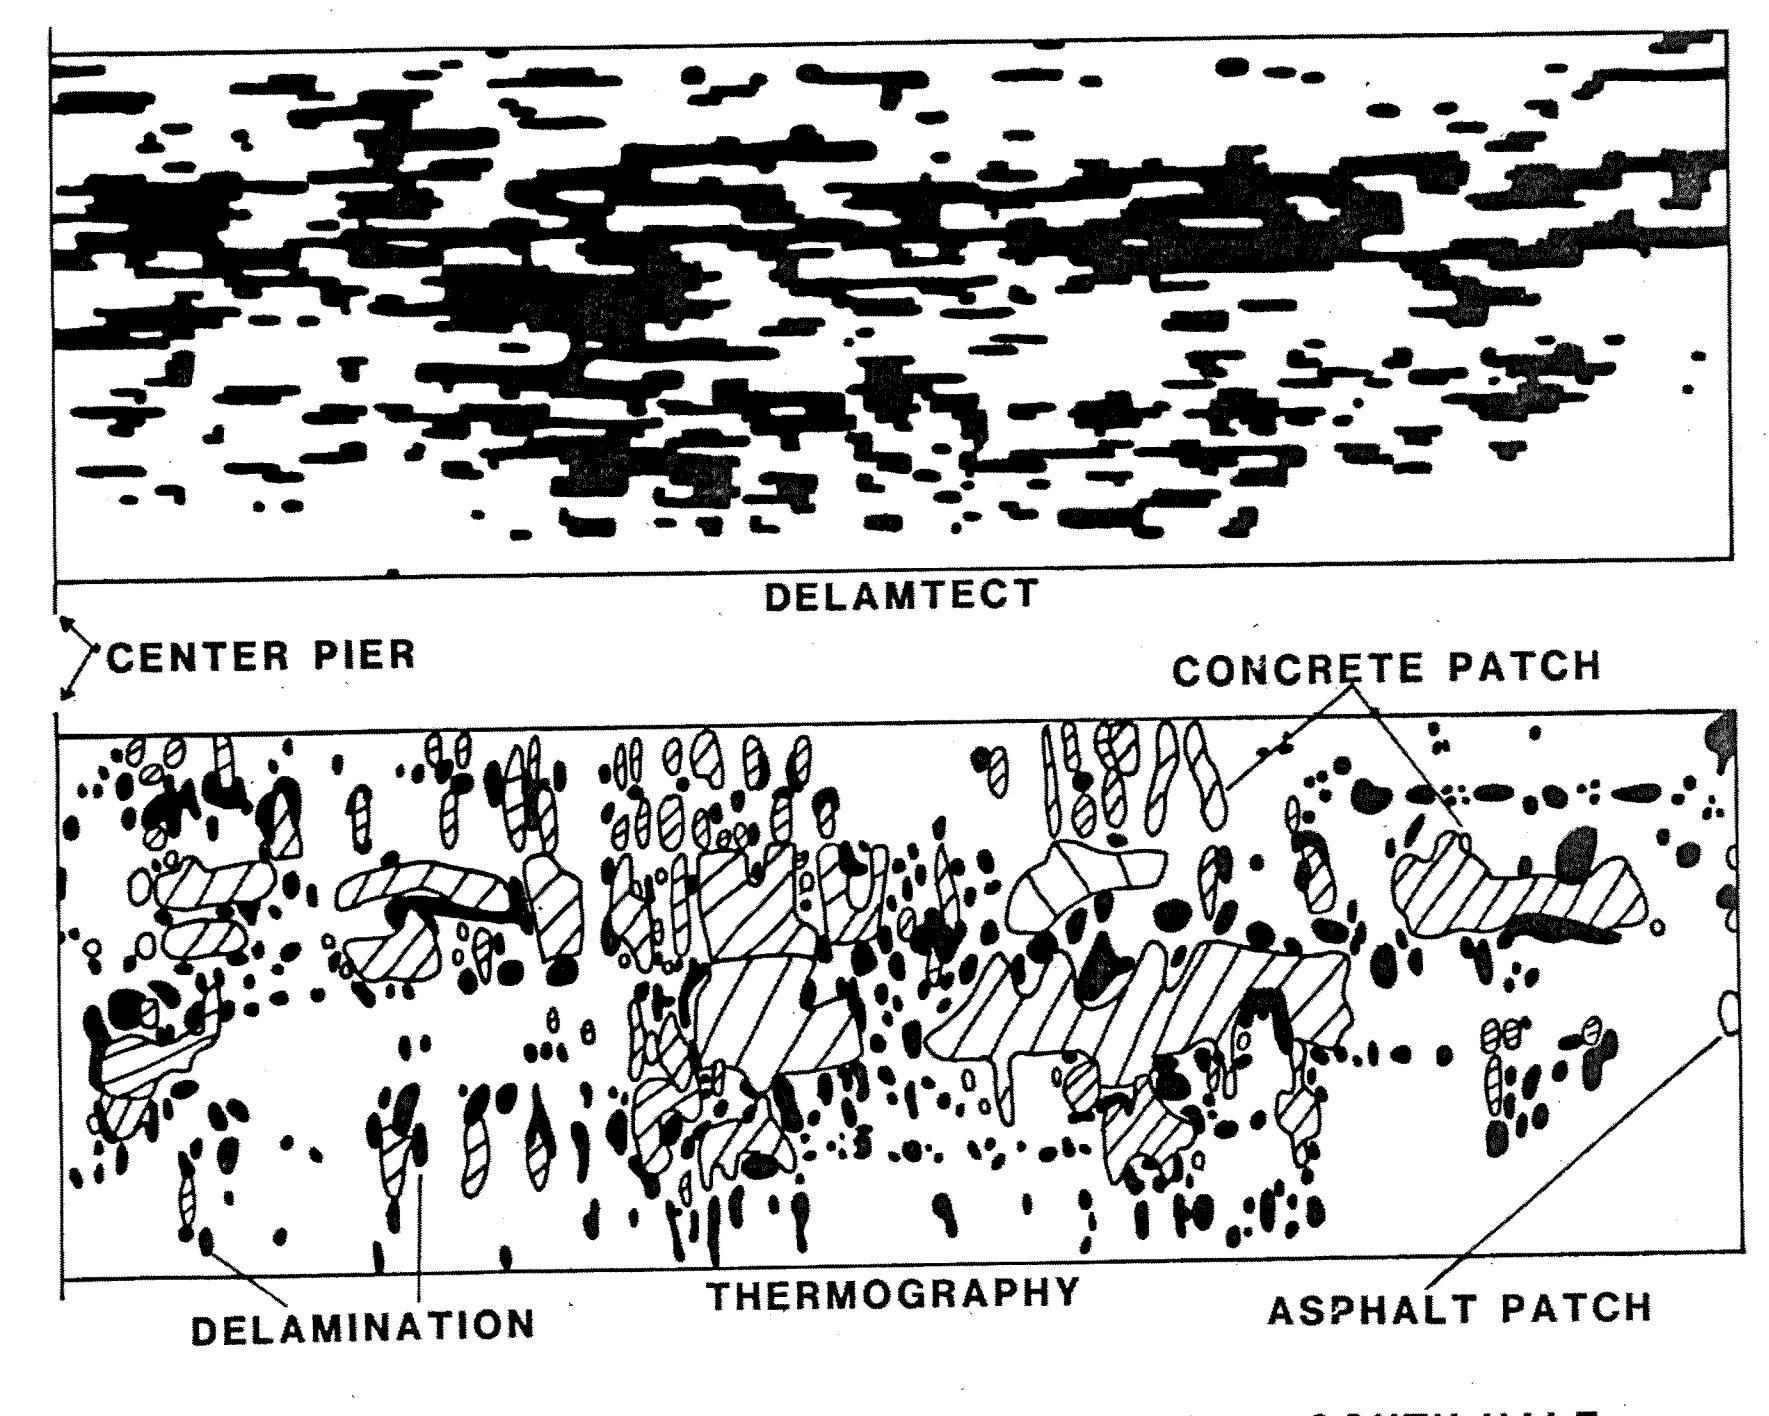
FIGURE 10. PARK AVENUE OVER I-35W/I-94 - SOUTH HALF

Infrared thermography found 10.1% of the deck area to be delaminated. Another 13.4% was patched. The Delamtect found 21.2% of the deck area to be delaminated. The results are shown in Figures 10 and 11. This deck has been patched with both concrete and bituminous. Concrete patches are usually sound and bituminous patches unsound when surveyed with the Delamtect. If the bituminous patches are included with the delaminations found by infrared thermography the results would compare favorably with the Delamtect findings.

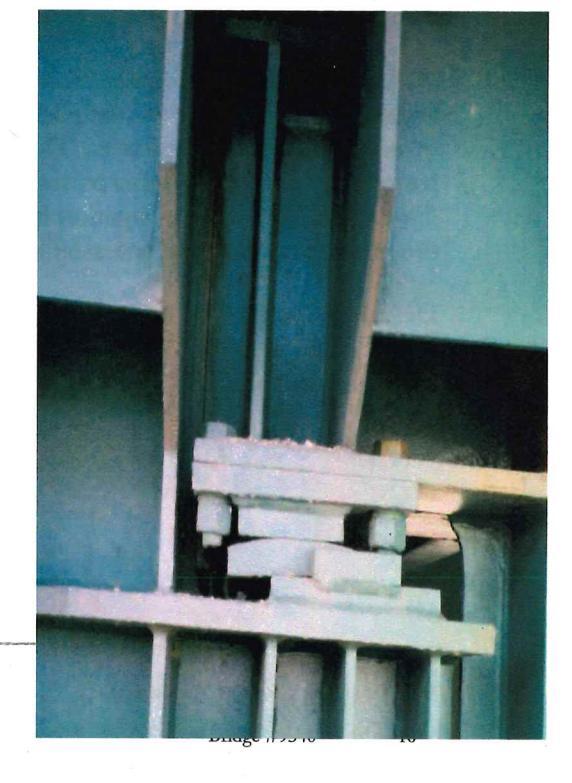
loss, moderate surface pitting; debris has begun to build up on hinge area. Additionally, the tops of the beam ends are contacting at the top flange or at the web along this joint. [94/2005] All hinge assemblies are expanded beyond tolerance; sliding plates extend 4" or more beyond the base plates, reducing bearing capacity. At beam #10, the sliding plate has tipped, falling off the base plate, and is preventing the joint from opening. [2005] Hinges should be flushed.

Sliding Plate @ West Fascia

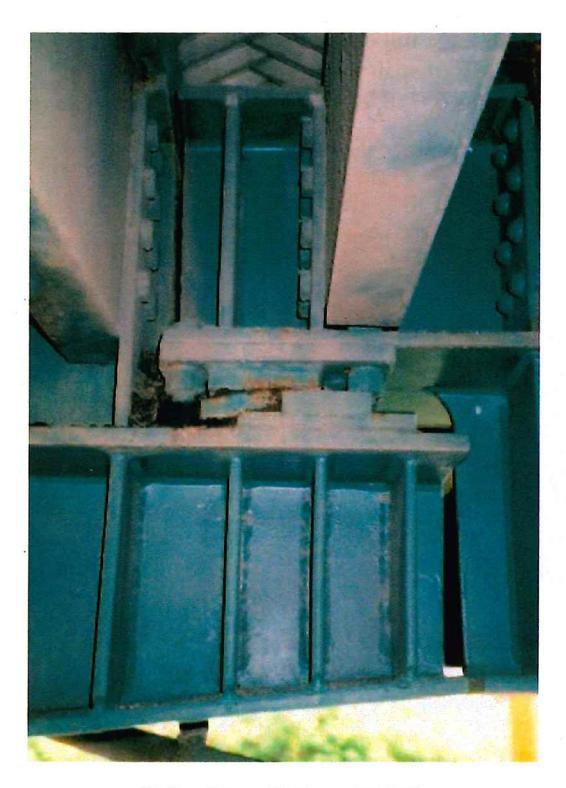
Sliding Plate @ Beam 5 NBL

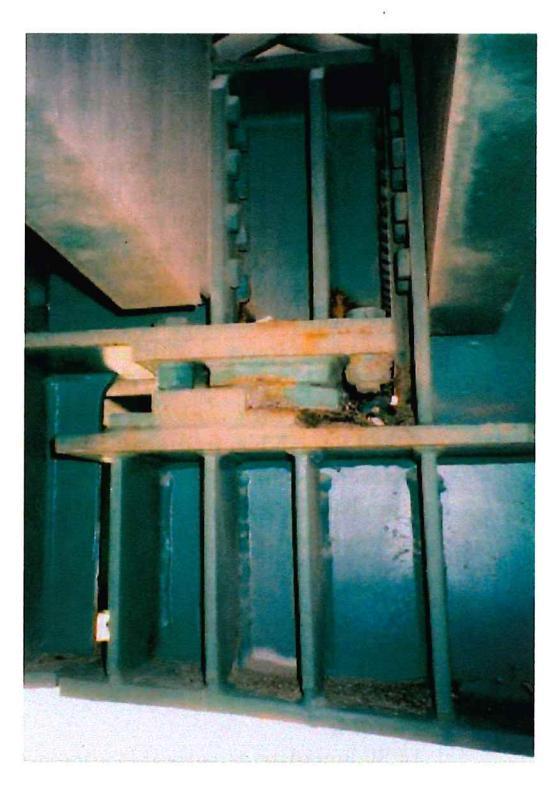
Sliding Plate @ Beam 6 NBL

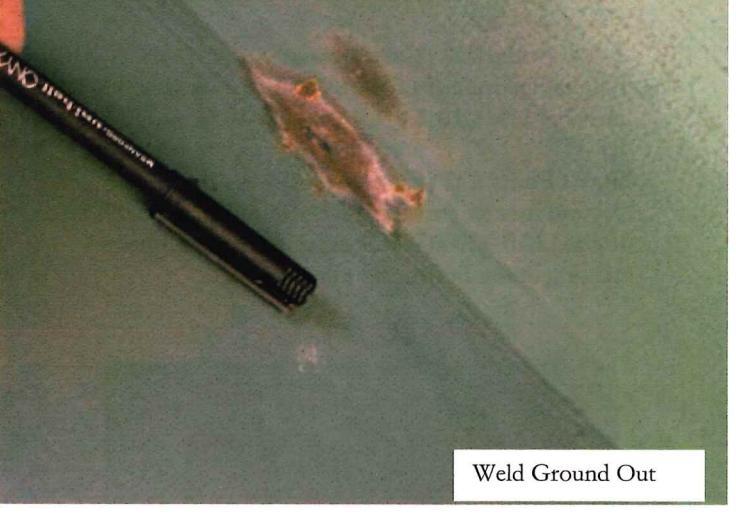
Panel Point #12 (East Truss):

[1999] Truss bottom chord member L12/L13 has a cracked tack weld at an interior stiffener. [2004] Ground out pit from past inspection.

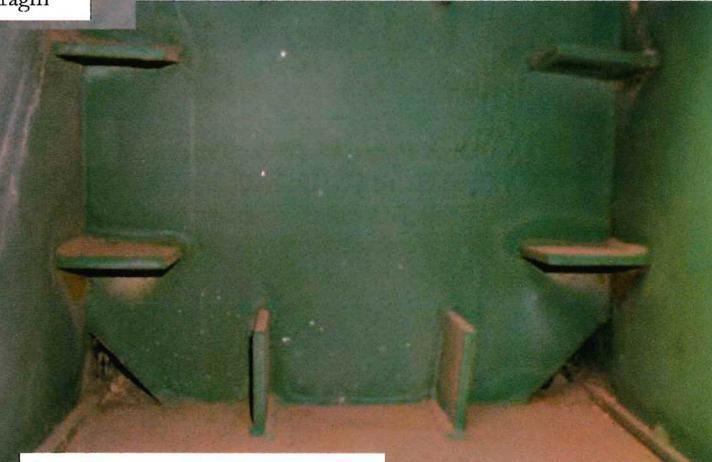
the top interior corners of member. See photo. Bottom chord L4/L5 has no diaphragm tabs, full weld on side & tack welds on other. See photo. Diagonal member L3/U4 has 4 diaphragms with tabs. See photo.

Diaphragm at Member L3 U4

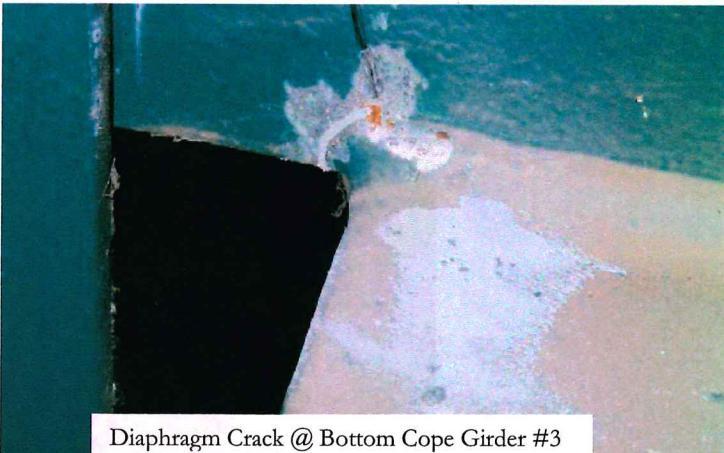
active railroad tracks below. [1999] Refer to Appendix "A" First Diaphragm South of Pier #9 graph for crack locations, description & repair to the diaphragm line. Girders 6, 7, 8, 9, & 10 are re-painted. Lateral bracing welded to web & stiffener. [2003] Bottom of deck has conduit on the east side. [2004] Girder 1C (NBL), crack at the diaphragm bottom cope, NE side measures 2" ("front face") and NW side measures 2-1/2"("Back face"). Girder 3 (NBL), crack at the diaphragm bottom cutout, measures 1-1/2" (both sides). [1998/2004] Girder #3 has a "tear" in the girder's web at the diaphragm girder connection. The "tear" measured 42" long on one side and 12" long on the other, was caused by out of plane bending between the diaphragm and the girder. Girder Connection Lowered & Girder Web Repaired with Splice Plate. [2002/06] Underside of deck has 260 SF of water saturation, & 4 SF of delamination. [2006] Girder #12 has paint failure from leaking de-icing system.

Water Saturation SB Bays 12, 13 & 14

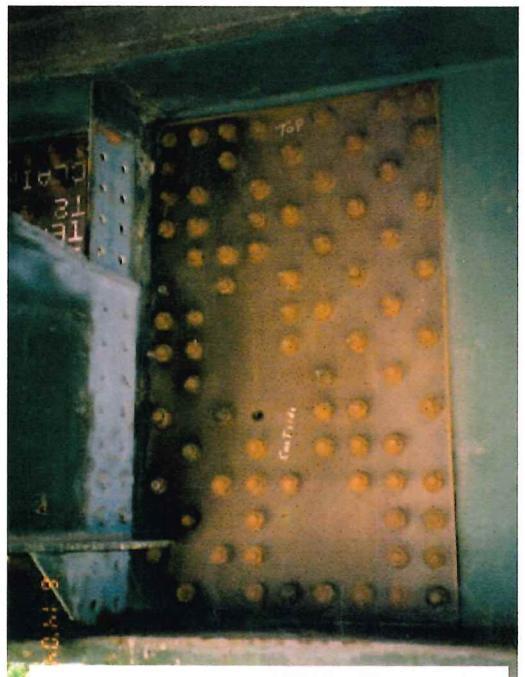
Web "Tear" G #3 @ Diaph Looking West
