## DEPARTMENT OF TRANSPORTATION

# Comprehensive Field Evaluation of Asphalt Patching Methods and Development of Simple Decision Trees and a Best Practices Manual

## June 2017

Research Project Final Report 2017-25 To request this document in an alternative format, such as braille or large print, call <u>651-366-4718</u> or <u>1-800-657-3774</u> (Greater Minnesota) or email your request to <u>ADArequest.dot@state.mn.us</u>. Please request at least one week in advance.

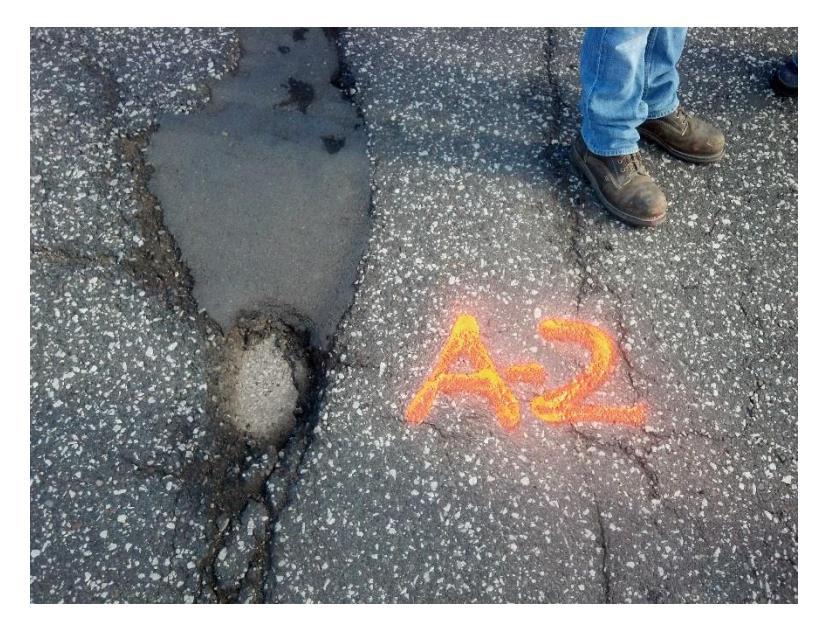
Figure 3.2 Pothole A-2 prior to Patching (After Cleaning).

Pothole A-2: This pothole was located in the non-wheel path of the driving lane. The pothole lies along a large transverse crack with the north face of the pothole being a previously placed patch material as shown in Figure 3.2. The pothole was prepped by sweeping. The size of the pothole was 13 inches x 9 inches x 2 inches.

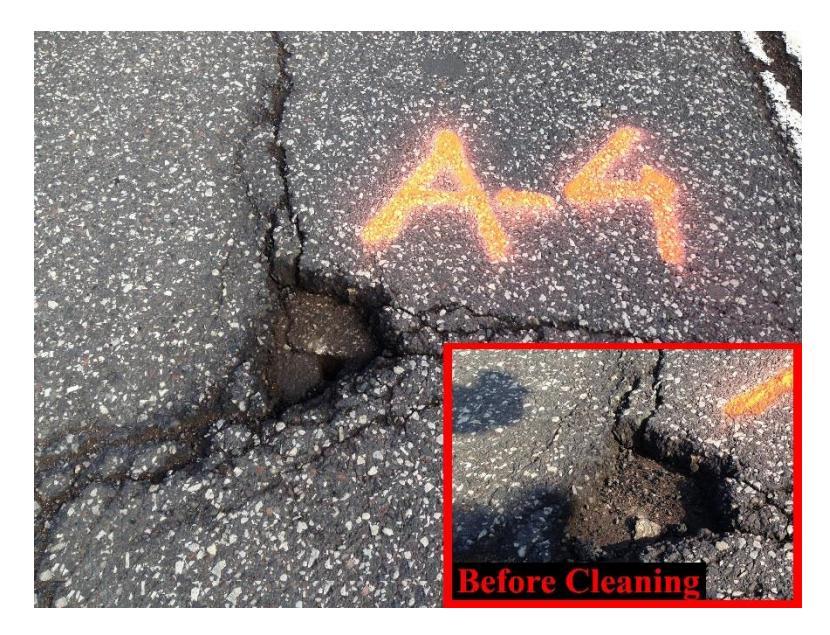
Figure 3.4 Pothole A-4 prior to Patching (Before and After Cleaning).

Pothole A-4: This pothole was located in the non-wheel path of the driving lane. The pothole exists at the intersection of a reflective longitudinal and transverse crack as shown in Figure 3.4. The pothole was prepped using compressed air. The size of the pothole was 10 inches x 10.5 inches x 1.5 inches.

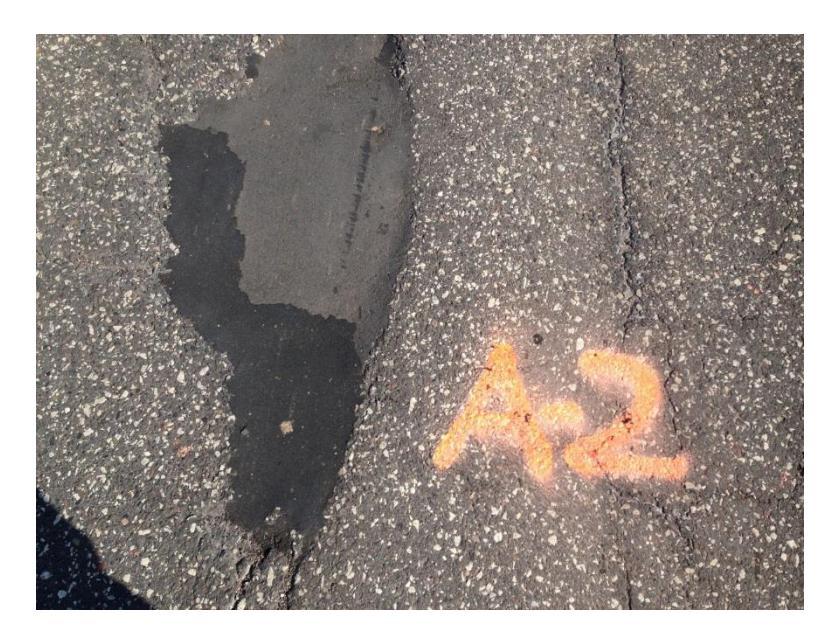
Figure 3.11 through Figure 3.20 provide some photographs of the patches taken at different times to demonstrate how cold mix patches aged over time. It appears that the largest change had occurred within the first three days after patching installation while the cold mix material was still compressing under self-weight and traffic loads. Loose material around the patch edges was also removed during this time. Minimal material was removed after the initial three days.

Figure 3.11 Pothole A-2 (3 Days after Patching).

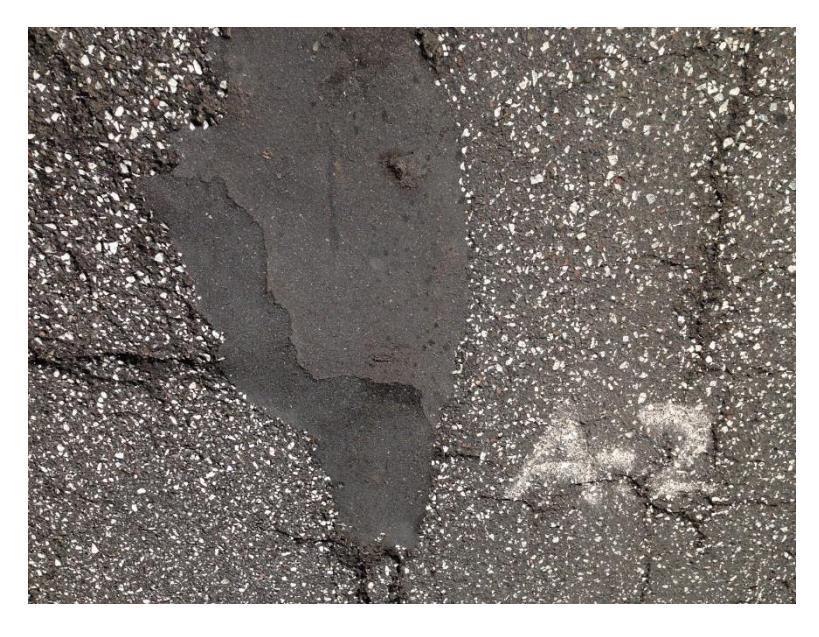
Figure 3.12 Pothole A-2 (149 Days after Patching).

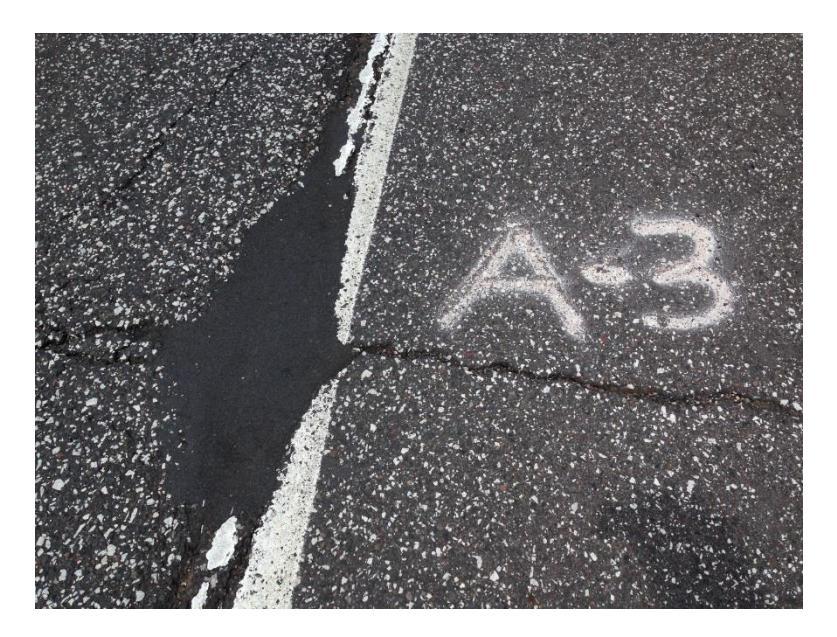
Figure 3.13 Pothole A-3 (149 Days after Patching).

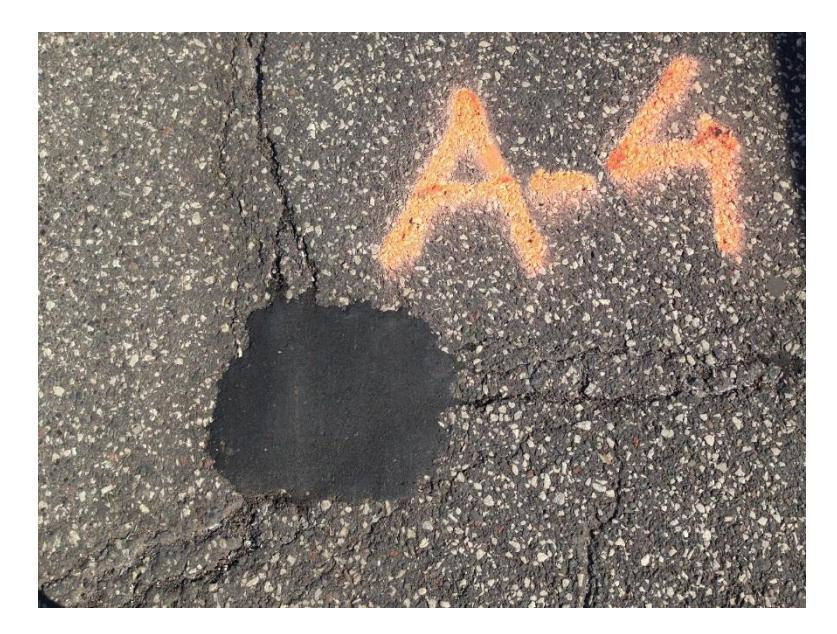
Figure 3.15 Pothole A-4 (3 Days after Patching).

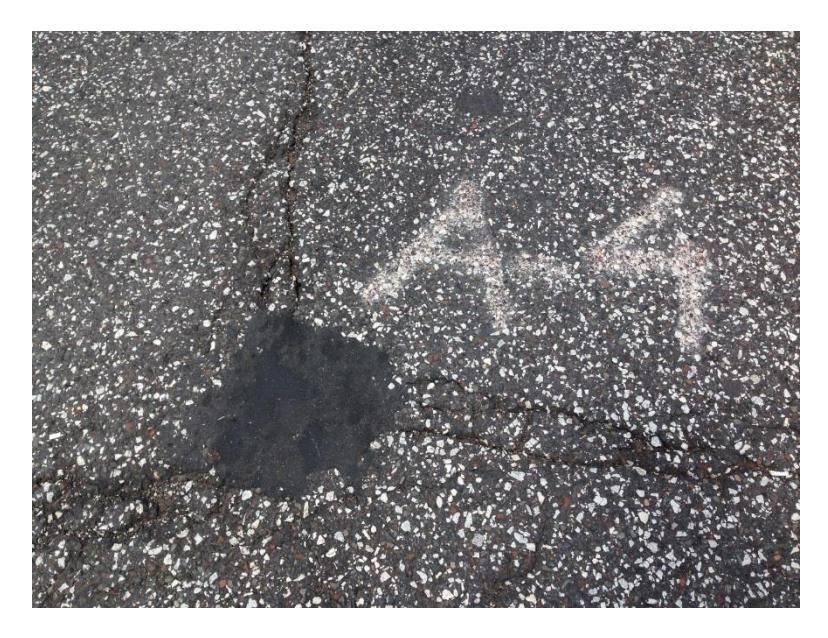
Figure 3.16 Pothole A-4 (149 Days after Patching).

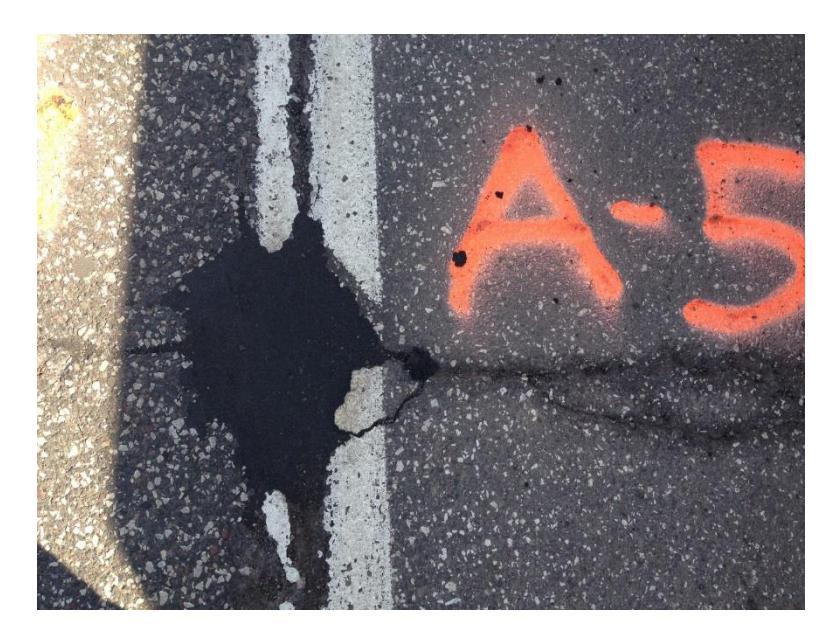
Figure 3.17 Pothole A-5 (3 Days after Patching).

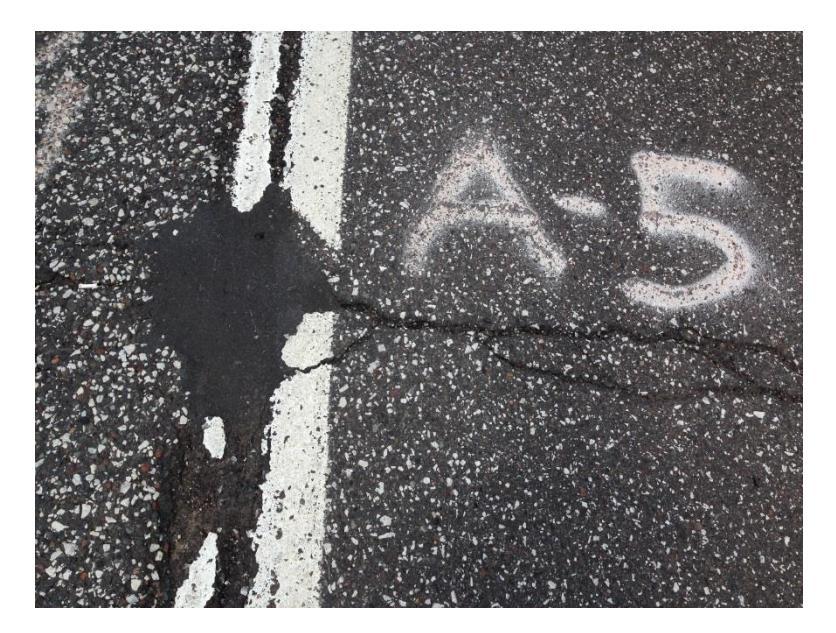
Figure 3.18 Pothole A-5 (92 Days after Patching).

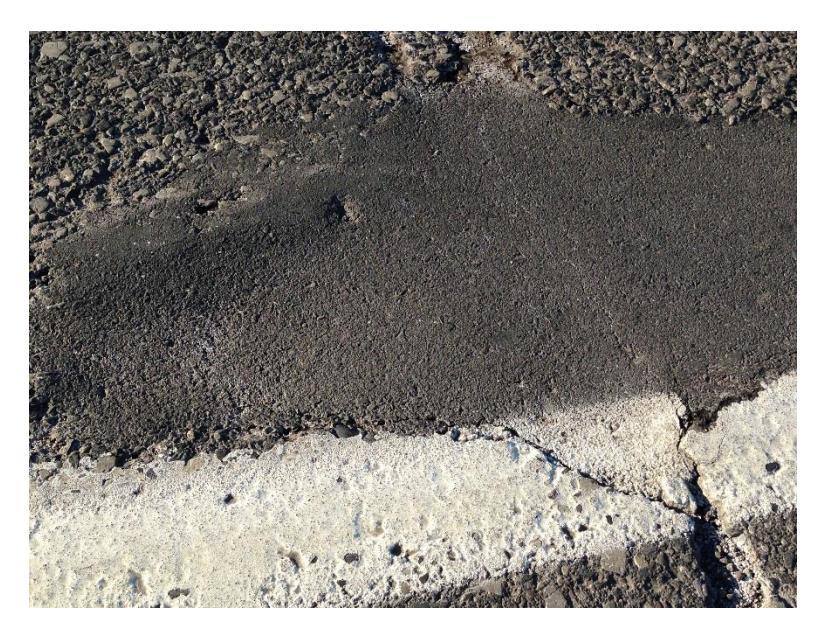
December 4, 2014, it was observed that the pothole A-5 experienced a significant depression in the material since the last visit, as well as some material loss near the bottom of the patch (Figure 3.20).

Figure 3.20 Pothole A-5 (240 Days after Installation).
## 3.2.1.2 Retention Analysis

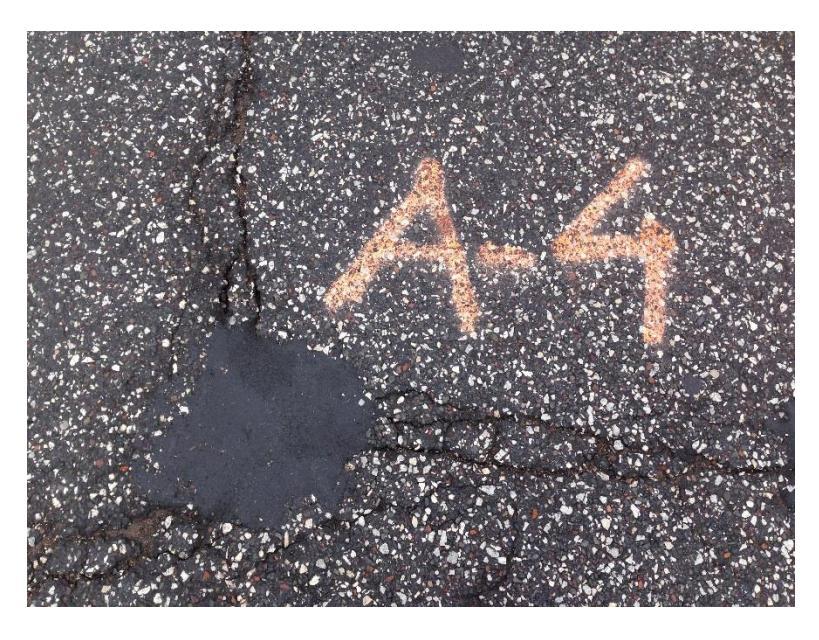
**Pothole A-4:** Two different site visit dates were used to calculate the retention of material. The dates of comparison are April 29, 2014 (Figure 3.21) and July 9, 2014 (Figure 3.22). During that 71 day time span, the patch lost was approximately 13% of its surface area. The material lost was mostly extra patch material overlaying the existing road. The entire pothole was still patched and protected from moisture.

Figure 3.21 Image used for A-4 Retention Calculation (4/29/14).

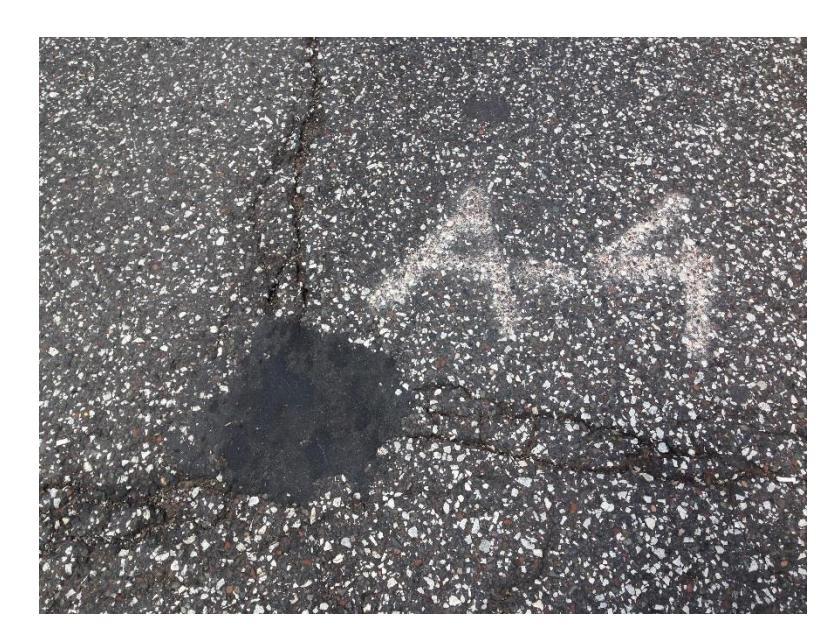
Figure 3.22 Image Used for A-4 Retention Calculation (7/9/14).

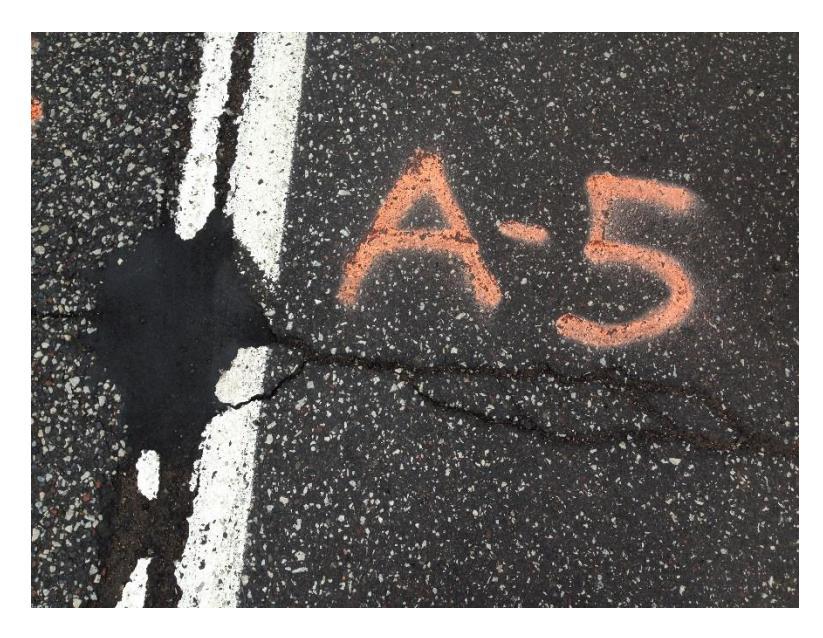
**Pothole A-5:** Three different site visit dates were used to calculate the retention of material. The dates of comparison are April 29, 2014 (Figure 3.23), July 9, 2014, and December 4, 2014 (Figure 3.24). Over time this patch lost a bit of material at the bottom. The total amount of material lost from April 29 to December 4 (219 days) was 17%.

Figure 3.23 Image Used for A-4 Retention Calculation (7/9/14).

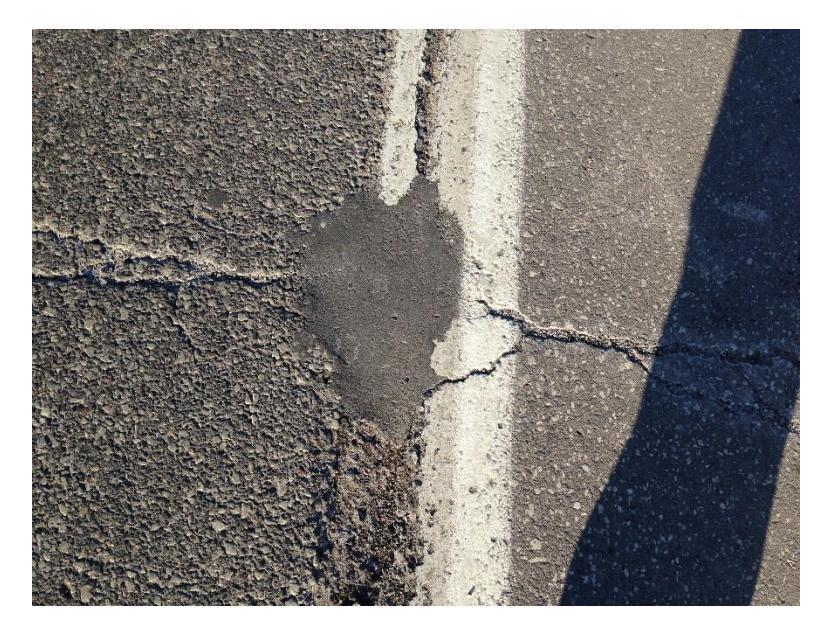
Figure 3.24 Image Used for A-5 Retention Calculation (12/4/14).

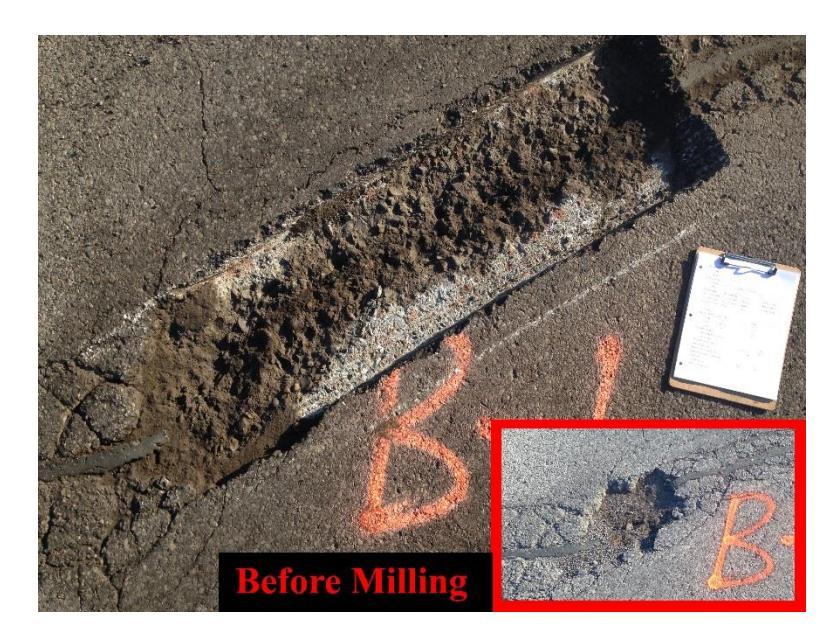
Pothole B-1: This pothole was located in the wheel path of the driving lane. The pothole lied along a large longitudinal crack with alligator cracking. The pothole was prepped with compressed air. The size of the pothole patch was 57 inches x 16 inches x 2.5 inches.

Figure 3.25 Pothole B-1 before and after Milling.

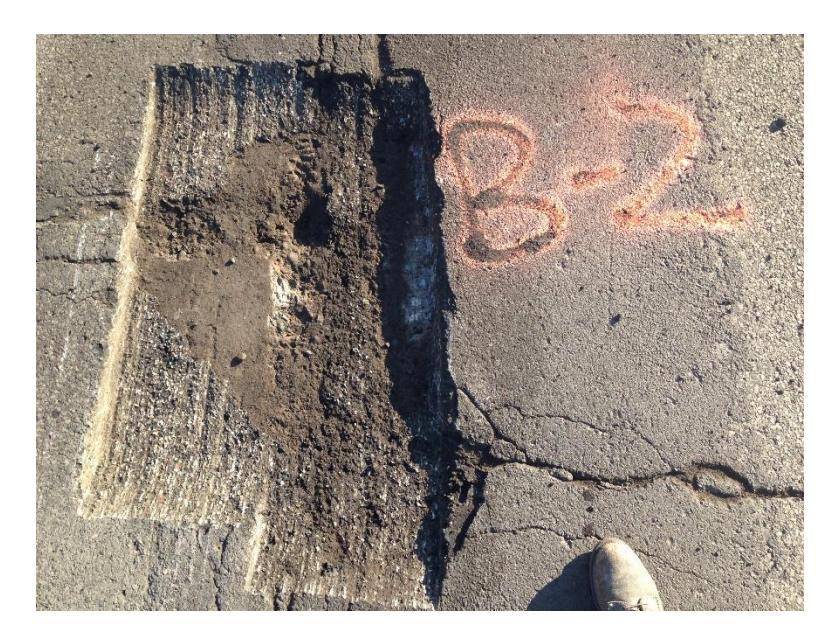
Pothole B-2: This pothole was located in the wheel path of the driving lane. The pothole lied along a large longitudinal crack with alligator cracking. Two transverse cracks ran through the pothole location. The pothole was prepped with compressed air. The size of the pothole patch was 45 inches x 30 inches x 3 inches.

Figure 3.26 Pothole B-2 after Milling.

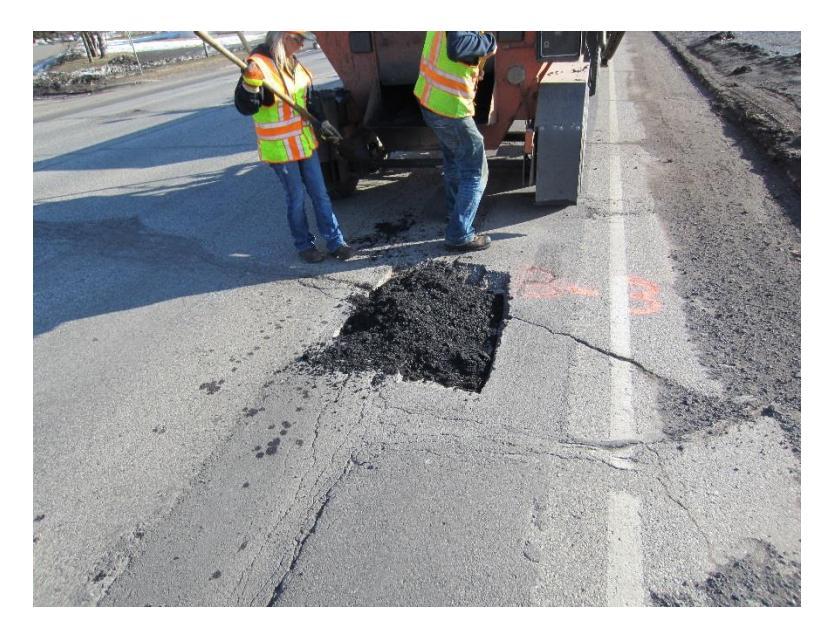
Pothole B-3: This pothole was located in the wheel path of the driving lane. The pothole lied along a large longitudinal crack with alligator cracking. A transverse crack ran through the pothole location. The pothole was prepped with compressed air. The size of the pothole patch was 47 inches x 34 inches x 3 inches.

Figure 3.27 Pothole B-3 while Filling with Cold Mix Material.

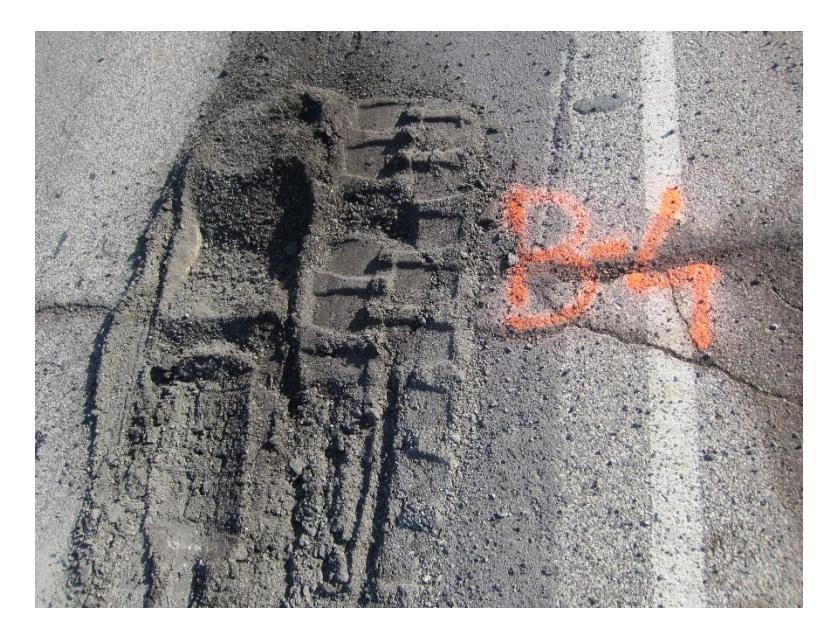
Pothole B-4: This pothole was located in the wheel path of the driving lane. The pothole lied along a large longitudinal crack with alligator cracking. A transverse crack ran through the pothole location. The pothole was prepped with compressed air. The size of the pothole patch was 61 inches x 32 inches x 2.75 inches.

Figure 3.28 Pothole B-4 with Milling Debris Still in Place.

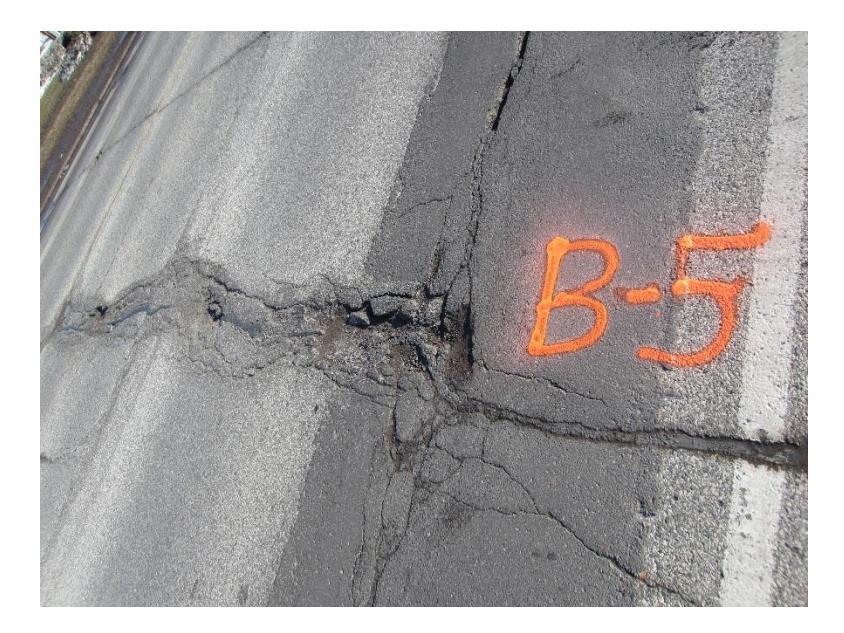
Pothole B-5: This pothole was located in the wheel path of the driving lane. The pothole lied along a large longitudinal and transverse crack with alligator cracking. The pothole was prepped with compressed air. The size of the pothole patch was 52 inches x 103 inches x 2 inches.

Figure 3.29 Pothole B-5 before Milling.

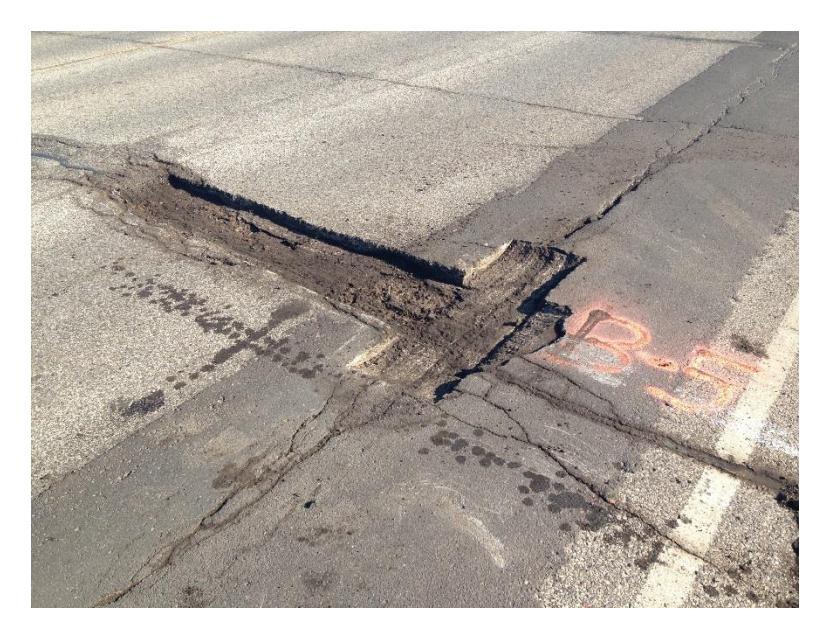
Figure 3.30 Pothole B-5 after Milling.

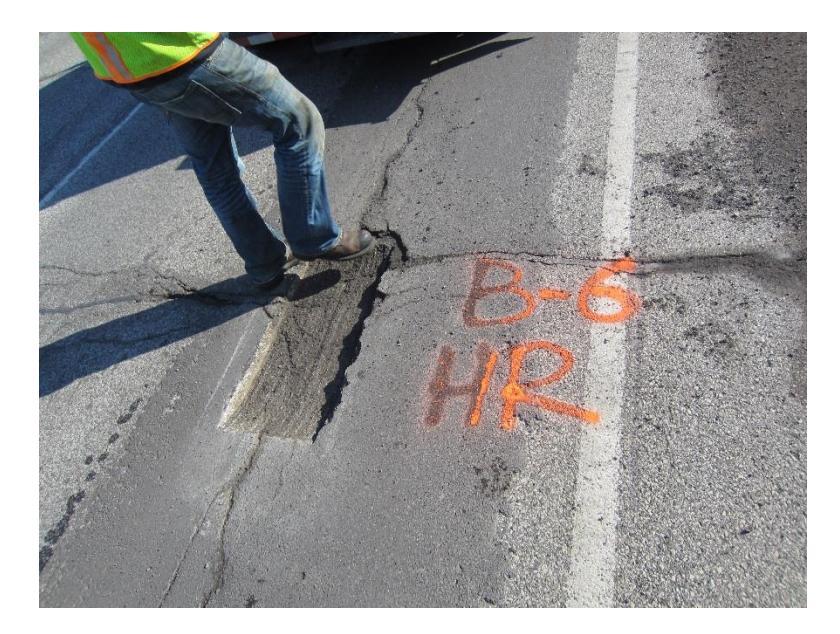
Pothole B-6: This pothole was located in the wheel path of the driving lane. The pothole lied along a large longitudinal crack with alligator cracking. The pothole was prepped with compressed air. Hot recycled asphalt millings were used to patch the pothole. The size of the pothole patch was 36 inches x 16 inches x 2 inches.

Figure 3.31 Pothole B-6 after Milling.

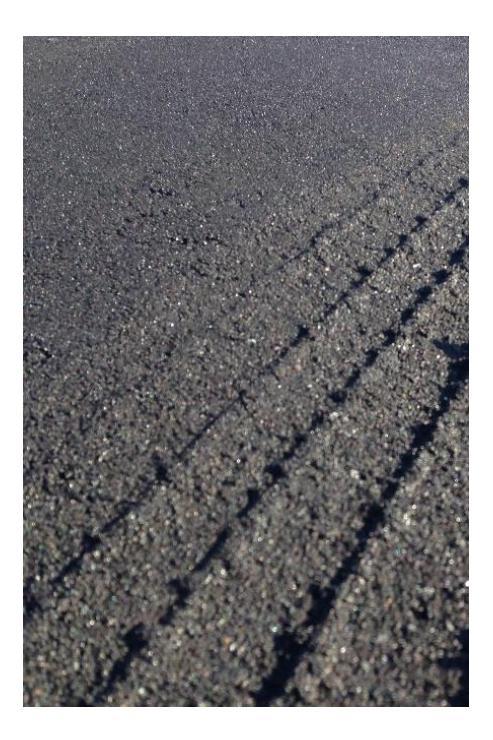
Figure 3.33 Settlement (Dishing) of Pothole B-2 an Hour after Compaction.

The cold mix patches at Site-B performed similar to Site-A. One difference at this site was the existence of significant dishing. After compaction, the potholes were flush with the roadway, however within the first hour several of the potholes had settled below the roadway surface. The depressed material is along the right edge of the crack. Pothole B-2 which suffered the most dishing was about ½ inch below the roadway surface within an hour (Figure 3.38).

The reason for this depression was due to the depth of the patch filled. Cold mix has a small aggregate size paired with a slow curing asphalt binder. These two factors prevent the patch material from forming a stiff structure. When the pothole depth is too large, like Pothole B-2, the patch material cannot support itself. This did not occur at Site-A, because all potholes had a depth less than two inches. Dishing is common in these patches along the edges due to the inability for hand compactor machinery to properly compact along the interface. The compactor rests on the existing roadway during the compaction process preventing a complete compaction along the patch interface. Over time this area compresses under self-weight and creates the dished area shown in Figure 3.38 through Figure 3.41. After three days the patches appeared to reach their steady state compaction level. Minimal material was lost after those three days.

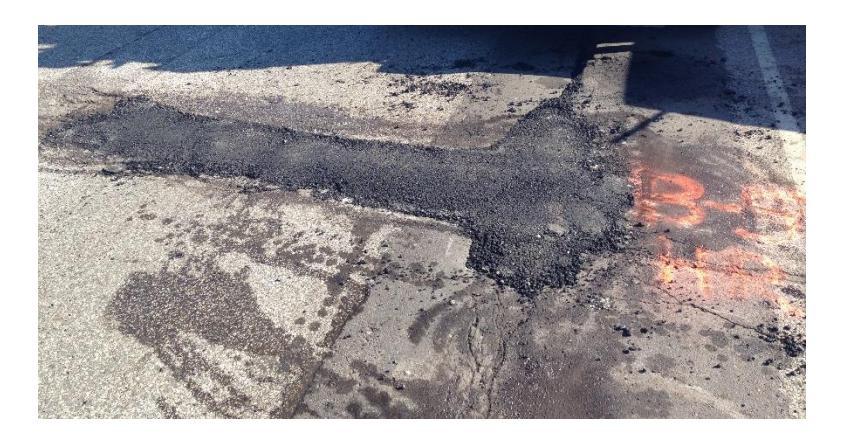
Figure 3.34 Pothole B-5 after Patching.

It may be stated that unlike the site A, all potholes were milled using a skid steer and cleaned using compressed air. Potholes B-1 through B-4 were patched using cold mix with a mix temperature of 50°F. Potholes B-5 and B-6 were patched using hot recycled asphalt. The material was 100% recycled millings from a previous project. The millings were heated to 295°F using the Stepp SRM 10-120 machine. While heating an additional 1.5 gallons of asphalt binder was added to the pug mill per 1,000 pounds of millings. Once the patches were placed they were tamped using a single plate compactor. After compaction, the potholes were flush with the roadway. Figure 3.31 to Figure 3.35 show some photographs of patched potholes. It may be stated that within the first hour, several of the potholes had settled below the roadway surface. Pothole B-2 (Figure 3.33) was about ½ inch below the roadway surface within an hour. It takes fifteen to twenty minutes to complete a pothole from milling to compaction. The patch material placed in pothole B-6 (Figure 3.35) was the first mix to come out of the SRM 10-120 hopper. It cooled more rapidly than the mix placed in B-5 (Figure 3.34) and appeared to be drier.

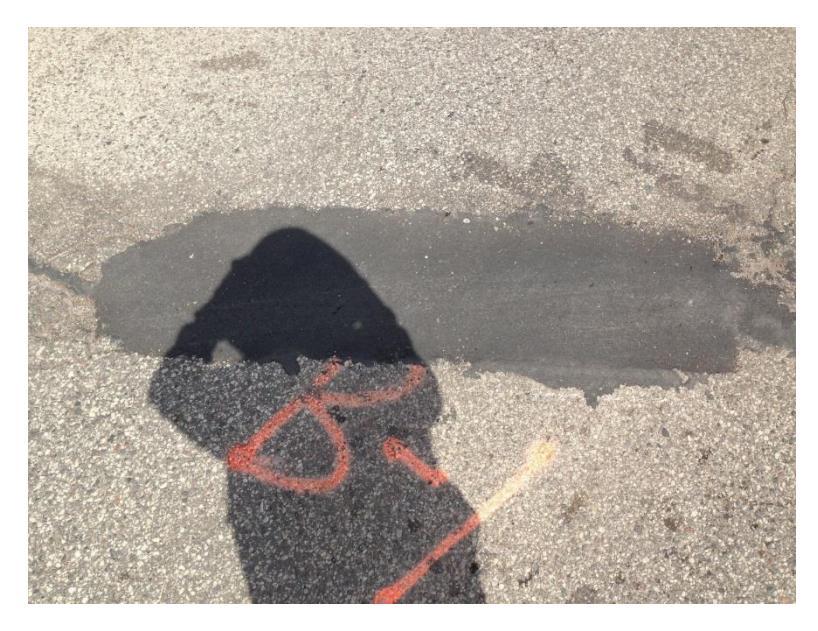
Figure 3.37 Pothole B-1 (3 Days after Patching).

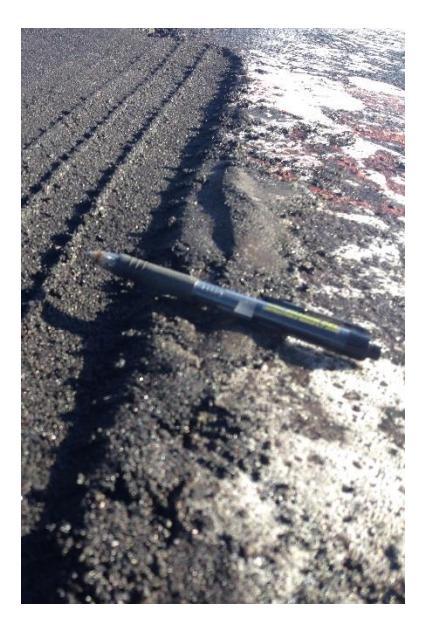
Figure 3.38 Settlement (Dishing) of Pothole B-2 an Hour after Compaction.

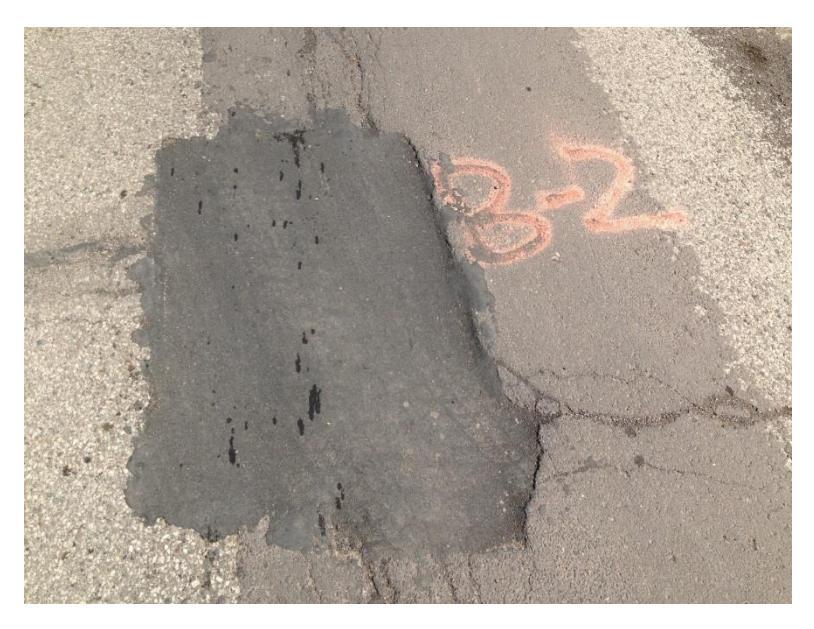
Figure 3.39 Pothole B-2 (3 Days after Patching).

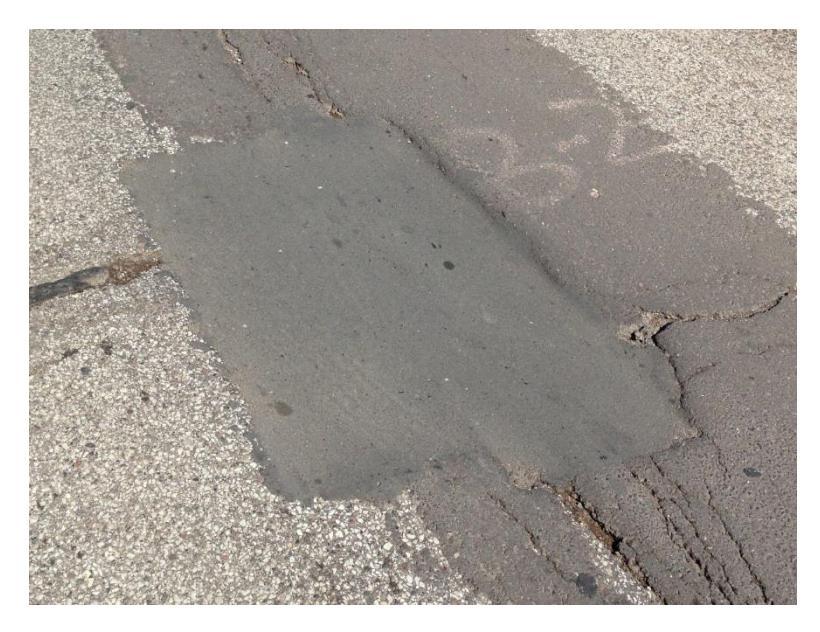
Figure 3.40 Pothole B-5 (146 Days after Patching).

An insignificant amount of additional oil was mixed into the millings to help rejuvenate the mix. For this mix 1.5 gallons of asphalt oil was added to approximately 1000 pounds of mill tailings. The result was a patch material that aged and oxidized at a rapid rate. This aging is visually apparent over time as shown in the Figure 3.42 to Figure 3.48. Raveling was a common distress due to the aged binder and significant material was lost along the edge and surface of the patches over time.

The placement of patch material actually facilitated further damage to the roadway. The damage occurring appears similar to pumping action that is common with concrete panels. As traffic loads travel across the patch area there is not an efficient load transfer causing vertical movement of the patch material. This movement ejects water and fine material from underneath the patch and abrades the adjacent roadway. Comparing Figure 3.43 and Figure 3.44 illustrates that damage to the roadway in Patch B-5. Figure 3.47 provides a close view of this deterioration in Patch B-6.

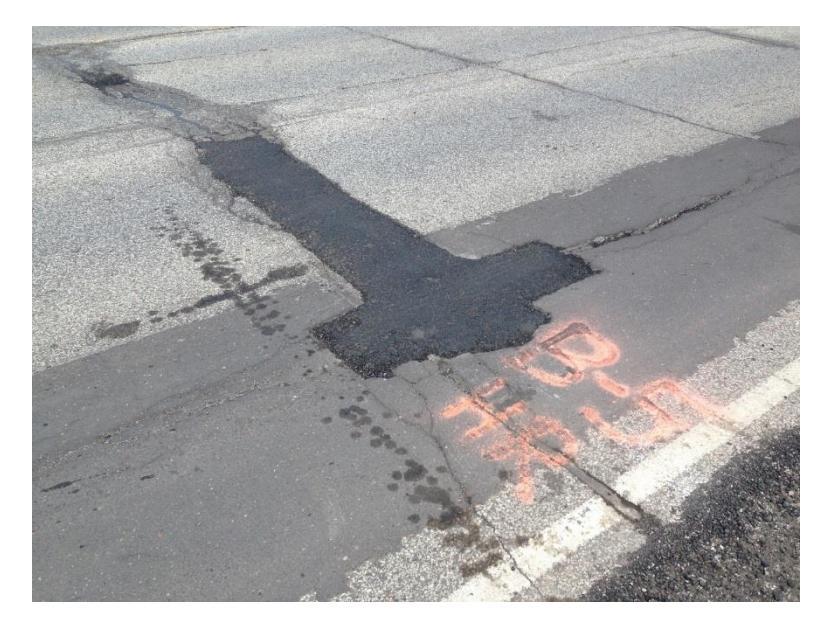
Figure 3.43 Pothole B-5 (3 Days after Patching).

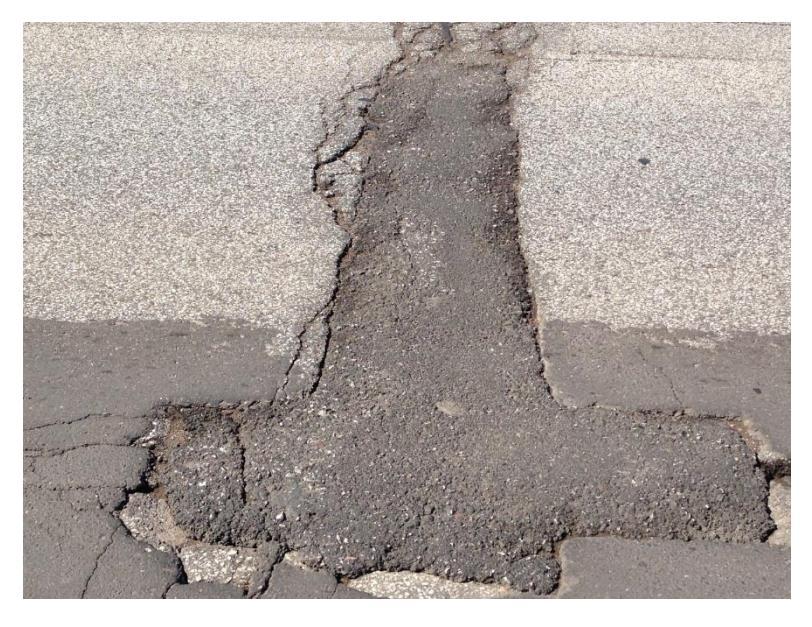
Figure 3.44 Pothole B-5 (146 Days after Patching).

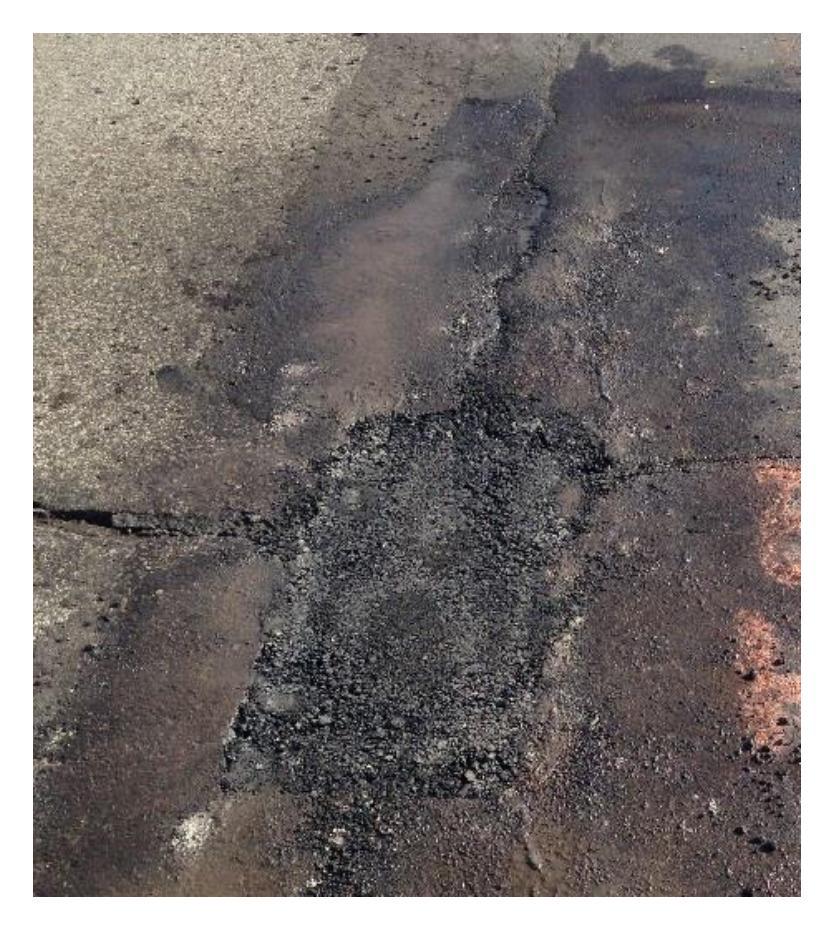
Figure 3.45 Pothole B-6 immediately after Patching.

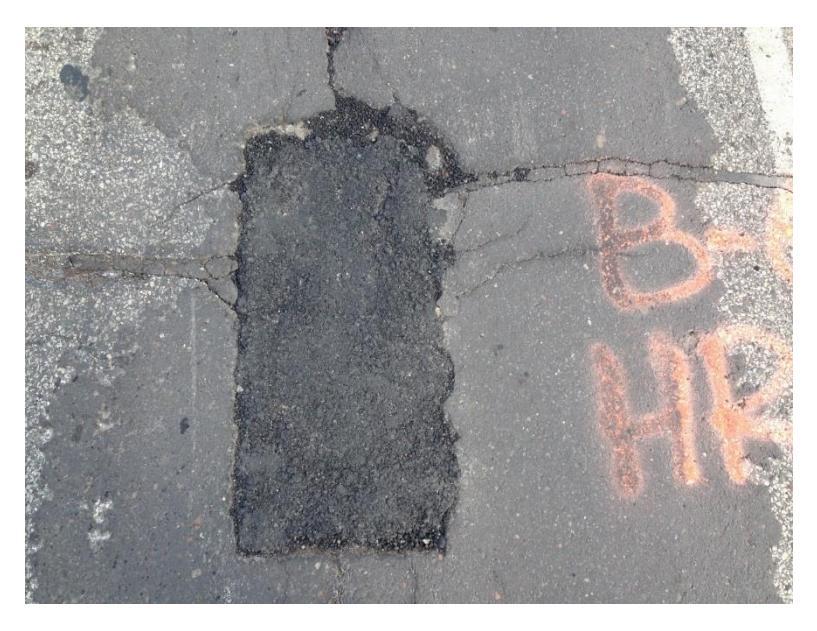
Figure 3.46 Pothole B-6 (3 Days after Patching).

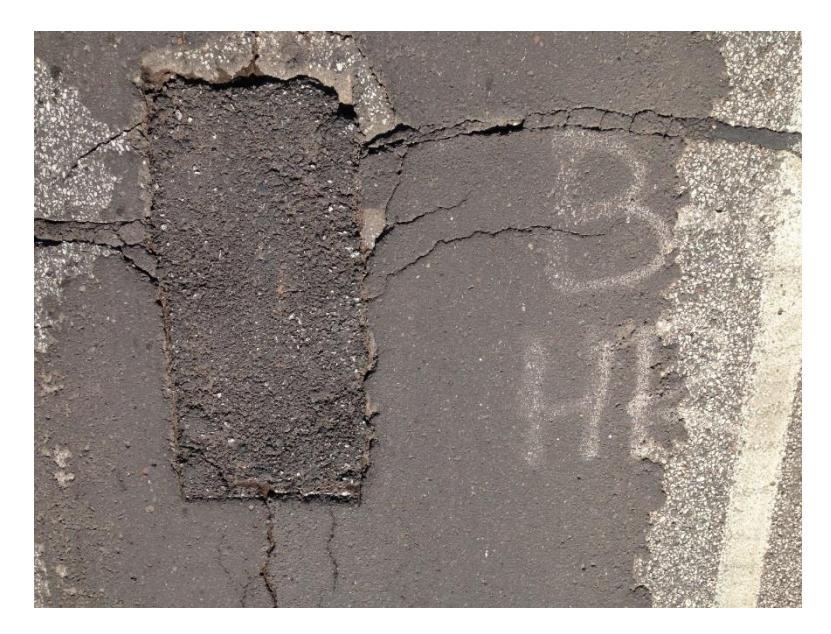
Figure 3.47 Pothole B-6 (146 Days after Patching).

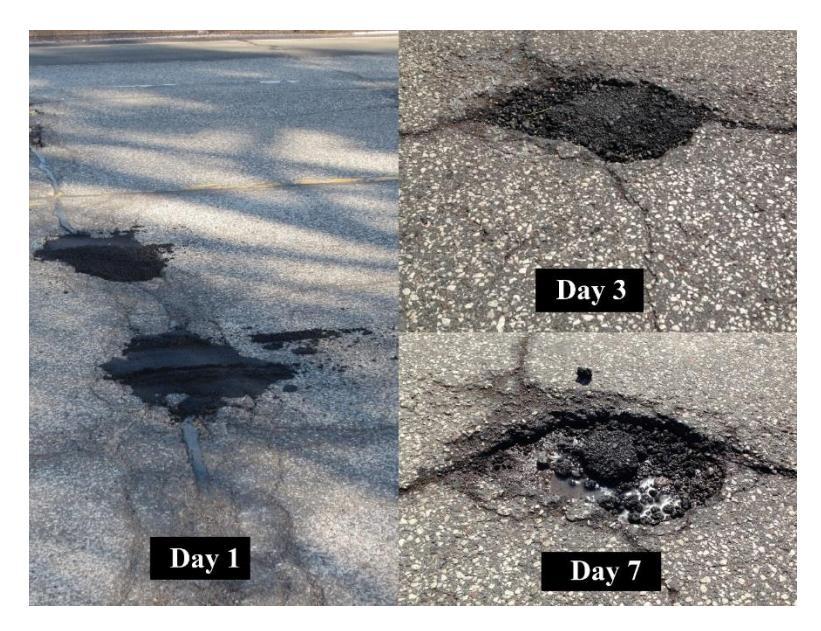
The importance of compaction is shown below in Figure 3.48. Extra hot recycled material was placed in smaller potholes in the wheel path. The potholes were not prepped before patching material was placed, and the material was only compacted under live traffic. As shown in Figure 3.48, the material was removed from the pothole after seven days. This serves as evidence that proper pothole preparation and patching material compaction can be the difference between a successful patch and a waste of resources. The last site visit conducted on December 4, 2014 (237 days after installation) showed that patches were affected by the first few uses of snow plows in the winter months.

Figure 3.48 Uncompacted Hot Recycled Material in Wheel Path.

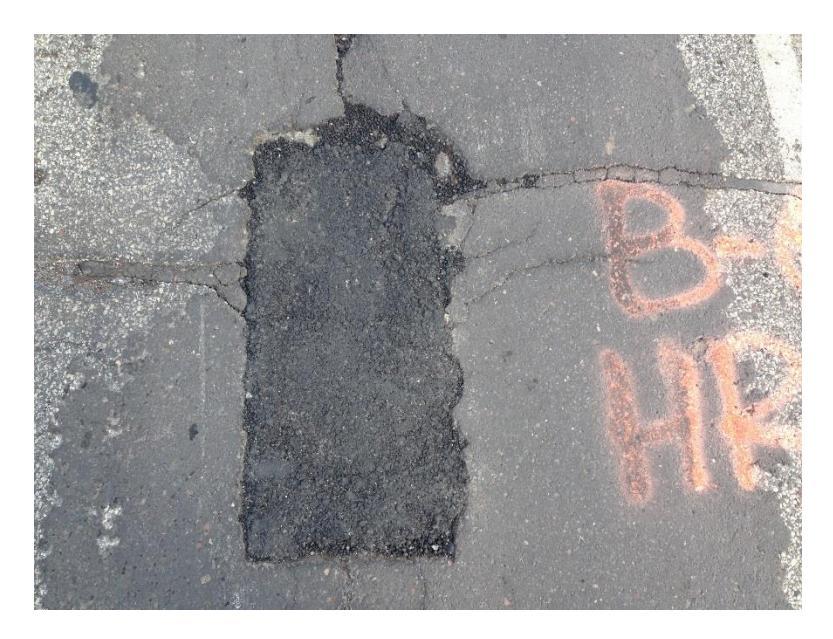
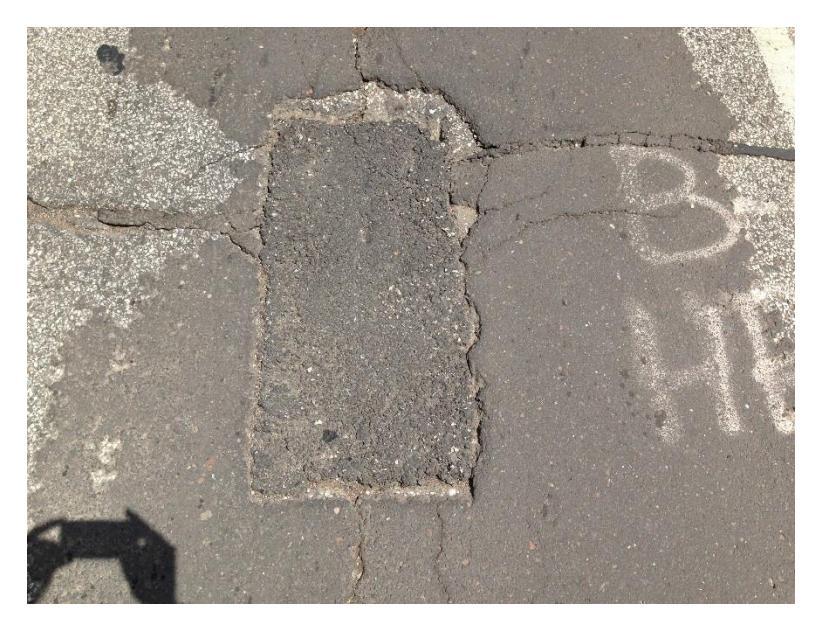
Two different site visit dates were used to calculate the retention of hot recycler material. The dates of comparison are April 14, 2014 (Figure 3.49) and July 9, 2014 (Figure 3.50). Unlike the two cold mix patches from Site-A, this patch lost a significant amount of material over time. The dry material previously discussed broke down over time and was removed from the pothole area. During this time (86 days) 19% of the patch material was lost. This percent only accounts for the material lost around the edge of the patch. The figures show that some material was also lost due to surface raveling.

Figure 3.49 Image Used for B-6 Retention Calculation (4/14/14).

Figure 3.50 Image Used for B-6 Retention Calculation (7/9/14).

It is not recommended that mill tailings are used as an aggregate with the hot recycle machine. The heating process is slow, the material comes out oxidized and ages quickly in the field, and there is a large presence of fine material in the mix, which can prevent the bond required between binder and aggregate. The additional oil added to the mix differs from the asphalt that exists in the mill tailings. The oil does not appear to rejuvenate the old asphalt but simply adds a negligible amount of new binder. This machine is best served as a mixer for creating a pothole patching material made of virgin sand and oil.

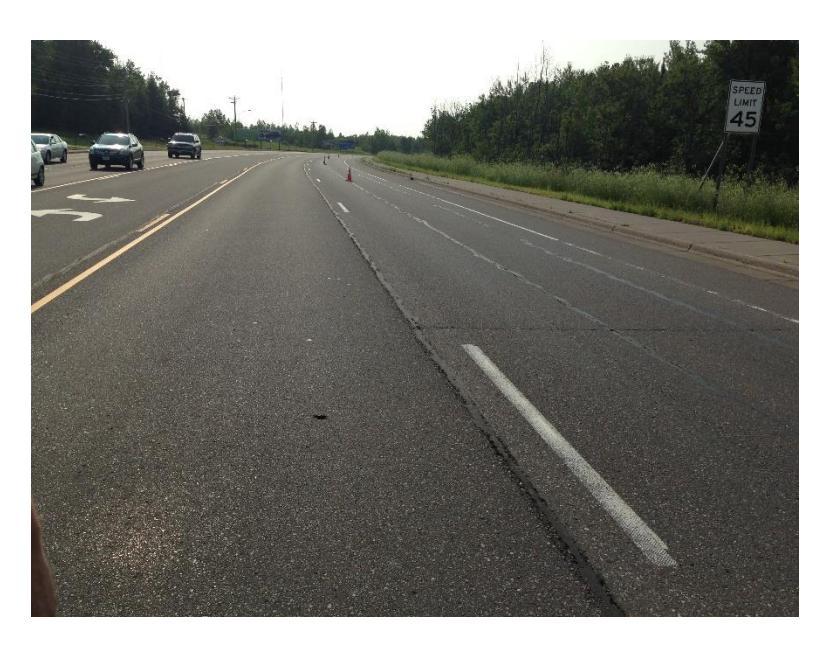
This roadway was distressed along the longitudinal joint (near centerline). The joint was a continuous crack with an average width of three inches. The crack was filled with sealer and raveling was present along the crack edges. Three locations (designated as D-1 through D-3) along the longitudinal crack were chosen to monitor the performance of hot mix asphalt patching materials.

Figure 3.55 Longitudinal Crack along Trinity Road.

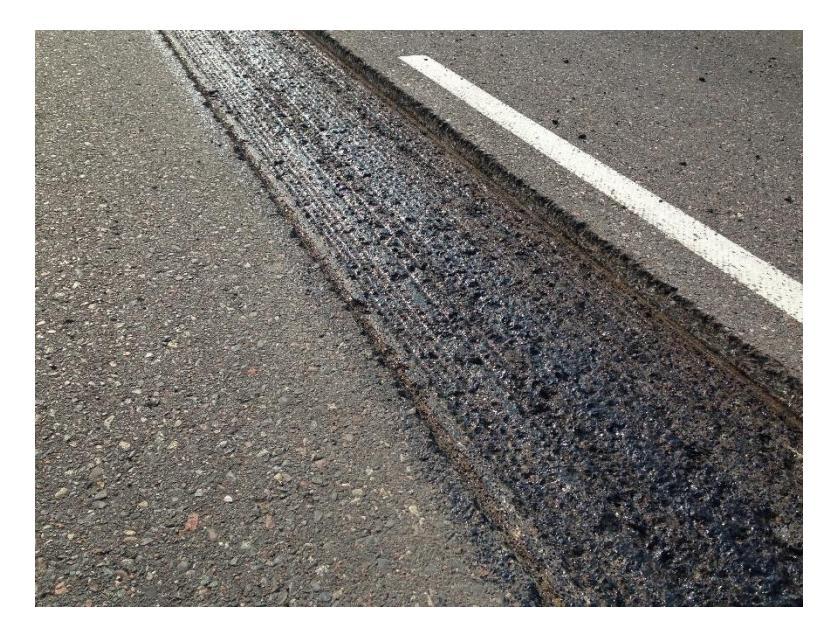
Figure 3.57 Milled Trench.

As shown in Figure 3.57 and Figure 3.58, one issue with the mill and fill operation in Site D was the tacking process used: (i) insufficient amounts of tack was applied to the milled trench and (ii) trucks placing HMA needed to place the truck's wheels into the trench in order to line up where the HMA was discharged. This led to the dirt and debris from truck wheels into the trench which covered some of the tack. Also tack stuck to the truck wheels at many locations further reduced the amount of effective tack. Without a sufficient tack coating, a strong bond at the interface of the patch will not occur, leading to possible delamination or freeze-thaw damage due to water infiltration. Figure 3.63 through Figure 3.65 provide three photographs of the patched locations taken 35 days after the installation of the patching. The patch interface at that time is shown below in Figure 3.66. Improper compaction may also lead to dished areas where hydroplaning and icy surfaces can occur.
