## DEPARTMENT OF TRANSPORTATION

# Comprehensive Field Evaluation of Asphalt Patching Methods and Development of Simple Decision Trees and a Best Practices Manual

## June 2017

Research Project Final Report 2017-25 To request this document in an alternative format, such as braille or large print, call <u>651-366-4718</u> or <u>1-800-657-3774</u> (Greater Minnesota) or email your request to <u>ADArequest.dot@state.mn.us</u>. Please request at least one week in advance.

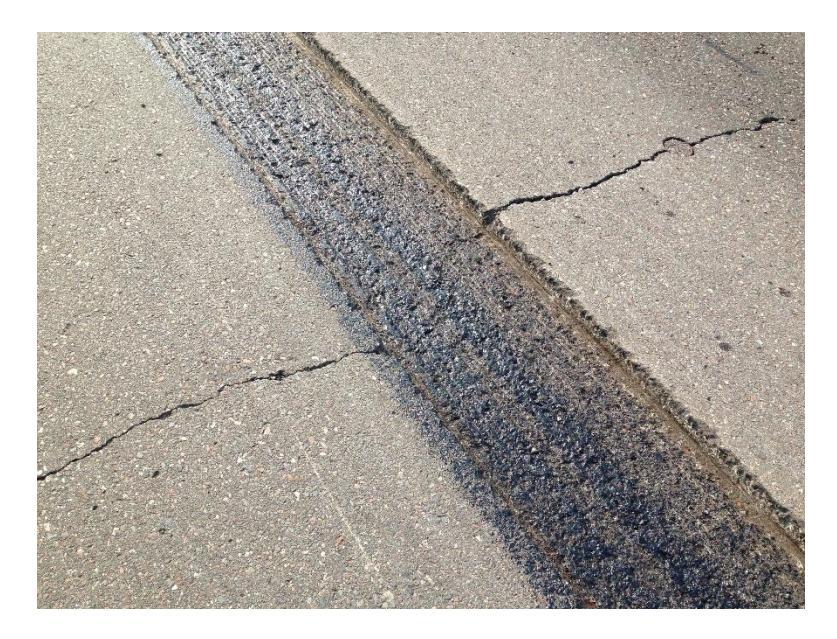
Figure 3.58 Milled Trench with Transverse Crack (Pothole D-3 Location).

As shown in Figure 3.57 and Figure 3.58, one issue with the mill and fill operation in Site D was the tacking process used: (i) insufficient amounts of tack was applied to the milled trench and (ii) trucks placing HMA needed to place the truck's wheels into the trench in order to line up where the HMA was discharged. This led to the dirt and debris from truck wheels into the trench which covered some of the tack. Also tack stuck to the truck wheels at many locations further reduced the amount of effective tack. Without a sufficient tack coating, a strong bond at the interface of the patch will not occur, leading to possible delamination or freeze-thaw damage due to water infiltration. Figure 3.63 through Figure 3.65 provide three photographs of the patched locations taken 35 days after the installation of the patching. The patch interface at that time is shown below in Figure 3.66. Improper compaction may also lead to dished areas where hydroplaning and icy surfaces can occur.

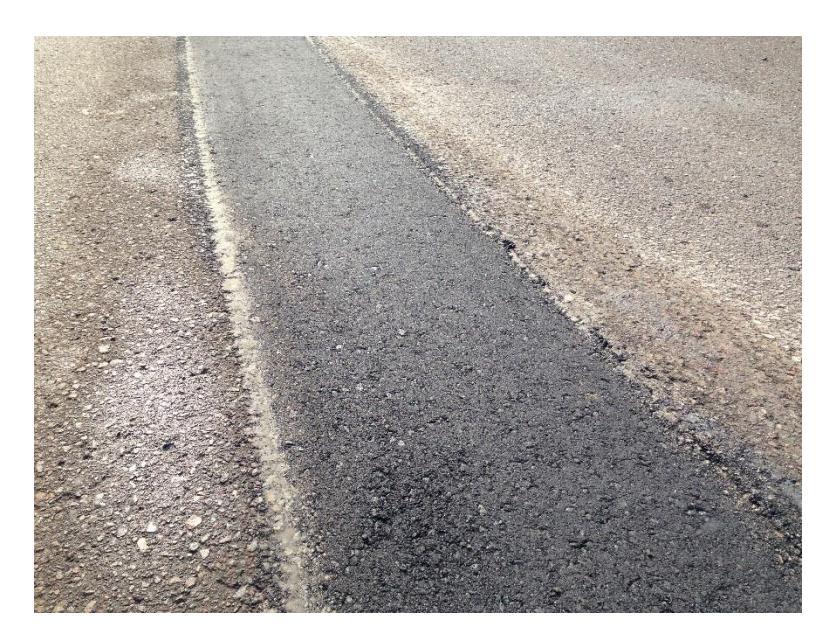
Figure 3.60 Pothole D-2 with Clean Compaction.

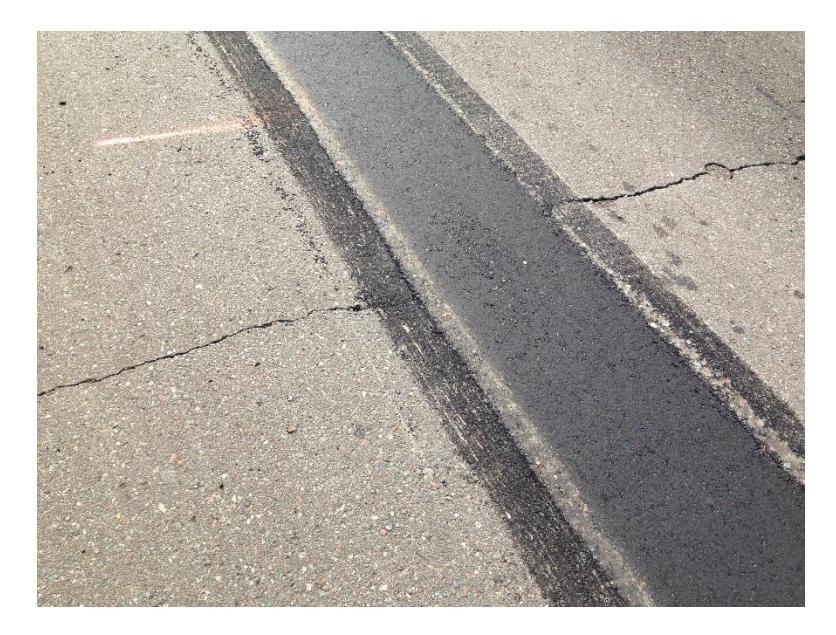
Figure 3.61 Pothole D-3 with Clean Compaction.

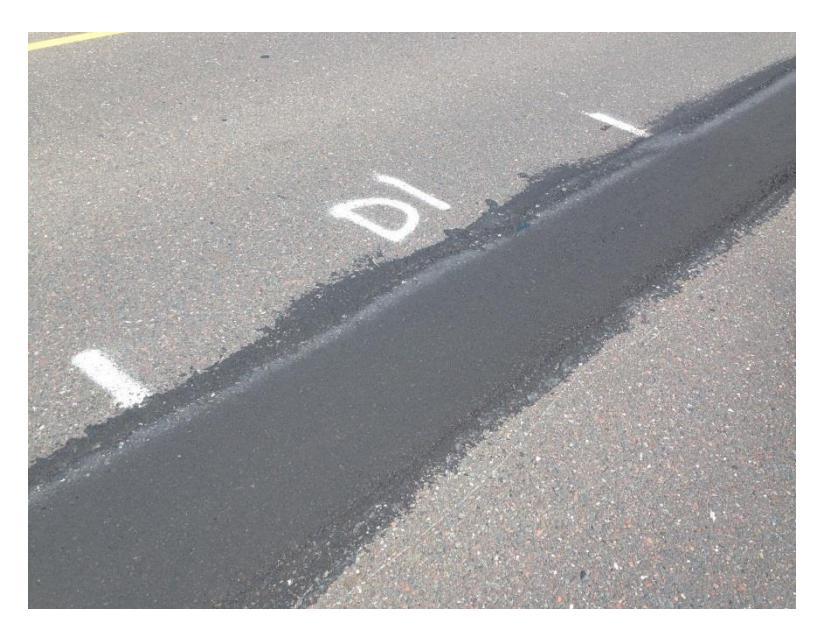
Figure 3.63 Pothole D-1 (35 Days after Patching).

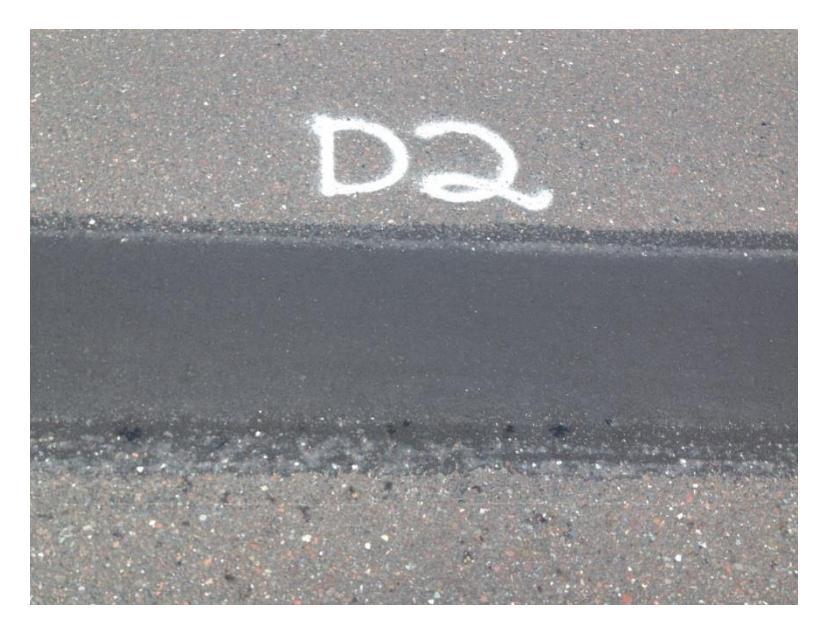
Figure 3.64 Pothole D-2 (35 Days after Patching).

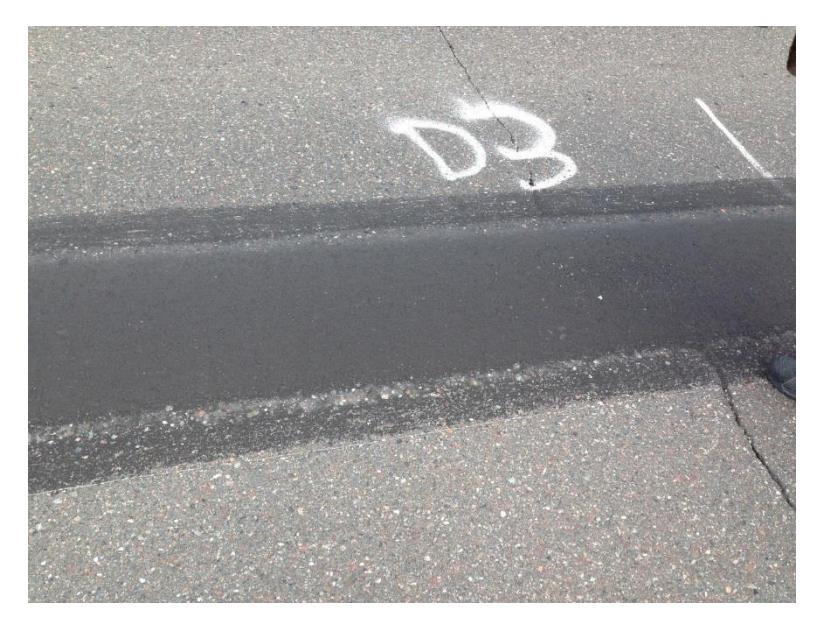
Figure 3.65 Pothole D-3 (35 Days after Patching).

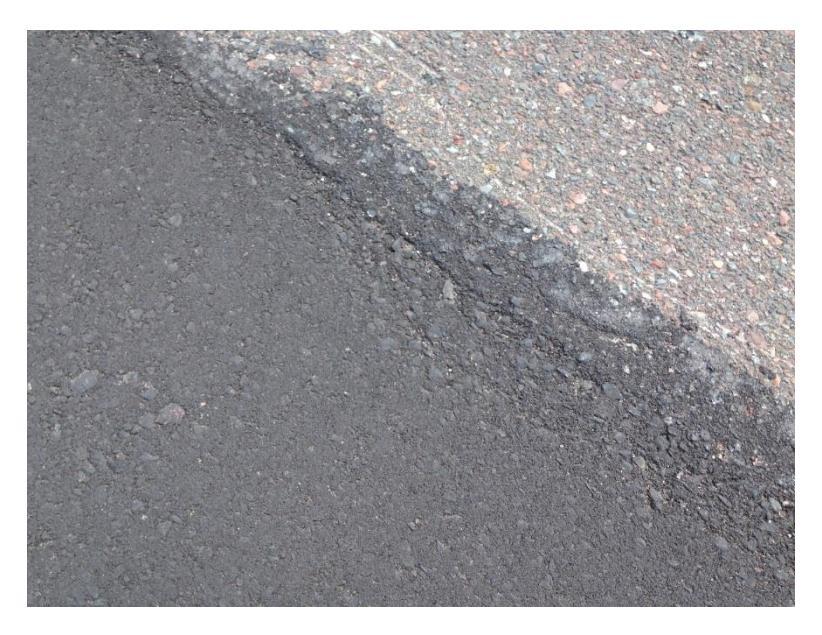
Figure 3.66 Patch Interface (35 Days after Patching).

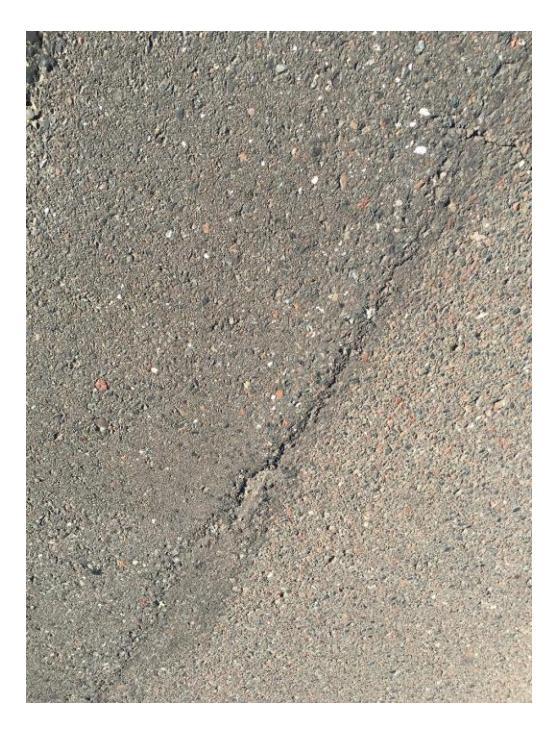
Site visits conducted on July 29, 2015 and October 20, 2015 revealed that severity of the raveling did not increase in second year of service. See Figure 3.69 and Figure 3.70. It was also discovered that the cracks that had propagated through and along the edges of the patches had been sealed sometime during the summer of 2015 (Figure 3.70 and Figure 3.71). This probably helped in arresting the raveling in the year two.

Figure 3.69 Pothole D-1 (446 Days after Installation).

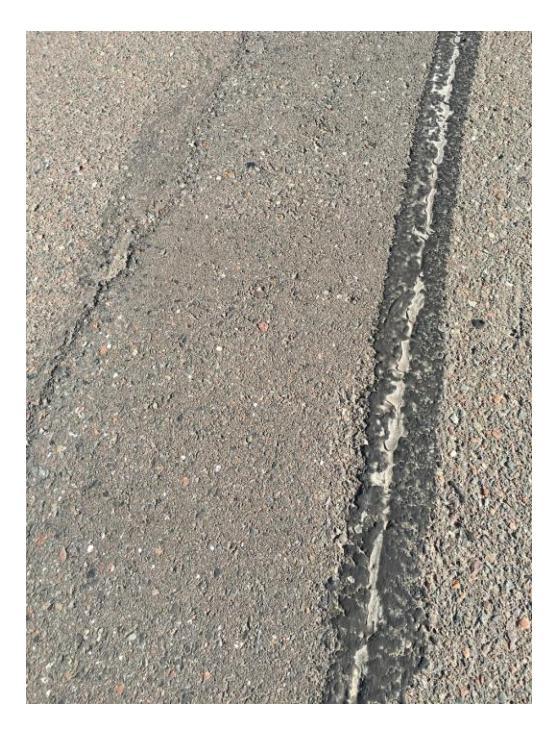
Figure 3.70 Pothole D-2 (426 Days after Patching).

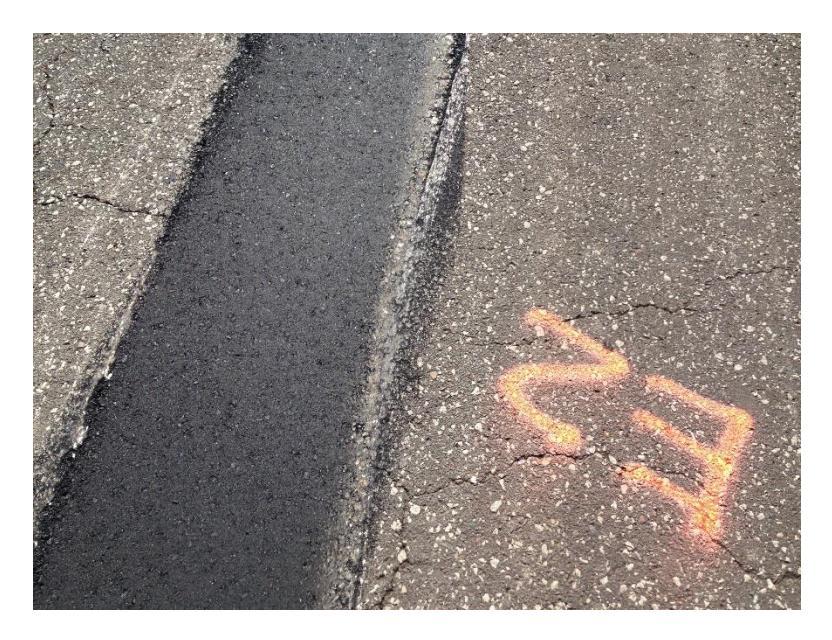
Pothole E-2: This pothole was located in the non-wheel path of the passing lane. The pothole lied along a large longitudinal crack. This crack was along the joint between the driving and passing lane. The pothole was prepped with a milling machine. The size of the milled pothole was 121 inches x 20 inches x 2 inches. Several smaller transverse cracks existed and ran into the milled trench.

Figure 3.73 Pothole E-2 after Compaction.

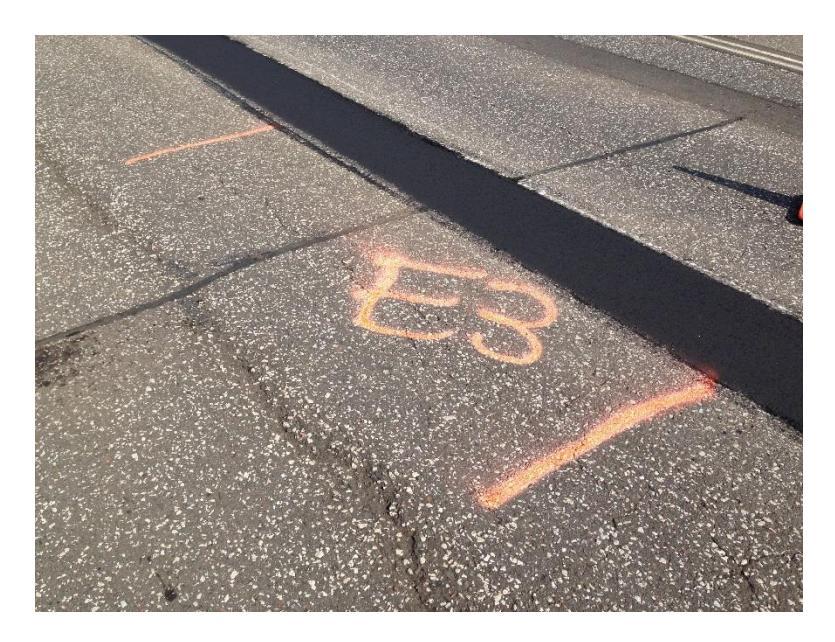
Pothole E-3: This pothole was located in the non-wheel path of the passing lane. The pothole lies along a large longitudinal crack. This crack is along the joint between the driving and passing lane. The pothole was prepped with a milling machine. The size of the milled pothole was 108 inches x 20 inches x 2 inches. Several smaller transverse cracks and one larger sealed transverse crack existed and ran into the milled trench.

Figure 3.74 Pothole E-3 after Compaction.

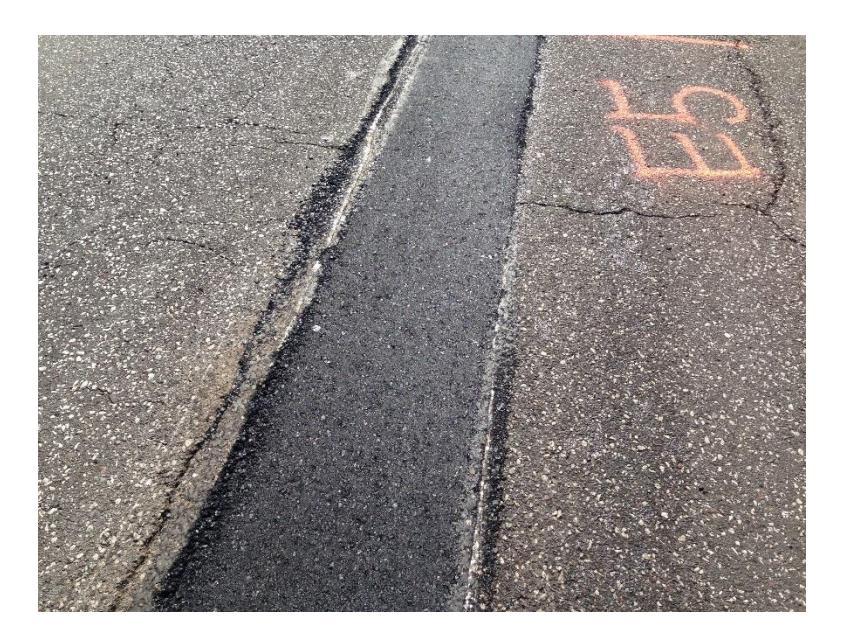
Pothole E-5: This pothole was located in the non-wheel path of the passing lane. The pothole was located along a large longitudinal crack. This crack was along the joint between the driving lane and passing lane. The pothole was prepped with a milling machine. The size of the milled pothole was 121 inches x 20 inches x 2 inches. Several medium sized transverse cracks existed and ran into the milled trench.

Figure 3.76 Pothole E-5 after Compaction.

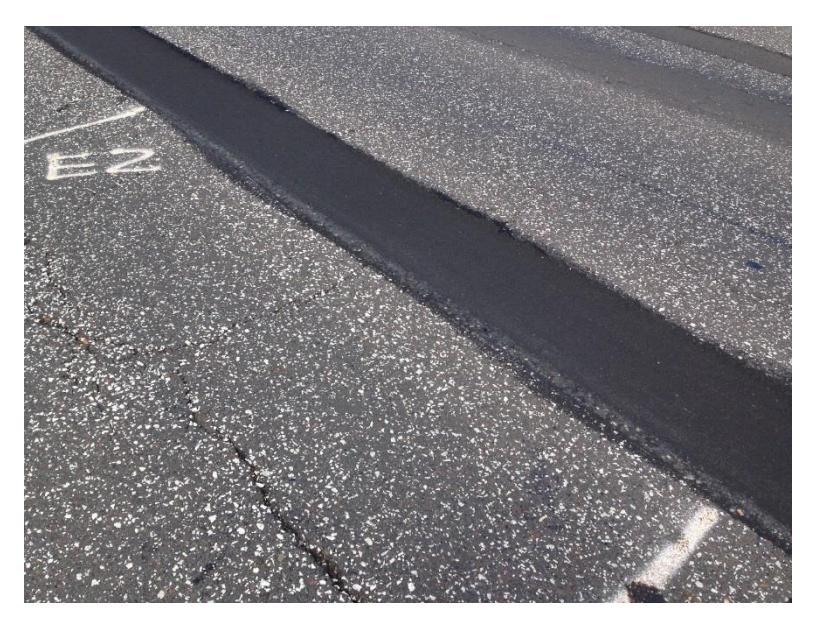
Figure 3.78 through Figure 3.85 provide a visual of how HMA mill and fill patches aged over time at Site E. This site illustrated the importance of proper patching method identification as well as the need for quality workmanship during the patching process. At this site, it was common to see longitudinal cracks parallel to the patch (Figure 3.81 and Figure 3.83). For patch work to be successful, it is imperative that maintenance is performed with quality workmanship. An example of poor workmanship is shown in Figure 3.80 where proper compaction was not applied near the edge of the patch. A final site visit for

Figure 3.78 Pothole E-2 (28 Days after Patching).

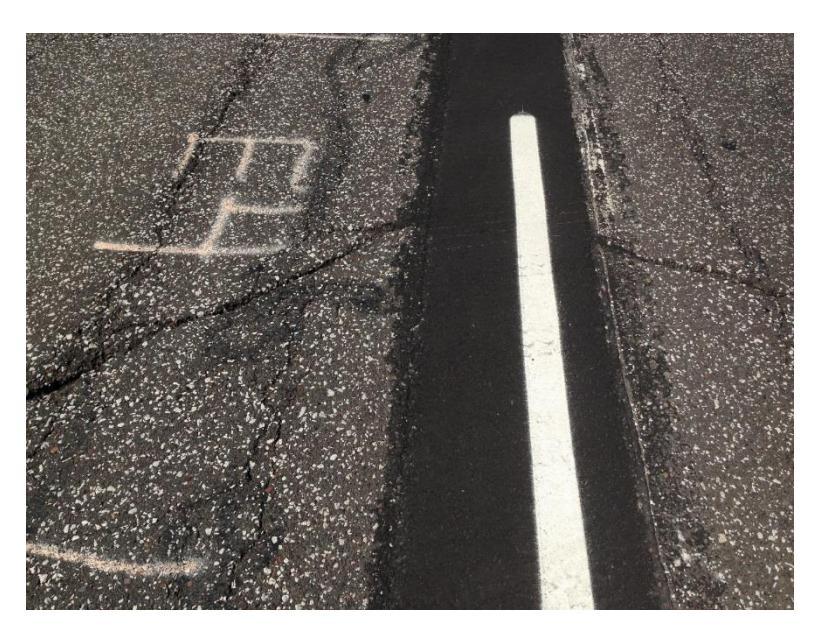
Figure 3.79 Pothole E-4 (28 Days after Patching).

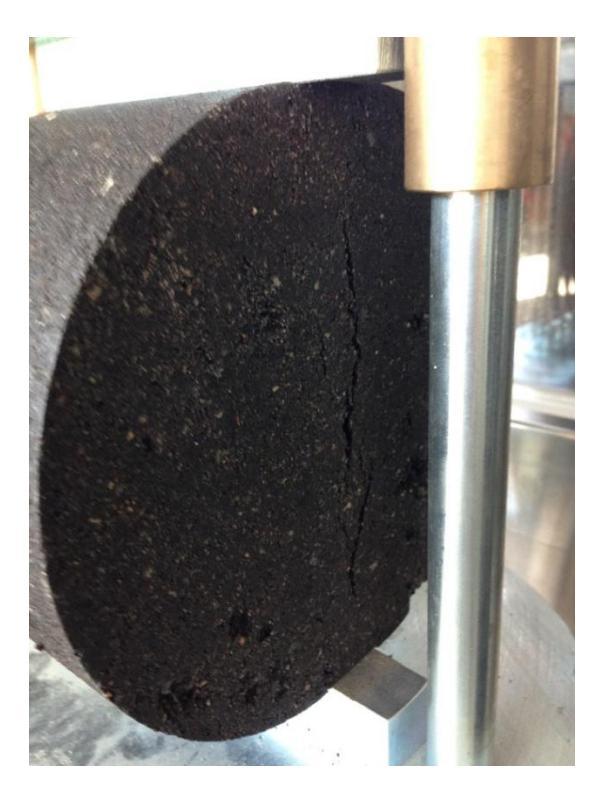
After seven days of curing, samples were tested for their indirect tensile strength. The test apparatus is shown below in Figure A4. Samples were placed in compression at a test rate of 25 mm/min. Data including the load, time, extension, stress, and strain on the sample are recorded for later analysis. Cracking of the samples occurs during testing and usually indicates the peak load has been reached (Figure A5).

Figure A5: Cracking of Sample due to Testing of Indirect Tensile Strength.
