What Can Be Expected With Multi-Lane Roundabouts?

June 2016 www.LRRB.org Report #2016RIC12

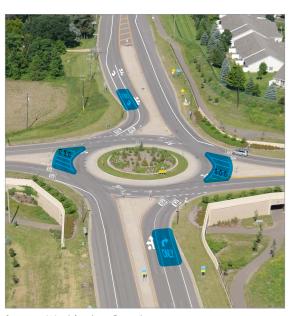
Source: Washington County
Modification indicated by blue highlight

Do not build for 20-year forecasts

Constructing roundabouts with more lanes than are needed for current traffic levels can create unnecessary opportunities for driver error. Roundabouts can be constructed to accommodate future expansion, yet be configured for current traffic levels to prevent driver error and to reinforce proper driving behaviors. This image shows a roundabout that was originally built to accommodate two through lanes in all directions, but was later modified such that the minor street approaches have only one through lane in the short term, thus reducing driver error and crashes.
