TECHNICAL SUMMARY

Assessment of GFRP-Reinforced Bridge Deck Performance

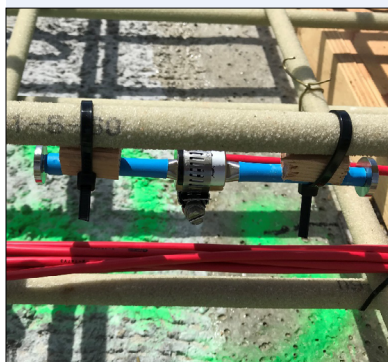
A GFRP sample underwent a variety of lab tests to demonstrate its material characteristics.

In the laboratory, GFRP samples supplied by MnDOT underwent tension loading until failure, enabling researchers to develop stress-strain curves to confirm the material's mechanical properties. Lastly, life-cycle cost analyses of the two bridge decks, including construction, materials, labor, operation and long-term maintenance costs, evaluated the economic potential of GFRP rebar as compared to traditional steel.

Lab tests indicated that the GFRP rebar has a high tensile strength, however, it is more brittle than steel, resulting in a more sudden failure unlike steel's more gradual yielding under stress. Because single GFRP rebars would not bear exceeded capacity, any GFRP failure will likely be more drawn out, providing warning of a potential failure.

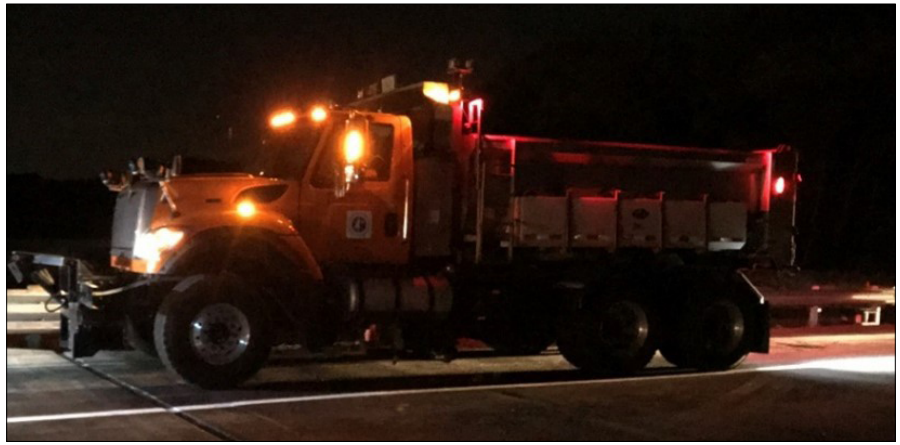
Girder distribution factors calculated from strain measurements taken during live-load testing were comparable to those calculated using AASHTO bridge design specifications.

Additional instrumentation attached to the girders and the bridge decks measured stresses and strains during live-load testing immediately after construction, after one year and after two years. The live-load tests replicated traffic load effects and were used to understand how the live loads are distributed from the points of application to the bridge deck and individual girders.

The live-load testing showed the performance of the bridge decks was comparable and consistent with design specifications. Similarly, long-term monitoring data revealed that while the GFRP deck recorded slightly higher strain values overall, the two decks behaved similarly over the monitoring period.
